Series F

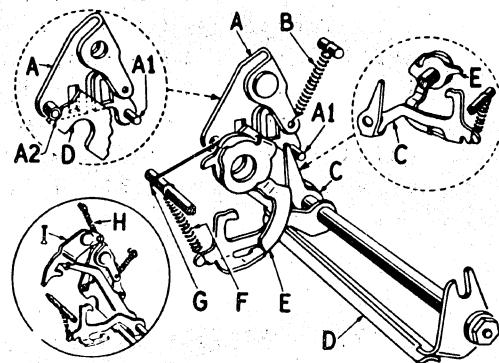
**1-CARRY FAILURE IN THE FIRST COLUMN**  
will be prevented by installing improved parts B, C, D, F, and G as illustrated.

Spring B is stronger to provide a more positive detenting action of bail D. Adding rack stop C is redesigned by removal of part of its upper extension. Carry bail D is reinforced to prevent weaving and loss of driving action between the last and first columns. Spring F is lighter to permit easier tripping of the adding rack stop C. Spring G is assembled on the intermediate rack stop E in the first column to assure positive indexing of a tripped carry.

Removal of the upper end of the extension of rack stop C requires the removal of latch I and spring H.

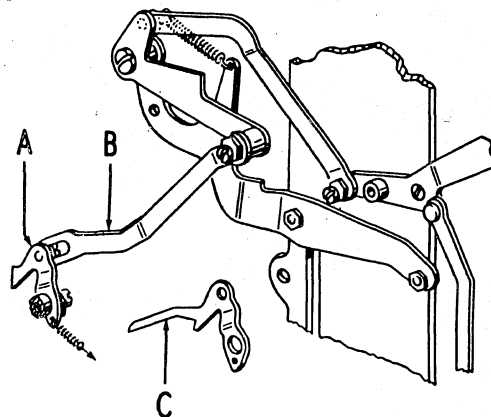
**2-INCORRECT FORM SPACING** caused by loosening of screw A (illustrated) may be eliminated by installing straight tubular rolled pin X36-7 (Mecanogram No. 549, Item 2) to secure the platen firmly to platen shaft B.

Installation requires drilling of the platen hub and platen shaft at right angle to screw A. Use drill Kit 260 No. 42 (.0935).

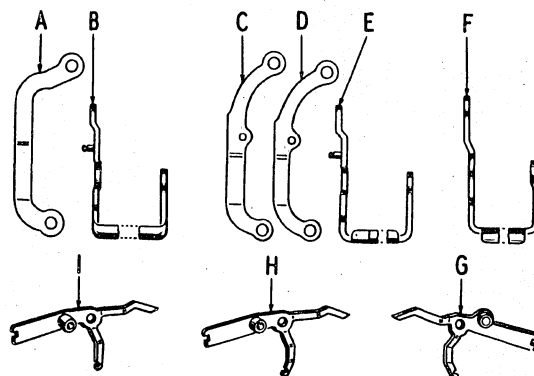
1-REPLACEMENT OF A HAMMER BLOCK BAIL P OR R, OR CONTROL ARM V OR W (PLATE 6, PRINTING SYMBOL LIST) will be facilitated by using one of the following blank hardened bails or bail control arms and grinding it to the desired outline:

The bail or control arm to be replaced may be used as a template for scribing the desired outline on the replacement part. Care should be used when grinding the bail or arm to avoid excessive heating which may result in loss of hardening.

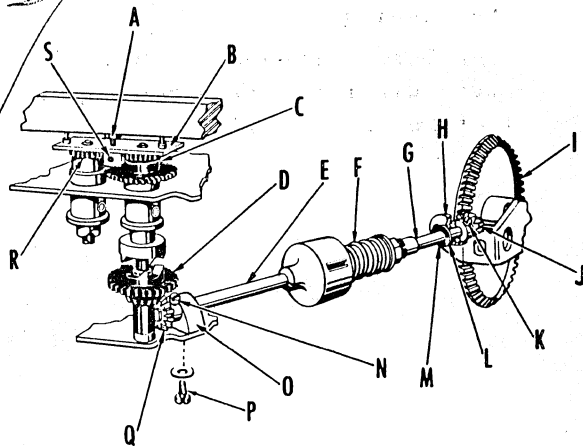
1-WEAR OF CARRIAGE DRIVE GEARS D, I, J AND Q in illustration, will be overcome by using the following revised tests and adjustments. Several part changes are also noted below. The revised tests and adjustments should be used with or without a change of parts in the machine.

1. Gear Q (FG106) and its mating gear on assembly D (1FG108) are case hardened and copper plated for identification. If gear D is worn, both gears D and Q should be replaced with the new copper plated gears.

However, if only gear Q is worn, the older cadmium plated gear 408303A may be used for replacement. Soft gears should not be mated with hard gears as severe wear will result.

1. Loosen screws K and P
2. Discard screw N when using shafts E without clearance cut.
3. Reduce end play of spindle C to approximately .003". In current construction, loosen set screw S and place a .003" feeler gauge between the bearing on plate B and spindle C. With the other bearing on plate B limiting against the top of spindle R, adjust screw A for a snug fit of the feeler gauge. Tighten set screw S.
4. Add or remove washers L, between clip M and bracket H, for .005" to .025" overall end play of clutch assembly between bracket H and hub of gear D.

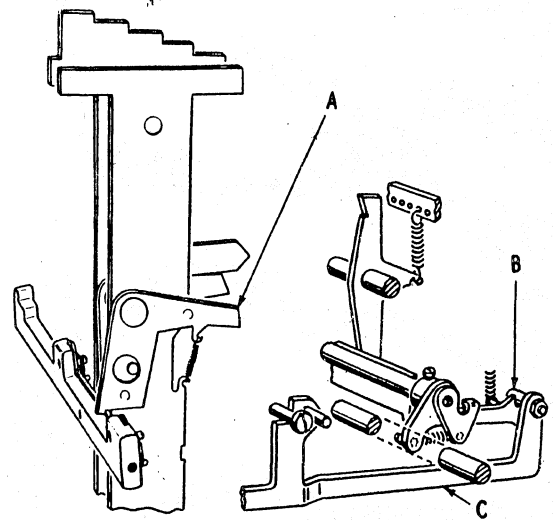
**1-CONTINUOUS MACHINE OPERATIONS IN SERIES M200 MACHINES** may result from failure of lift pawl A to be released before power indexing slide C is released. Inability to adjust for the proper timing relationship between the releasing of these two parts may be caused by the horizontal arm of the lift pawl being too long.

The arm of lift pawl A on cipher multiplier plate and full cent plate 1A-74107 No. 1 and on tens multiplier plates 1A-74107 Nos. 2, 4, 6, 8, 10, 12, 14, 16, 18, and subtract plate 1A-16 1/2A Fte. 134 has been shortened .015" beginning with Machine Serial No. M9029D so that eccentric screw B may be adjusted for releasing slide C after the lift pawl has been released.

The arm of the lift pawl on the second cycle (Unit) multiplier plates has also been shortened to the same dimension as the above numbered plates, beginning with Machine Serial No. M9296D.

Machines prior to Serial No. M9029D containing pawls A that are difficult to adjust for proper timing of release should have the multiplier plates replaced with plates containing the shorter lift pawls. Plates with the shorter lift pawl are being temporarily identified with red paint in or near the stamped plate numbers.

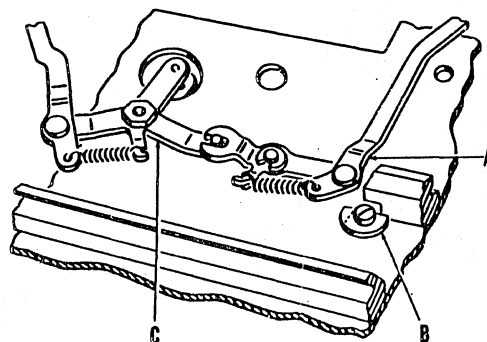
**1-BREAKAGE OF RIBBON FEED ARM ASSEMBLY C (BP, PLATE 31-4, SERIES P CARRIAGE PARTS CATALOGUE)** may be caused by a false limit of arm A against washer B. Stock should be removed from this washer as indicated by the dotted lines in the illustration during the next attention.

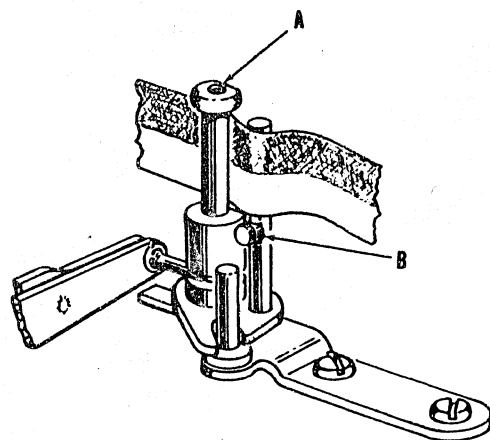
**3-PARTIAL BLACK AND RED PRINT CAUSED BY sagging of the ribbon on styles NA-2 and W2 carriages** will be corrected by installing improved ribbon guide post assemblies A (1-83205R and L) containing guide roller B.

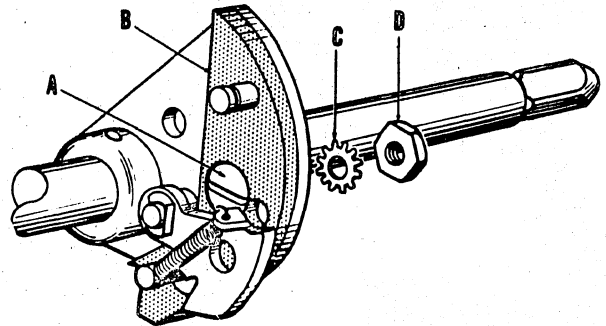
Wear of cam AG will be prevented by installing auxiliary cam B as illustrated. It should be installed in all Series P machines (between serial numbers P146871D to P174985D and P18011C to P20797C) on the next attention.

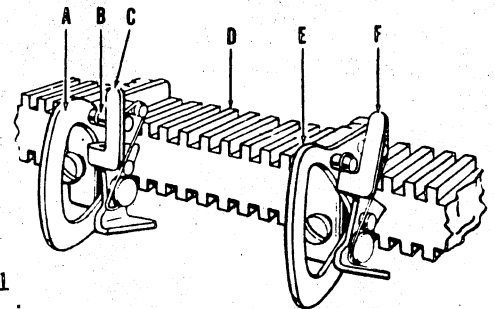
**3-FAILURE OF CARRIAGES ON SERIES P400 AND P600 MACHINES TO SKIP TABULATE INACTIVE COLUMNS** may be caused by limit stop E becoming partially dislodged from stop bar D during the changing of lever F from skip to normal position.

Improved stops (1-903215 No. 6 for P400, and 11-903215 No. 6 for P600 machines) now contain longer stud B which provides a limit for lever C as it is moved from skip to normal position thereby safeguarding the stop from being partially dislodged from bar D.
