ERRATA

IMSAI SYSTEM
 CP-A REV. 4
 COMPONENT SIDE
 ECO 77-098

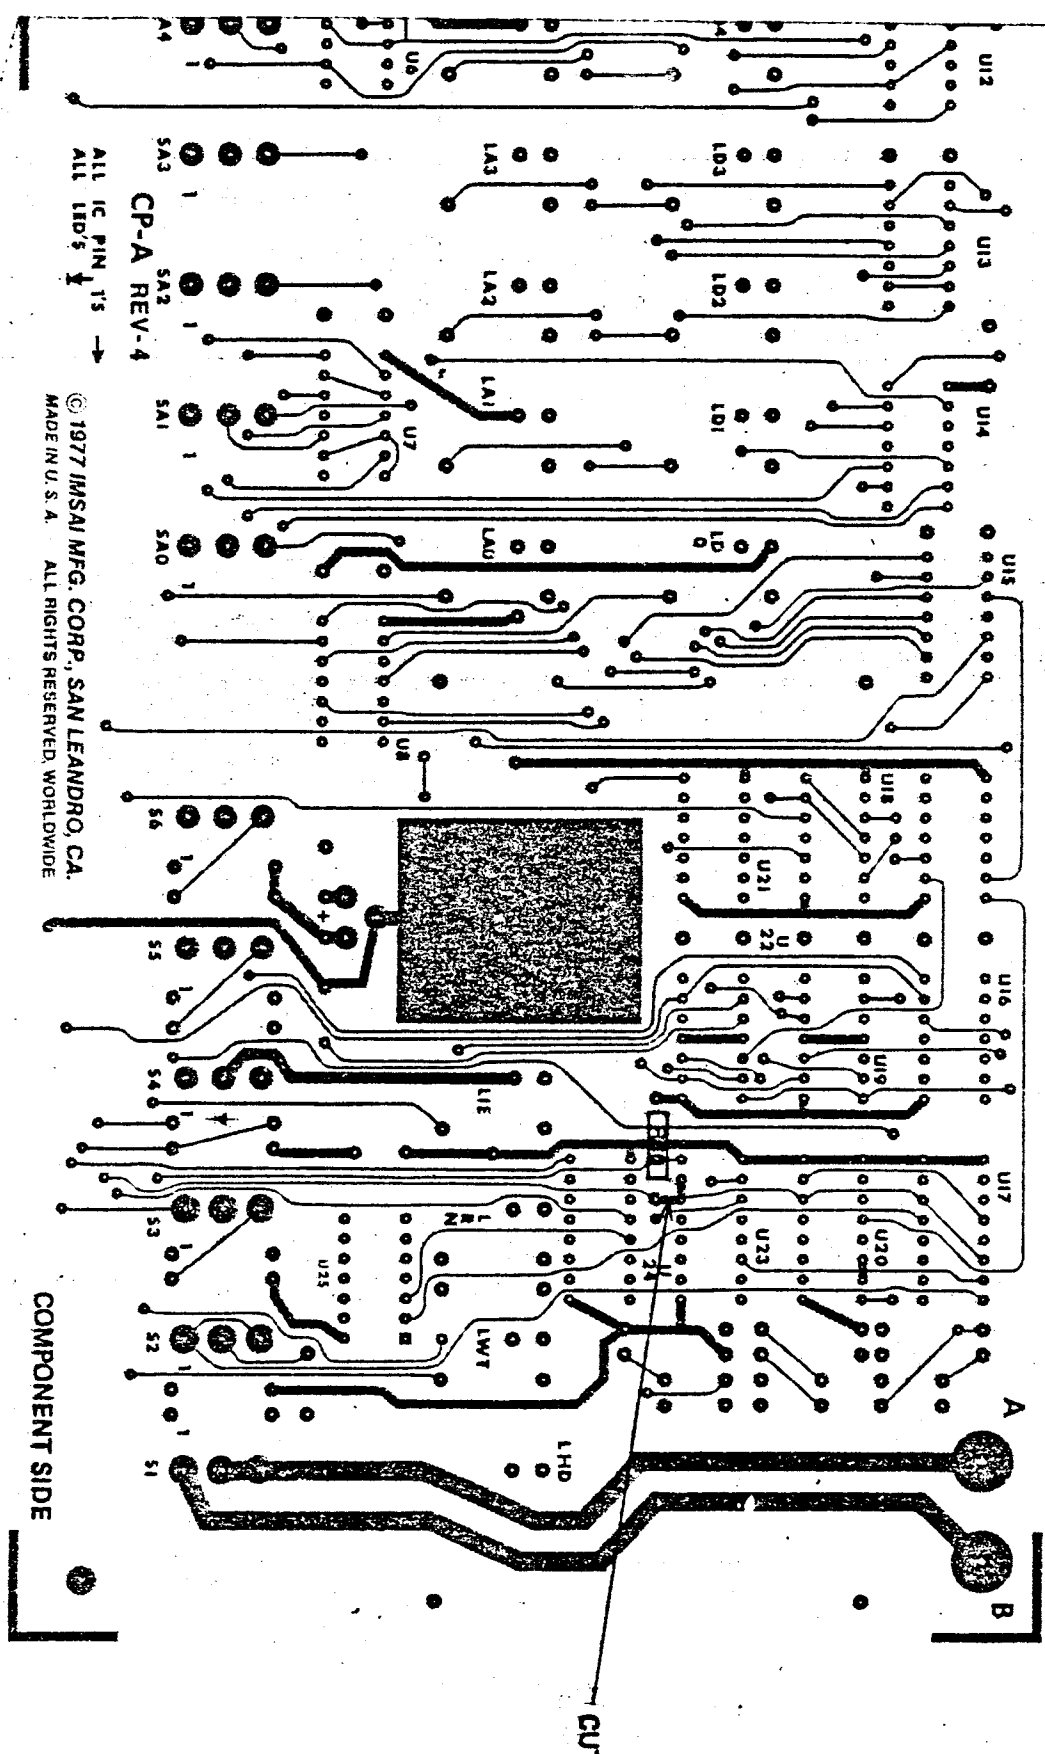
These modifications should be made to prevent the spurious triggering of one-shots on the CP-A while in RUN mode, causing unpredictable program execution.

This modification will disable one-shots (3 74123 Dual Monostable Multivibrators) during RUN.

1) Cut the trace between U23, Pin 11 and R60.
