TITLE HIGH RELIABILITY THYRISTOR (TRIAC)			PIB NO. DK- 3005
PRODUCT LINE:	TAPE DISK FORMATTER <input checked="" type="checkbox"/>	EQUIPMENT CHANGED MCB (Motor Control 102826-XX Ed.)	MODEL SERIES AFFECTED D3000
			EFFECTIVE DATE 11-5-73

TITLE HIGH RELIABILITY THYRISTOR (TRIAC)

PIB NO.
DK- 3005

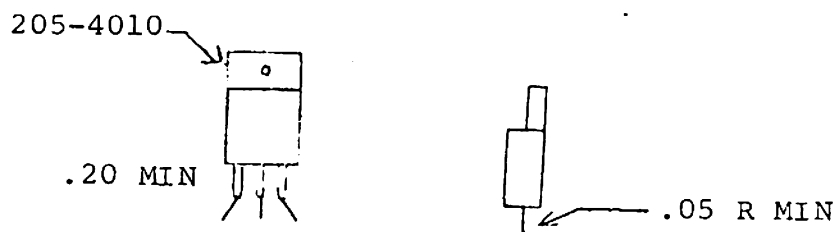
The lead to lead spacing of the (new) triac, 205-4010, is narrower than the original triac (205-0106). The two outside leads of the new part shall be bent outward slightly to attain the proper lead spacing as shown below:
