**TITLE** UPPER SECTOR TRANSDUCER ADJUSTMENT

**PIB NO.**  
DK- 3013

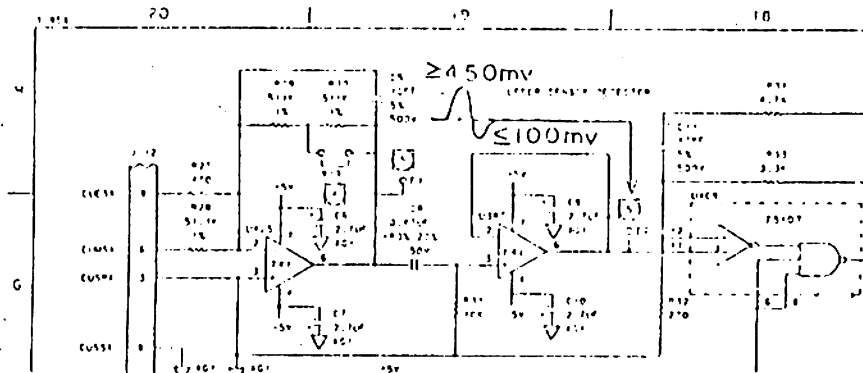
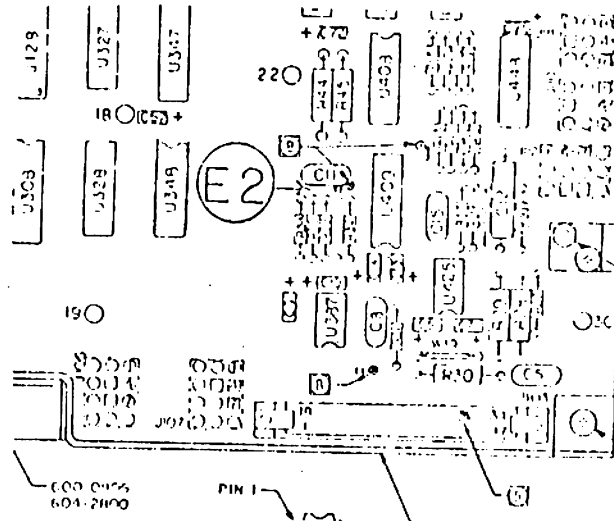
FIGURE 1

(Only Part of Schematics Shown for Clarity)

- 1.3 Upper sector transducer may be adjusted by utilizing D3000 manual Rev. C., Pages 6-128, 6-130, Section 6-18 (Magnetic Transducer Gap).

A DISK PACK MAY BE DISASSEMBLED AND THE SECTOR RING USED FOR ADJUSTMENT IF NO ADAPTER BOWL SET-UP TOOL (103619-01) IS AVAILABLE.
