PRODUCT IMPROVEMENT BULLETIN

TITLE D3000 OPERATOR CONTROL PANEL SWITCHES					рів NO. DK3031
ORODUCT TAPE II DISK IX LINE: FORMATTER II	EQUIPMENT CHANGED Switch 102357-XX		MODEL SERIES AFFECTED D3000		EFFECTIVE DATE 4/15/75
CLASS OF BULLETIN:		ORDER PART KIT NQ.		EFFECTIVITY	
■ IMPROVEMENT □ RETROFIT ON FAILURE □ RETROFIT RECOMMENDED IX SERVICE INFORMATION ONLY		N/A		All D3000 Disk Drives	
				_

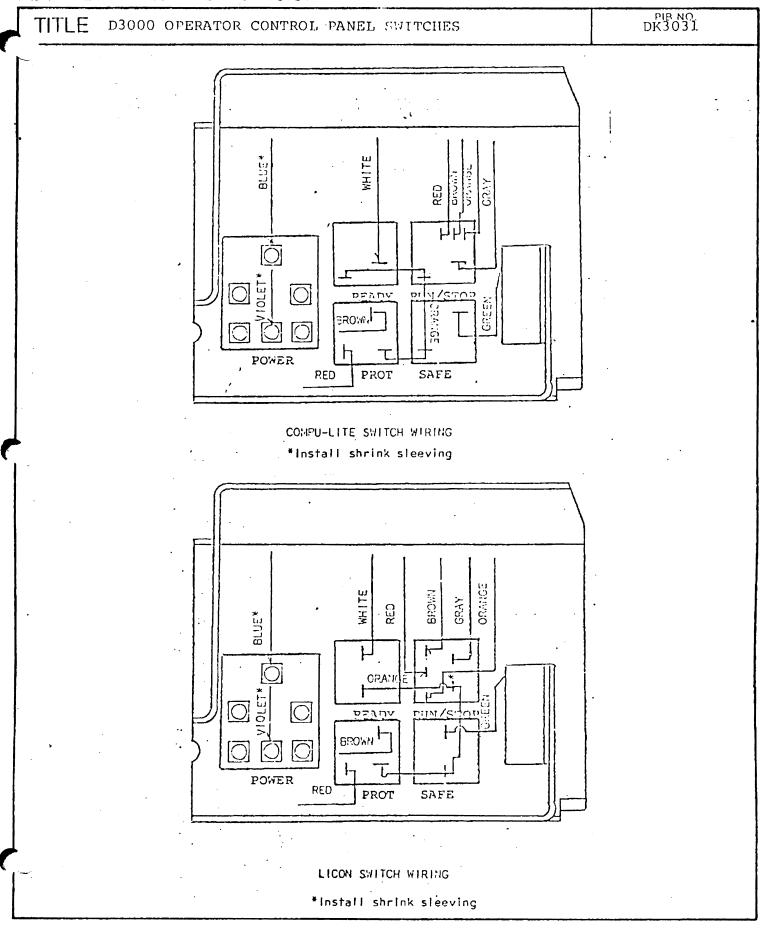
- When replacing a switch in the operator control panel, refer to appropriate figure for wiring. (Attached)
- Ensure that before installing the switch that the switch terminals are twisted 45°. If the 45° twist does not exist, the terminal could be pushed into the switch body causing damage inside the switch.
