PERIPHERAL EQUIPMENT DIVISION

TITLE TO ELIMINATE SHORTING OF NTRHGC AND NLAU2G ON 200 TPI			PIB NO. DK3035		
PRODUCT LINE:	TAPE DISK FORMATTER	EQUIPMENT CHANGED Logic PCBA 103685	MODEL SERIES AFFECTED D3000	EFFECTIVE DATE 5/16/75	
CLASS OF BULLETIN:		ORDER PART KIT NO.:	EFFECTIVITY		
<input type="checkbox"/> IMPROVEMENT <input type="checkbox"/> RETROFIT ON FAILURE <input checked="" type="checkbox"/> RETROFIT RECOMMENDED <input type="checkbox"/> SERVICE INFORMATION ONLY		N/A	All OPT46 200 TPI Disk Drives prior to S/N 151600202 with part number 901581, 901587, 901588, 901590 & 901597.		
PURPOSE: There is a possibility that some D3000, 200 TPI, DIABLO OPT46 compatible disk drives were shipped with the internal temperature go line and attention line # 2 shorted together. All drives listed in the effectivity block should be checked for this condition. The attached wire list provides the necessary circuitry to make these signals available at the I/O interface.

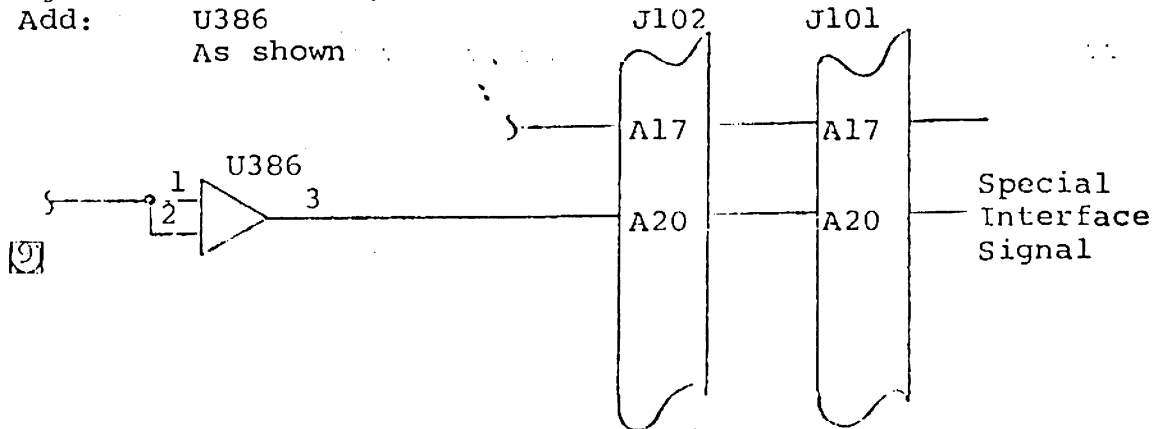
Drawing 103684, Sheet 3, Zone G/11

Add: U386
As shown

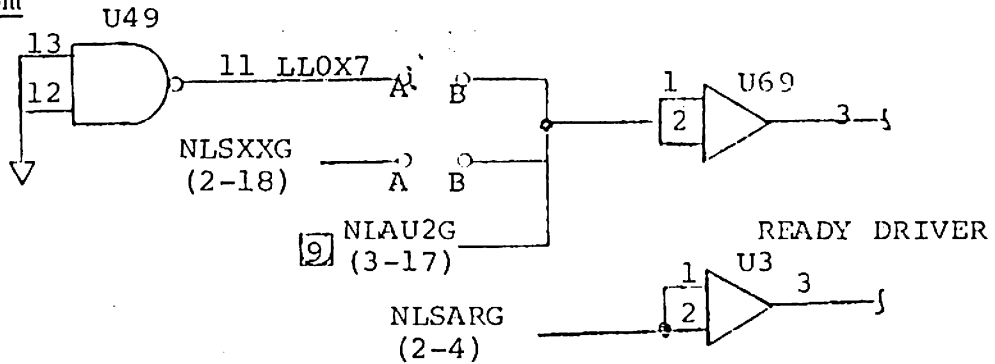
From

103684, Sheet 3, Zone B/18, 19

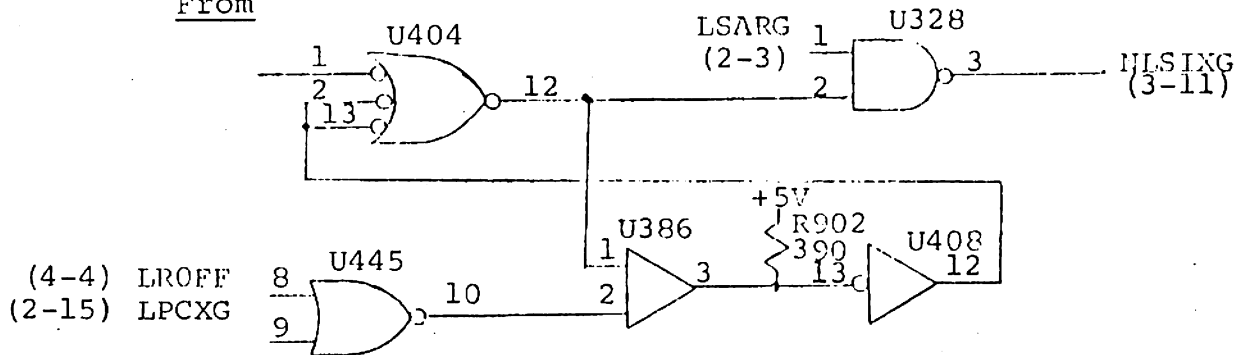
From

103684, Sheet 4, Zone C/6, 7, 8

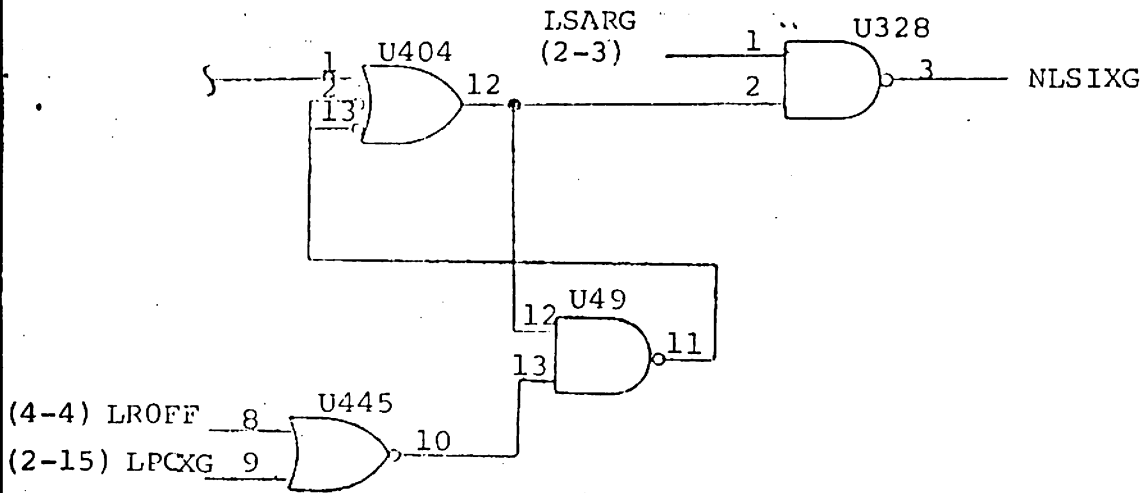
To

Address Error Latch
