TITLE SERVO, X+O CHANGING			PIB NO. DK3066	
PRODUCT LINE:	TAPE DISK FORMATTER X	EQUIPMENT CHANGED N/A	MODEL SERIES AFFECTED D3000	EFFECTIVE DATE 2/15/77

TITLE SERVO, X+0 CHANGING

PIB NO.
DK3066

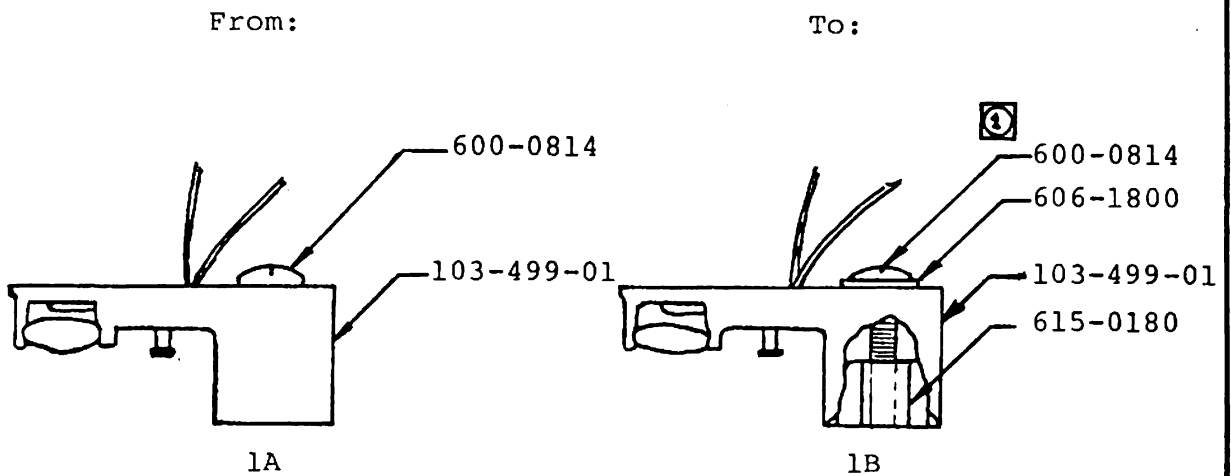
(FIGURE 1)

Loose Lamp and Lens Assembly, resulting in gain change of X+O signal.

① Torque 10-15 inch pounds.

1. Remove Lamp and Lens Assy - exercise caution as not to scratch the Glass Scale Assembly.
2. Remount the Lamp and Lens Assembly with the spacer P/N 606-1800 inside the body. (See Figure 1B).
3. Install screw (8-32x7/8) with #8 washer (P/N 606-1800)
4. Tighten screw to 10-15 inch pounds (or tighten until SNUG plus 15°, if Torque Wrench is unavailable).
5. Insure that the Sensor Receiver Assembly (A.K.A. Reticle) to Scale clearance is .005 ± .001 inch, by adjusting the post height with the screw located in the center of the post.
