PRODUCT IMPROVEMENT BULLETIN

TITLE CARTRIDGE DOOR C	PIB NO. DK 3067				
RODUCT TAPE (DISK X FORMATTER	EQUIPMEN	A MODEL SERIES AFFECTED D3000 (Front loads)		EFFECTIVE DATE 2/15/77	
CLASS OF BULLETIN:		ORDER PAR KIT NO.	EFFE EFFE	EFFECTIVITY	
(_) IMPROVEMENT (X) RETROFIT ON FAILURE		N/A	Front load D3	000 prior to april	
[] RETROFIT RECOMMENDED [] SERVICE INFORMATION ONLY

TITLE CARTRIDGE DOOR OPENER BINDING ON FRONT LOADS

PIB NO. DK3067

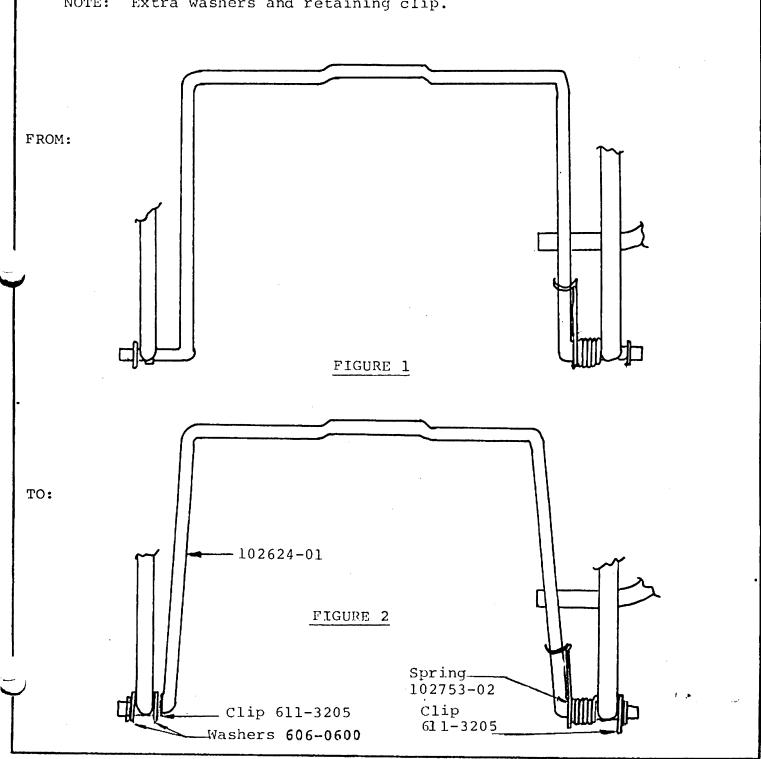
To inform customers of a dimension change to the Door Opener (P/N 102624-01) and Spring (P/N 102753-02) that would insure the return of the Cartridge Door Opener to its original position.

Excessive binding of the cartridge-Door-Opener, resulting in failure to open the Disk Cartridge upon insertion.

- 1. Remove old Door-Opener and hardware.
- Install new Door-Opener, identifiable by dimension change; (See figure 1 below)
- 3. Install new Spring and hardward in accordance with Figure 2. NOTE: Extra washers and retaining clip.
