PRODUCT IMPROVEMENT BULLETIN

TITLE IMPROVE AIR CLEANINESS IN DISK CAVITY						PIB NO. <i>DK3073</i>
PRODUCT TAPE [: DISK X LINE: FORMATTER :		EQUIPMENT CHANGED Lower Disk Cover		MODEL SERIES AFFECTED D3XXX		EFFECTIVE DATE 2/1/78
CLASS OF BULLETIN:			ORDER PART KIT NO. 108120-01		EFFECTIVITY All D3000 Top and Front Load Excluding the D3000 Extension.	
x IMPROVEMENT						
RETROFIT ON FAILURE			TIME REQUIRED			
x RETROFIT RECOMMENDED						
[SERVICE INFORMATION ONLY

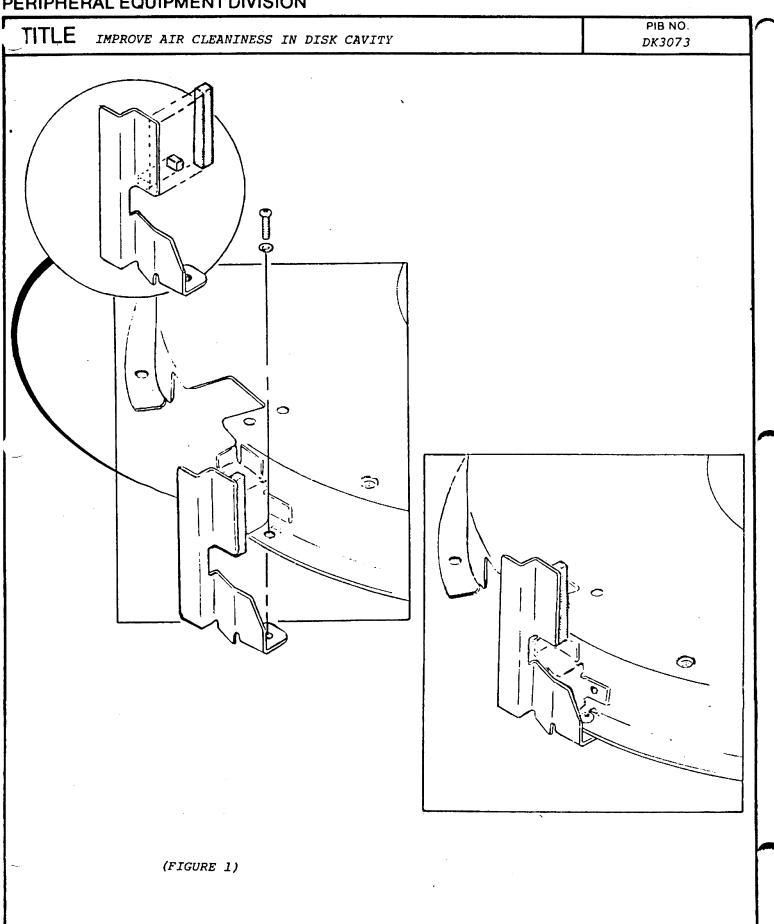
Excessive head crashes contributed to environments not complying to "clean room" standards.

INSTALLATION PROCEDURE: (See figure 1)

- 1) Remove power from unit.
- 2) Raise Logic PCBA.
- 3) Locate Hole in lower Disk Cover adjacent to white Disk Guide.
- 4) Install Baffle as per Figure 1.
 - a. Slip lower lip of baffle underneath the hole located in step 3.
- 5) Install phillips head screw (10-32X5/16) with lock washer.

- 1) Bending and or adjustment of the Baffle may be necessary to ensure a snug fit of the foam against the Lower Disk Cover.
- 2) Verify that the Bail Door Opener (P/N 102624) can be moved throughout its range without interference.
- 3) Ensure that the Positioner does not interfere when at its inner most position.
 - a. Power on
 - b. Remove J205
 - c. Install Disk Cartridge
 - d. Depress Run Switch
 - e. After 20 seconds manually Load Heads on to media, and check for interference. NOTE: If interference is not present, return to original configuration.
