SERVICE LETTER

NUMBER: DK3013

SUBJECT: POSITIONER OPTIC CHECKLIST

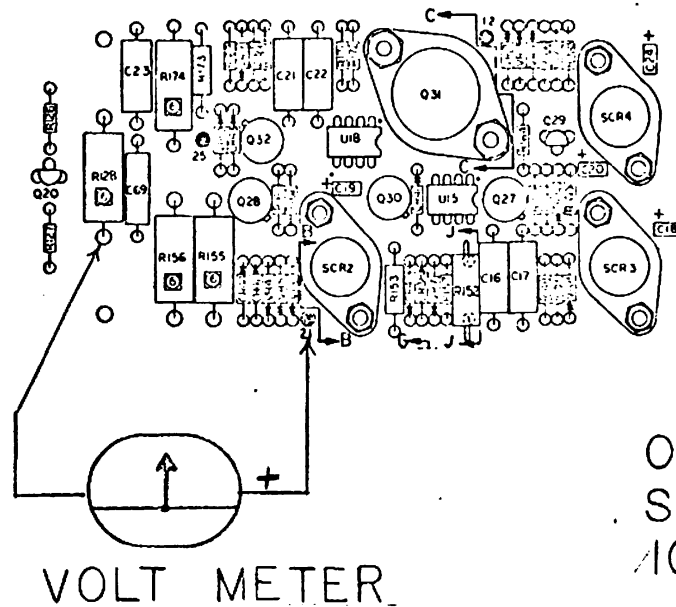
FIGURE 1

- a. The amplitudes of X+90 and X+0 have been decreasing slowly and have required several adjustments of R79 and R69 over extended periods of time (weeks or months)
- b. A lamp voltage, as measured between TP21 and the lower lead of R128 on the servo PCBA, greater than 5.2 VDC will decrease lamp life. (See Fig. 1, Page 4)
- c. A lamp voltage, as measured between TP21 and R128 on the Servo PCBA, is 4.6V or less is an indication that blackening has already occurred.

ONLY PART OF
SERVO BOARD
102811 IS SHOWN

- a. On the Servo PCBA, use TP21 as the positive terminal and the lower lead of R128 as the return (SEE Fig. 1, Pg. 3)
- b. An initial lamp voltage of 4.6V or lower indicates blackening has probably already occurred. Recommended action is replacement of the lamp assembly and incorporation of FCN DK3006.

- c. If the voltage across the lamp exceeds +5.21 VDC, the lamp voltage shall be considered excessive and FCN DK3006, Lamp Portion, Section V-A should be incorporated into the Servo PCBA. The lamp voltage measured prior to FCN DK3006, or lamp assembly replacement, was C4 _____. and list C4 on CSR in area provided for comments.
