BFD-68 Boot Delay after Power On

When using the BFD-68 controller, there is a 10 second delay after jumping to \$8020 (to boot the disk) until any disk activity takes place. The 68A version of the board does not have this issue. This paper describes why this problem occurs.

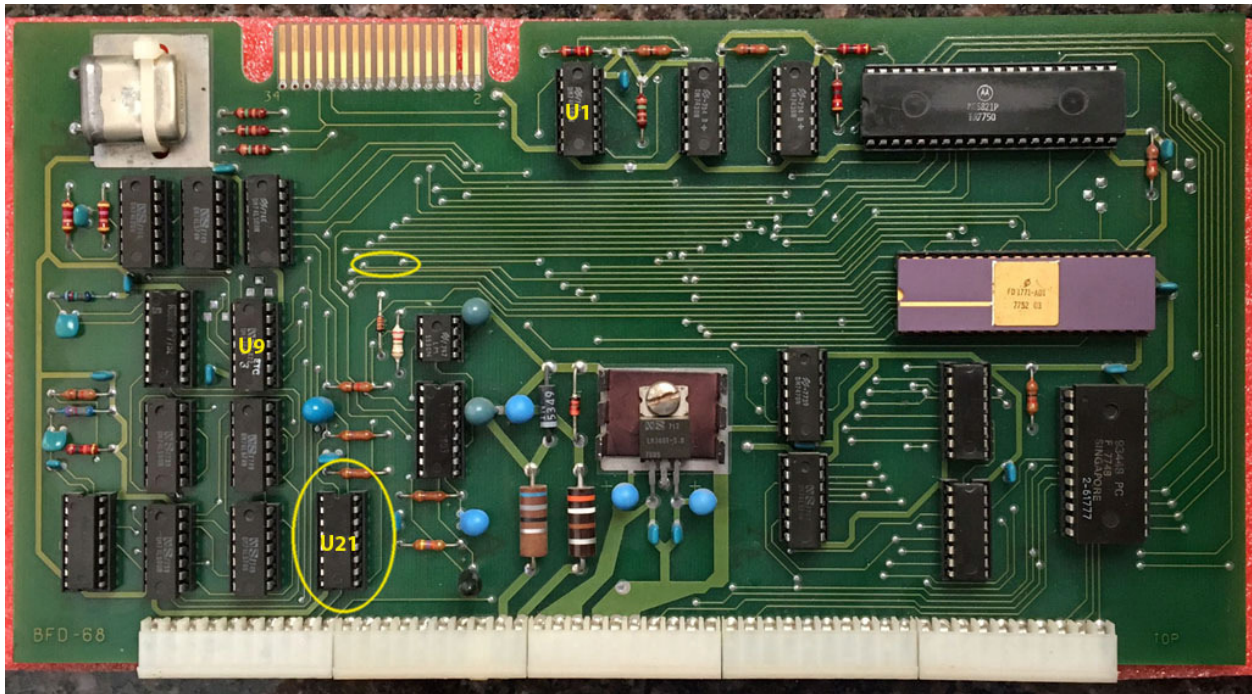
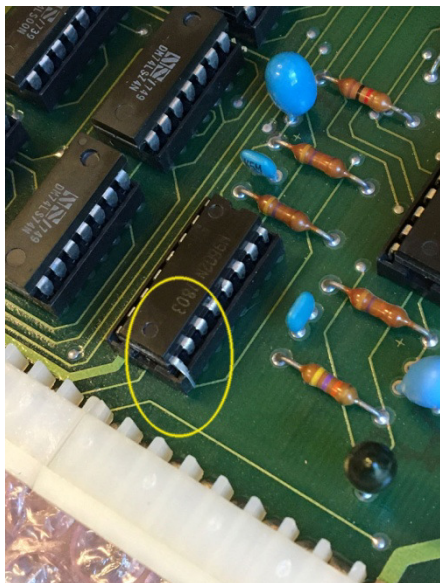
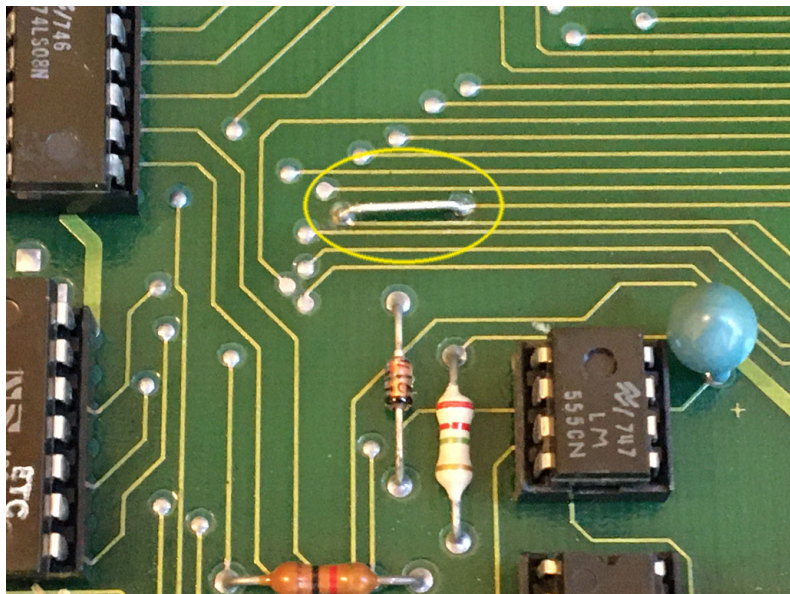
- 1) On power up, due to the start up timing of the PIA and the 1771, the 1771 powers up thinking it has an error and asserts INTRQ. The power on reset of the 1771 (generated by a one-shot on the board) does **not** clear INTRQ.

- 2) The 1771 reset also writes a RESTORE command (seek to track zero) to the command register. However, the command will not execute until INTRQ is cleared by the host computer. This requires the host to read the status register or write another command.

- 3) At this point – just after power on, the SWTPC 6800 is at the SWTBUG prompt waiting for the operator to type J 8020 to boot the disk. The 1771 has INTRQ set and a RESTORE command is pending execution. When then the operator subsequently issues a jump to \$8020 to boot the computer, the boot ROM reads the 1771 status register which clears the INTRQ condition in the 1771. This, in turn, causes the 1771 to then execute the RESTORE command already in the command register. Note that the RESTORE command initiated by reset does not load the head, so the drive select signal – which is AND'd with the head load signal – is not asserted to the drive. This, in turn, means the drive's Track 0 output will not be seen by the 1771, so the 1771 ends up issuing 256 step pulses before aborting the command. Doing the math, you'll find that $256 * 40\text{ms}$ per step is the 10 second delay that occurs.

- 4) After the boot code reads the status register as described above, which, in turn, releases the reset RESTORE command to execute, the boot code writes its own RESTORE command to the 1771 and then waits in a loop for it to complete. This new RESTORE command does not affect the reset RESTORE that is already running, so when the boot code thinks its own RESTORE command has finished, it is actually the reset RESTORE that just finished. However, since the drive was not selected during the RESTORE, the drive did not actually step to track zero. This, in turn, means the seek and read the ROM then performs to read the boot sector will most likely fail. This failure causes the boot loop to repeat, which then finally executes properly and the system boots.

The ten second delay can be eliminated with a minor board mod that makes the BFD-68 work the same as the "A" version of the controller in regard to this problem. See the two areas circled in yellow below.

- 1) Lift pin 9 of U21 out of its socket
- 2) Install a jumper between the pads circled in yellow closer to the top of the board

This mod connects the head load output (HLD) of the 1771 (pin 28) to U1 pin 1, replacing the FKTR00 signal previously connected to U1 pin 1. FKTR00 comes from U21 pin 9 which is disconnected by lifting the pin out of its socket. The HLD signal is picked up at a feedthru going to U9 pin 1.
