SUBJECT: IDENTIFICATION AND CONVERSION MODEL V3 OF ZCB BOARD UNITS AFFECTED: ALL SYSTEMS	V3-0022
	DATE: 1 DEC. 1981 PAGE: 1 OF 4

CONDITION: Identification of the different versions of the ZCB PCB.

VECTOR TECHNICAL ADVISORY

PRODUCT IMPROVEMENT BULLETIN

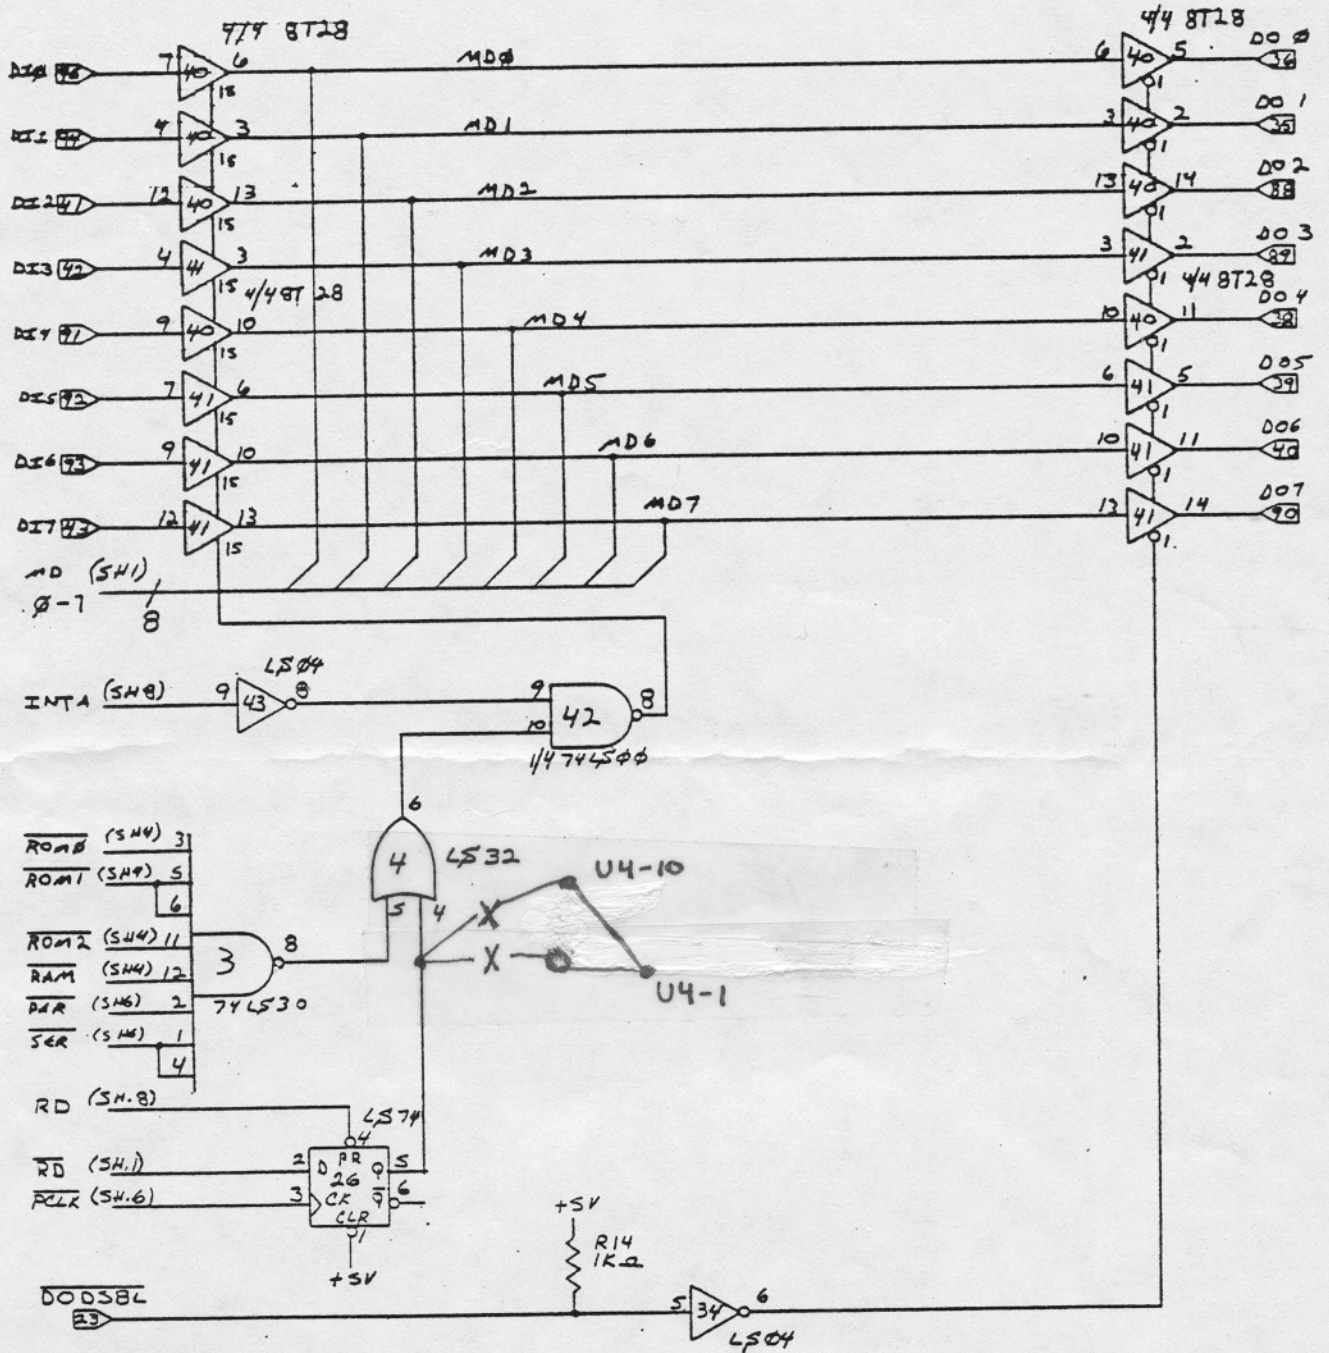
SHEET 2/9
DATA BUS CONTROL

The Revision 3 ZCB board is now in production at Vector. This Revision was implemented in order to delay the RD signal, which was creating a race condition that caused a data glitch. This "glitch" could create memory errors that were attributed to the 64K PCB. This revision is a factory only modification. The error condition is apparent when a 64K PCB is swapped or the LS244's are changed to resolve a memory error, but the original 64K PCB functions properly with a different ZCB board. The attached schematic should be added to your ZCB documentation.

U26-1	to	U26-14
U26-2	to	U33-9
U26-3	to	U33-13
U26-4	to	U33-8
U26-5	to	U4-4
U4-1		U4-10
cut U4-4	to	U4-10
cut U4-4	to	feed-thru and U4-1
