Index**A**

Announcement - IBM Fiftieth Anniversary Model Typewriter 12
Announcement of the IBM Model 95 Typewriter With Extended Memory 22
APM Correction 8
APM Revisions 12

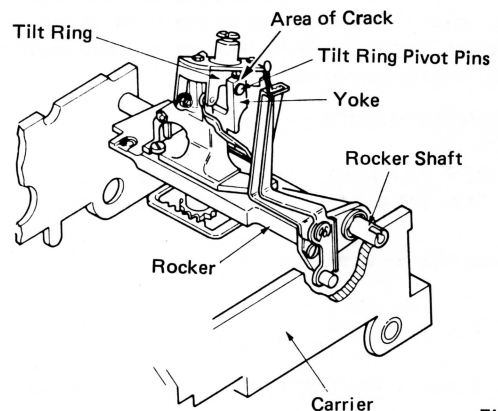
Figure 1

Poor print quality, especially of the underscore, may be caused by a crack in the yoke near the tilt ring pivot pins. (Figure 1)

If the yoke is found to be cracked, replace the rocker asm. (2-450: Part Number 1440310) rather than the carrier asm. A method of removing the rocker is as follows:

1. Remove cardholder bracket asm. (2-493).
2. Disconnect shift mode switch (3-309).
3. Loosen the rocker pivot shaft retaining screws (2-6, 2-404).
4. Remove rocker pivot shaft retaining "C"-clip (2-274).
5. Remove rocker return spring (2-313).
6. Slide rocker pivot shaft to the left until the shaft is out of the rocker asm. (2-272). [Holding the thrust washer (2-271)].
7. Remove the rocker asm. (2-450).
8. Install new rocker asm., reverse steps 1-6.
9. Check all related selection adjustments.

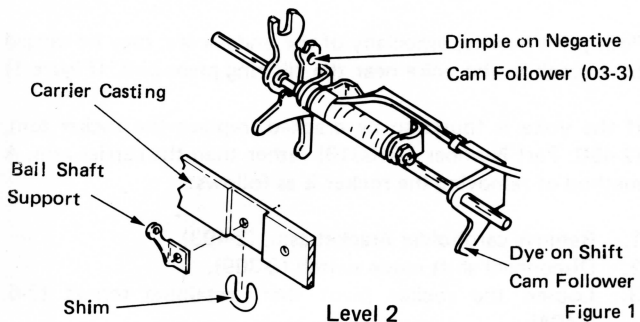
The negative cam follower (03-003) on the rack transfer bracket assembly (03-041) has been changed to improve negative transfer motion. The new level cam follower has a dimple on the upper right side, and new level bracket assemblies may be marked with blue dye on the shift cam follower (Figure 1).

These brackets do not require the shim (03-043) needed on old level steel brackets. The shim will no longer be included in the rack transfer bracket B/M.

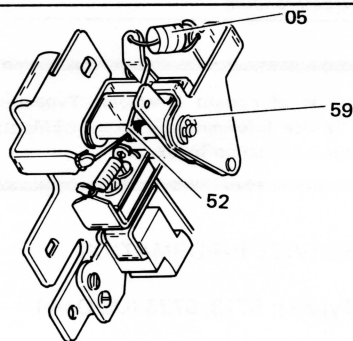
Figure 1

If experiencing piling, chugging (Model 50/60) or system busy (Model 75) install the redesigned knockoff arm return spring (06-52). This spring provides more reliable inhibitor restoring and increases the escapement magnet seal force. The old knockoff arm return spring should be removed and discarded.

To install the spring remove the C-clip (06-59) and slide the components on the stud to the left until the spring can be installed, then reassemble. The override spring (06-05) may be removed to facilitate installation.

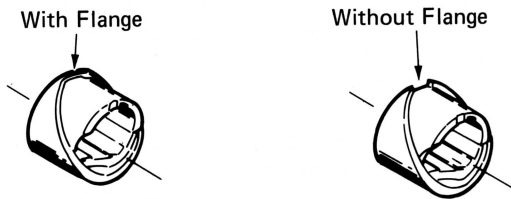
Figure 1

Some Ribbon Cassette System machines contain tape lift and feed cams (02-498) without a flange on the low dwell of the tape lift camming surface (Figure 1). A missing flange does not affect tape lift and will not cause correcting tape lift failures.

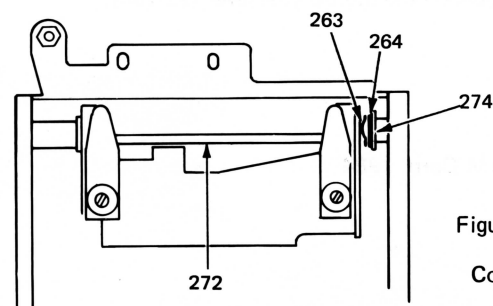
Figure 1

When experiencing inconsistent print quality and/or voids in low velocity repeat characters and all print adjustments are correct (particularly velocity cam follower clearance), install the compression washer B/M (02-270). Lubricate the washers before assembly with a film of #23 grease.

Adjust the rocker shaft to compress the washer without causing an excessive bind. To do this, half cycle the print shaft and load the rocker shaft to the left with a minimum of 6 lbs. of force to compress the washer (a spring scale may be used). Then tighten the retaining screws (02-6, 404). While still half cycled check for binds by manually moving the rocker to the print position. The rocker must restore completely under tension of the restoring spring.

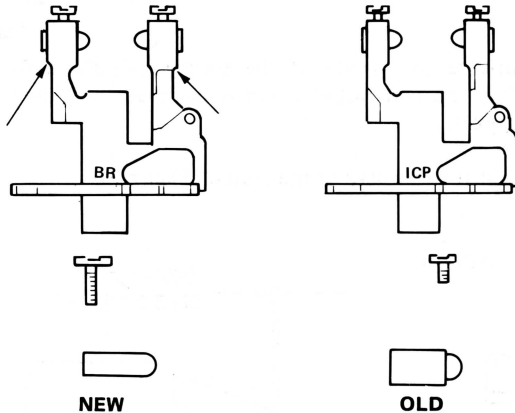
Figure 1

Carrier yokes (02-275/276) have been redesigned to prevent cracking around the tilt ring pin screw (02-269) hole. These yokes will have thicker uprights and use smaller diameter tilt ring pins (02-278) and longer tilt ring pin screws (02-269). See Figure 1.

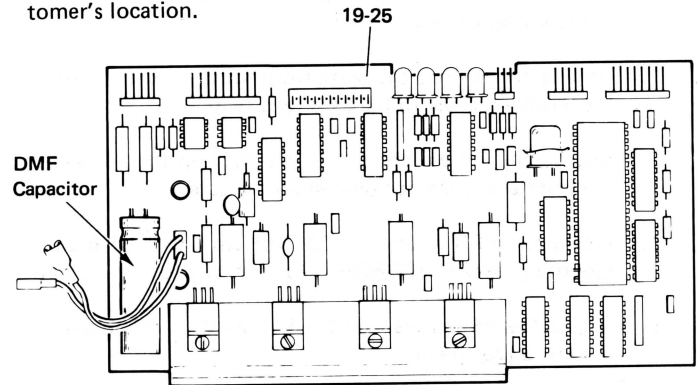
Figure 1

The escapement control board (19-025) uses a capacitor which contains a small amount of Dimethylformamide (DMF). (Figure 1) Under normal use the capacitor does not pose a health problem.

Precautions should be taken when a leaking or damaged capacitor is found. Polyethylene gloves (p/n 2200041) should be worn when handling a board with a leaking or damaged capacitor. A board with a leaking or damaged capacitor should be placed in a plastic bag (p/n 9900387) before handling further. Any spilled material should be cleaned up with a shop cloth. Gloves and rags may be disposed of at the customer's location.

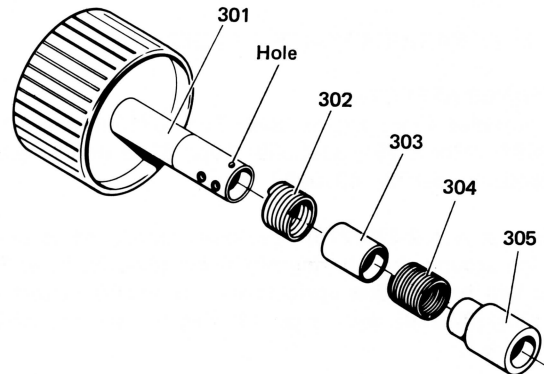
Figure 1

An override clutch has been added to the left end of the platen assembly. The clutch prevents index and alignment failures caused by inconsistent drive in the index mechanism.

1. Remove and discard the left platen knob (22-301), left bushing (22-305), and the washer between the index emitter wheel (23-20) and the c-clip (23-21).
2. Insert the extension of the override spring (22-302) into the hole in the new platen knob shaft (Figure 1).

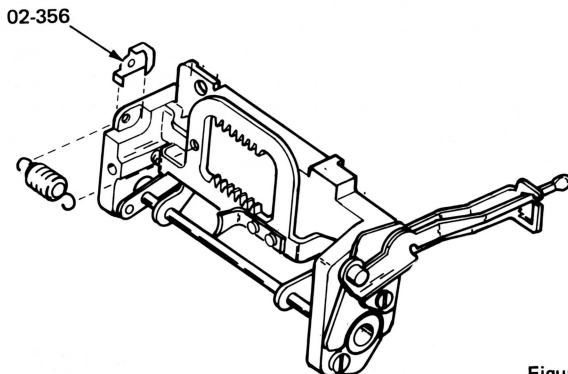
Figure 1

A wear prevention clip is now available to prevent the rack return spring (02-298) from wearing through the rocker casting (02-289). The clip also provides a new surface if the rocker casting is partially worn or completely worn through. The existing spring will be used with the clip.

Note: Squeezing the clip together slightly before installing will help hold it in place while remounting the spring (Fig. 1).

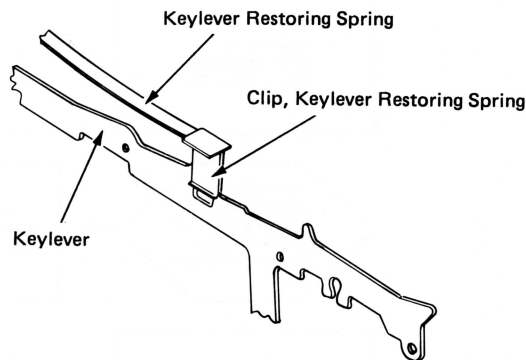
Figure 1

A single operation keylever restoring spring clip (21-85) and a repeat operation keylever restoring spring clip (21-86) are now available for use on Electronic Typewriters Model 50/60/75. These clips will prevent the keylever restoring spring (21-74, 80) from slipping off the keylever.

When installing either clip remove top section of the keyboard (21-084). To install a single-operation keylever restoring spring clip, slide the flat part of the clip on the restoring spring first (Fig. 1).

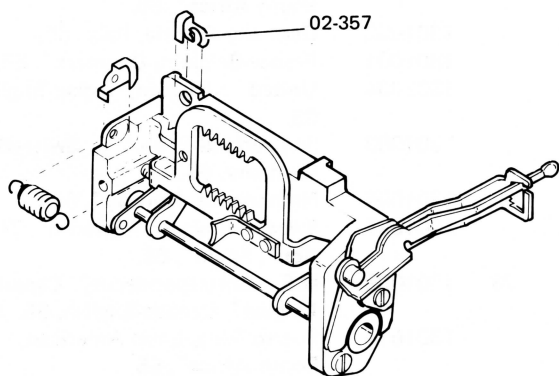
Figure 1

A wear prevention clip is now available to prevent the rocker return spring (02-313) from wearing through the rocker casting (02-289). The clip also provides a new surface if the rocker casting is partially worn or completely worn through. The existing spring will be used with the clip.

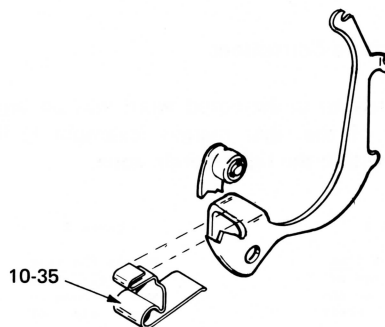
Figure 1

A cycle clutch latch support has been released for field use. This support will reduce PSCC extra cycles caused by the latch not holding the sleeve.

To install the support, remove the print shaft belt, the PSCC backcheck pawl (10-44) and the restore arm (10-71). Slide the support onto the restore arm (fig. 1) and re-install the restore arm (fig. 2), the backcheck pawl, and the print shaft belt.

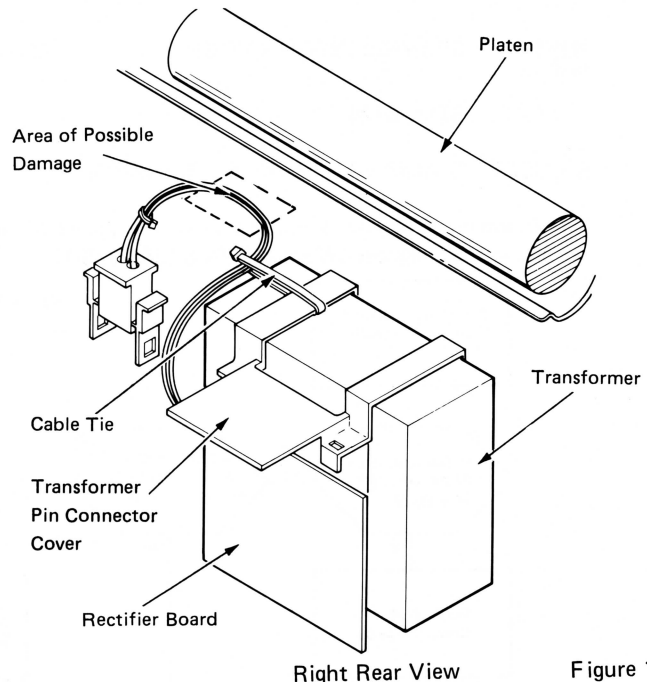
Figure 1

Transformer leads on affected machines may be positioned so that they are in the path of the carrier leadscrew nut. Insulation damage can occur to the primary power leads of the transformer, **exposing live voltage to the machine frame**. This involves the risk of electric shock.

Replace any transformer(s) with lead damage.

Install wire tie (29-03) between the transformer leads and the transformer pin connector cover (12-52) (see Figure 1) on **all** machines within the specified serial range to ensure adequate clearance between the transformer leads and the leadscrew nut. The cable tie is plantinstalled above the specified serial range.

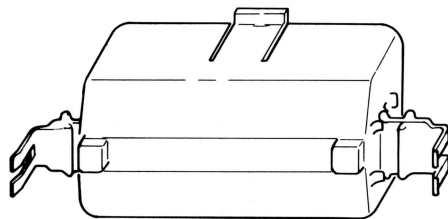
Figure 1

A new level carrier cable support box is now available for the XTDT-II. The thickness of the material has been increased and the cutouts on the left and right sides of the box have been removed, (Figure 1). These changes will prevent the box from separating from the XTDT-II board assembly during use.

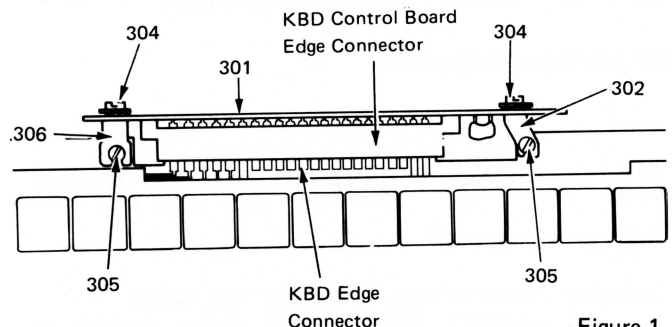
Figure 1

NOTE: Some early level keyboard logic mounting clips (21-302, 306) were shorter and affected the edge connector's reliability by forcing the top of the connector upwards, opening its contacts. If, when reconnecting, the keyboard control board edge connector and the keyboard edge connector cannot be aligned without downward pressure to the connector, replace the keyboard logic mounting clips.
