HINSDALE CENTRAL OFFICE FIRE FINAL REPORT

EXECUTIVE SUMMARY

Joint Report of:

March 1989

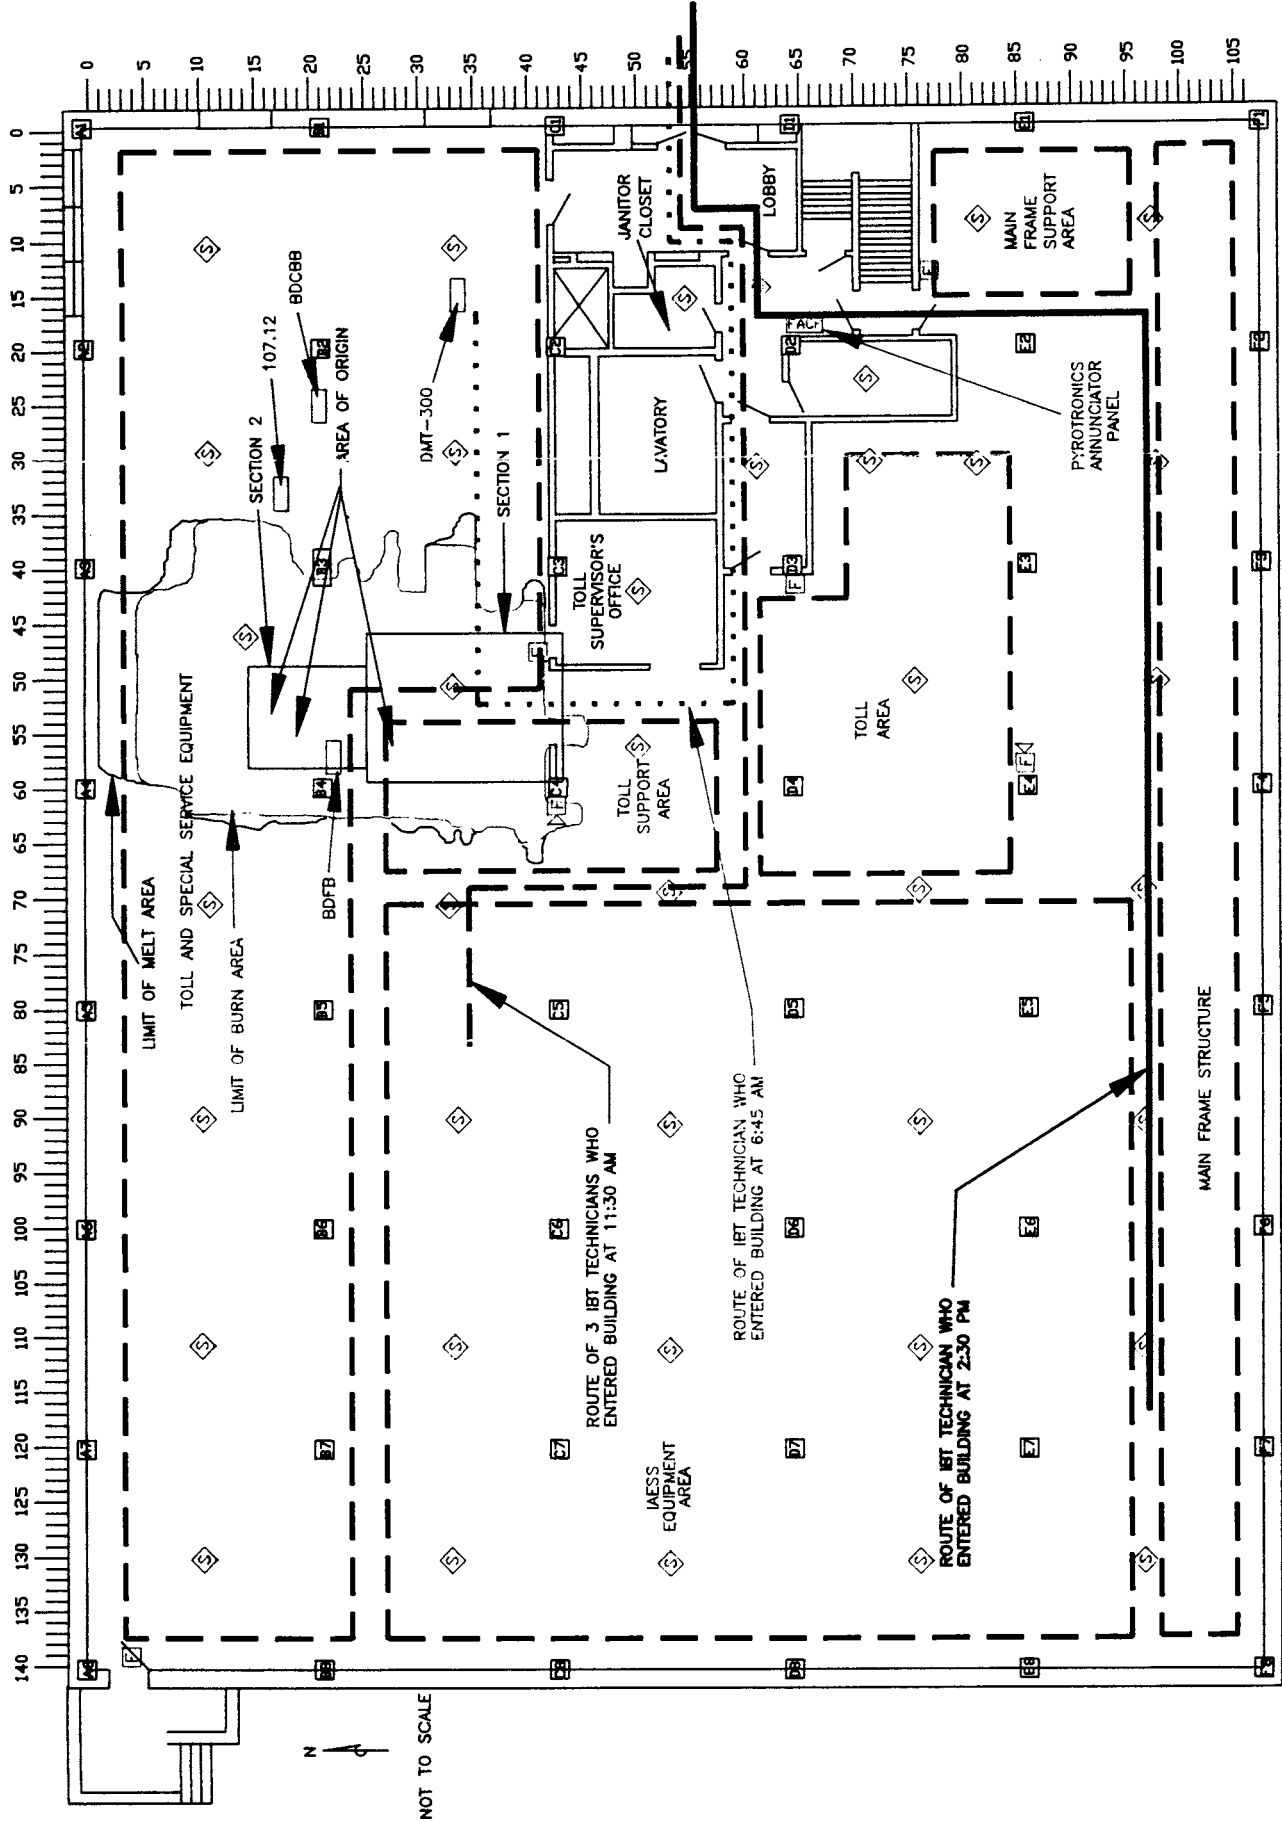
Figure 2

FIRST FLOOR - ROUTES OF ENTRY INTO BUILDING ON MAY 8, 1988, BURN/MELT LIMITS AND FIRE PROTECTION SYSTEM

Two entries were made into the HCO during the morning of May 8, 1988 by IBT technicians to perform normal work functions and no abnormal conditions were found. The last person in the HCO prior to the discovery of the fire was an IBT customer services technician, who entered the HCO early in the afternoon. A residential phone was reported out of order, which required the technician to perform some work in the central office to correct the problem. He reportedly entered the front door, turned left, and went into the main frame area in the south end of the building as shown in Figure 1. The technician located the particular line with the service problem, disconnected it, and reconnected service to a spare line. He noticed no problems within the building but did not enter the area where the fire damage would later occur. Upon completing his work, he left the building at approximately 2:46 p.m. These activities are illustrated in Figure 2.

During the entire firefighting effort, the burning appeared to spread from the initial area of flames, outward and mainly northward. Burning was confined to an area approximately forty feet by thirty feet. The fire consumed the majority of the wire insulation around both power and communications cables housed in the overhead cable tray in this area, as shown in Photograph 2. Although there was burning of other combustible items in the ceiling area, minimal direct fire damage occurred to associated telecommunications equipment located below the cable trays, as depicted in Photograph 3. Significant smoke and corrosion damage was incurred throughout the first floor.

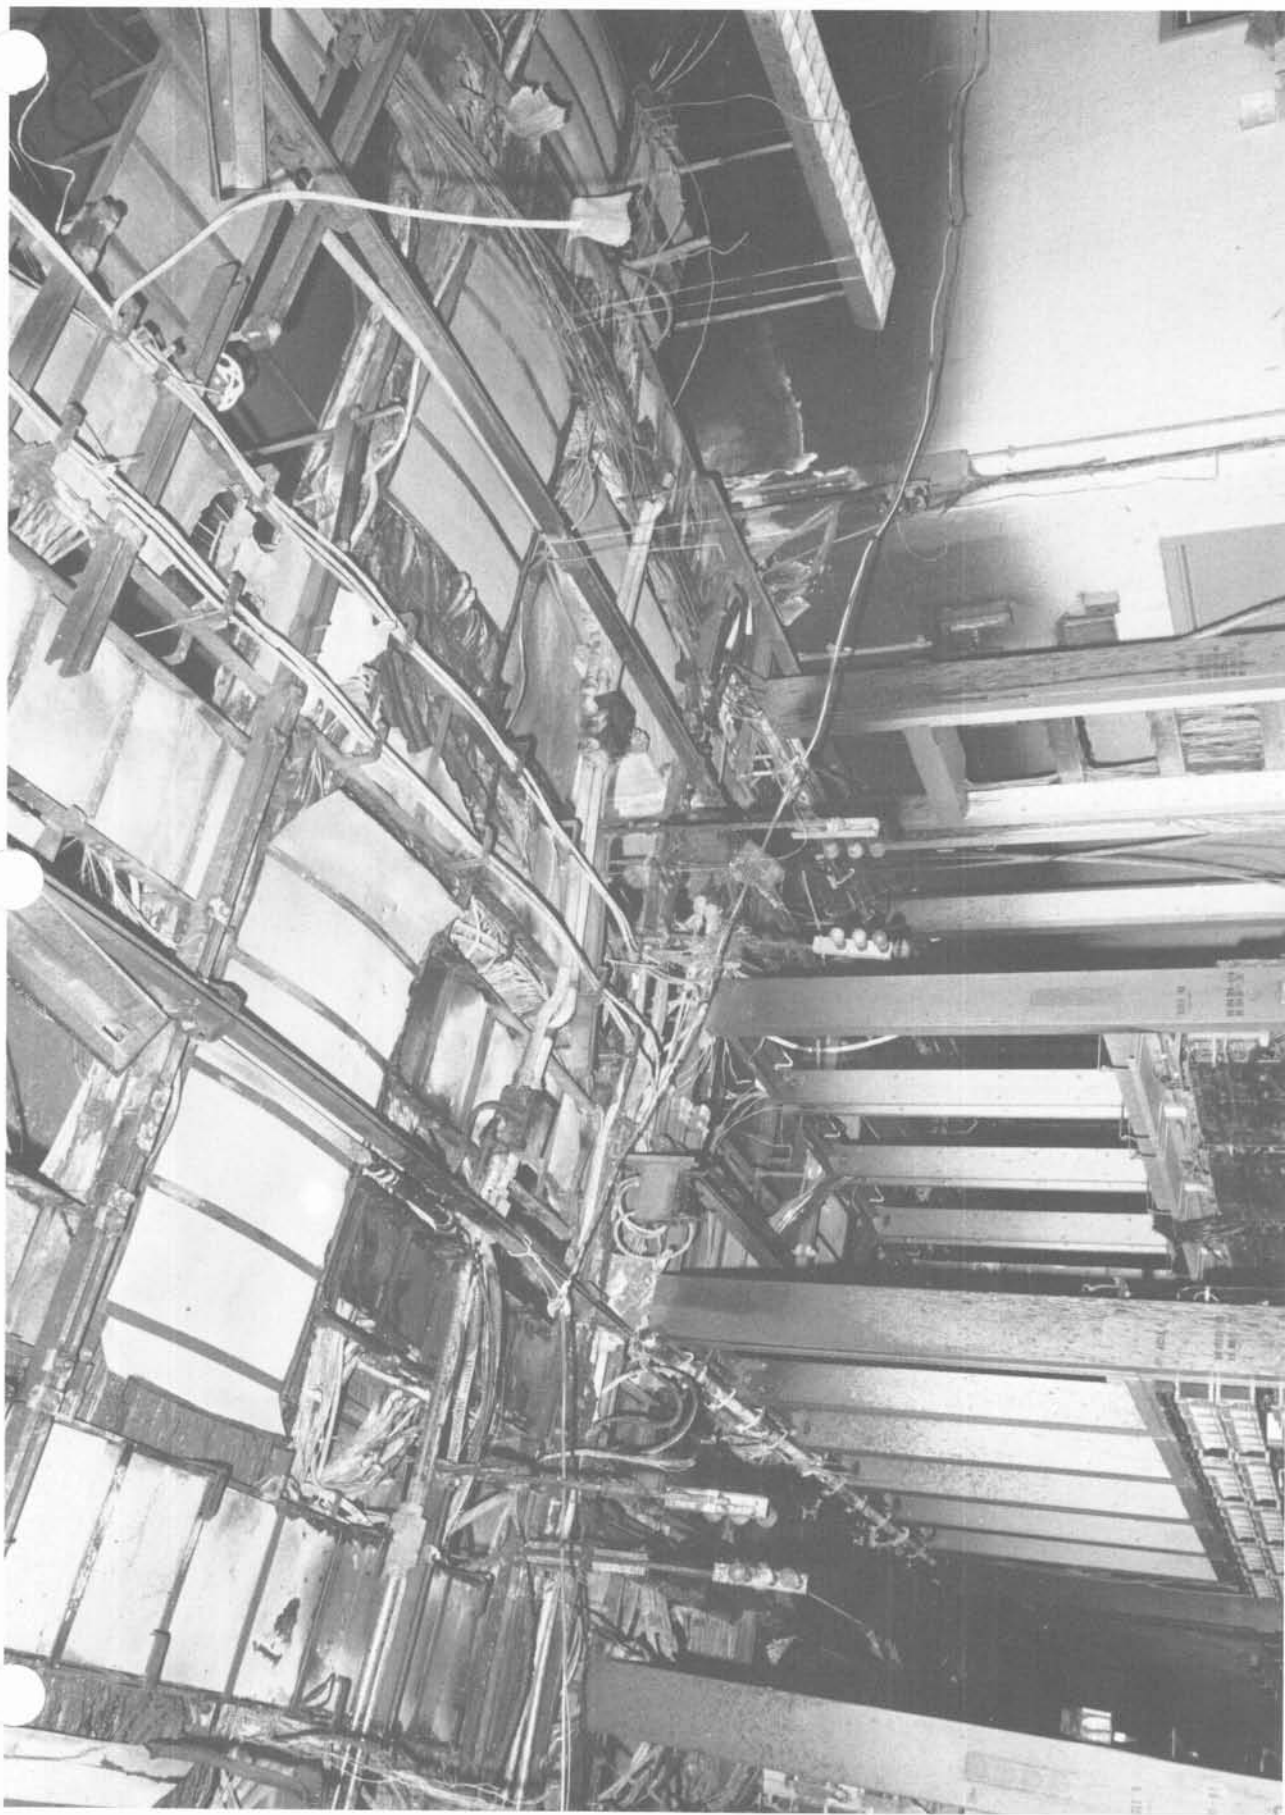
Photograph 2.
Fire damaged cable trays suspended from ceiling in the Toll Equipment Area of the first floor

Damage to both communication and power cables was found during the examination of evidence. Extraneous materials were found in the cable trays. Areas where cables were being crushed against portions of the supporting trays were also found.

Cable trays were often fitted with a cross trays containing vertical retainers or stanchions. As cables were loaded into the main tray, they often rested on top of these metal bars, crushing the insulation. During the fire, at least four dc power cables were in this position and with the addition of heat, failed electrically, causing various degrees of arcing. These events were not the cause of this fire but were secondary sources of ignition which aided the fire spread.

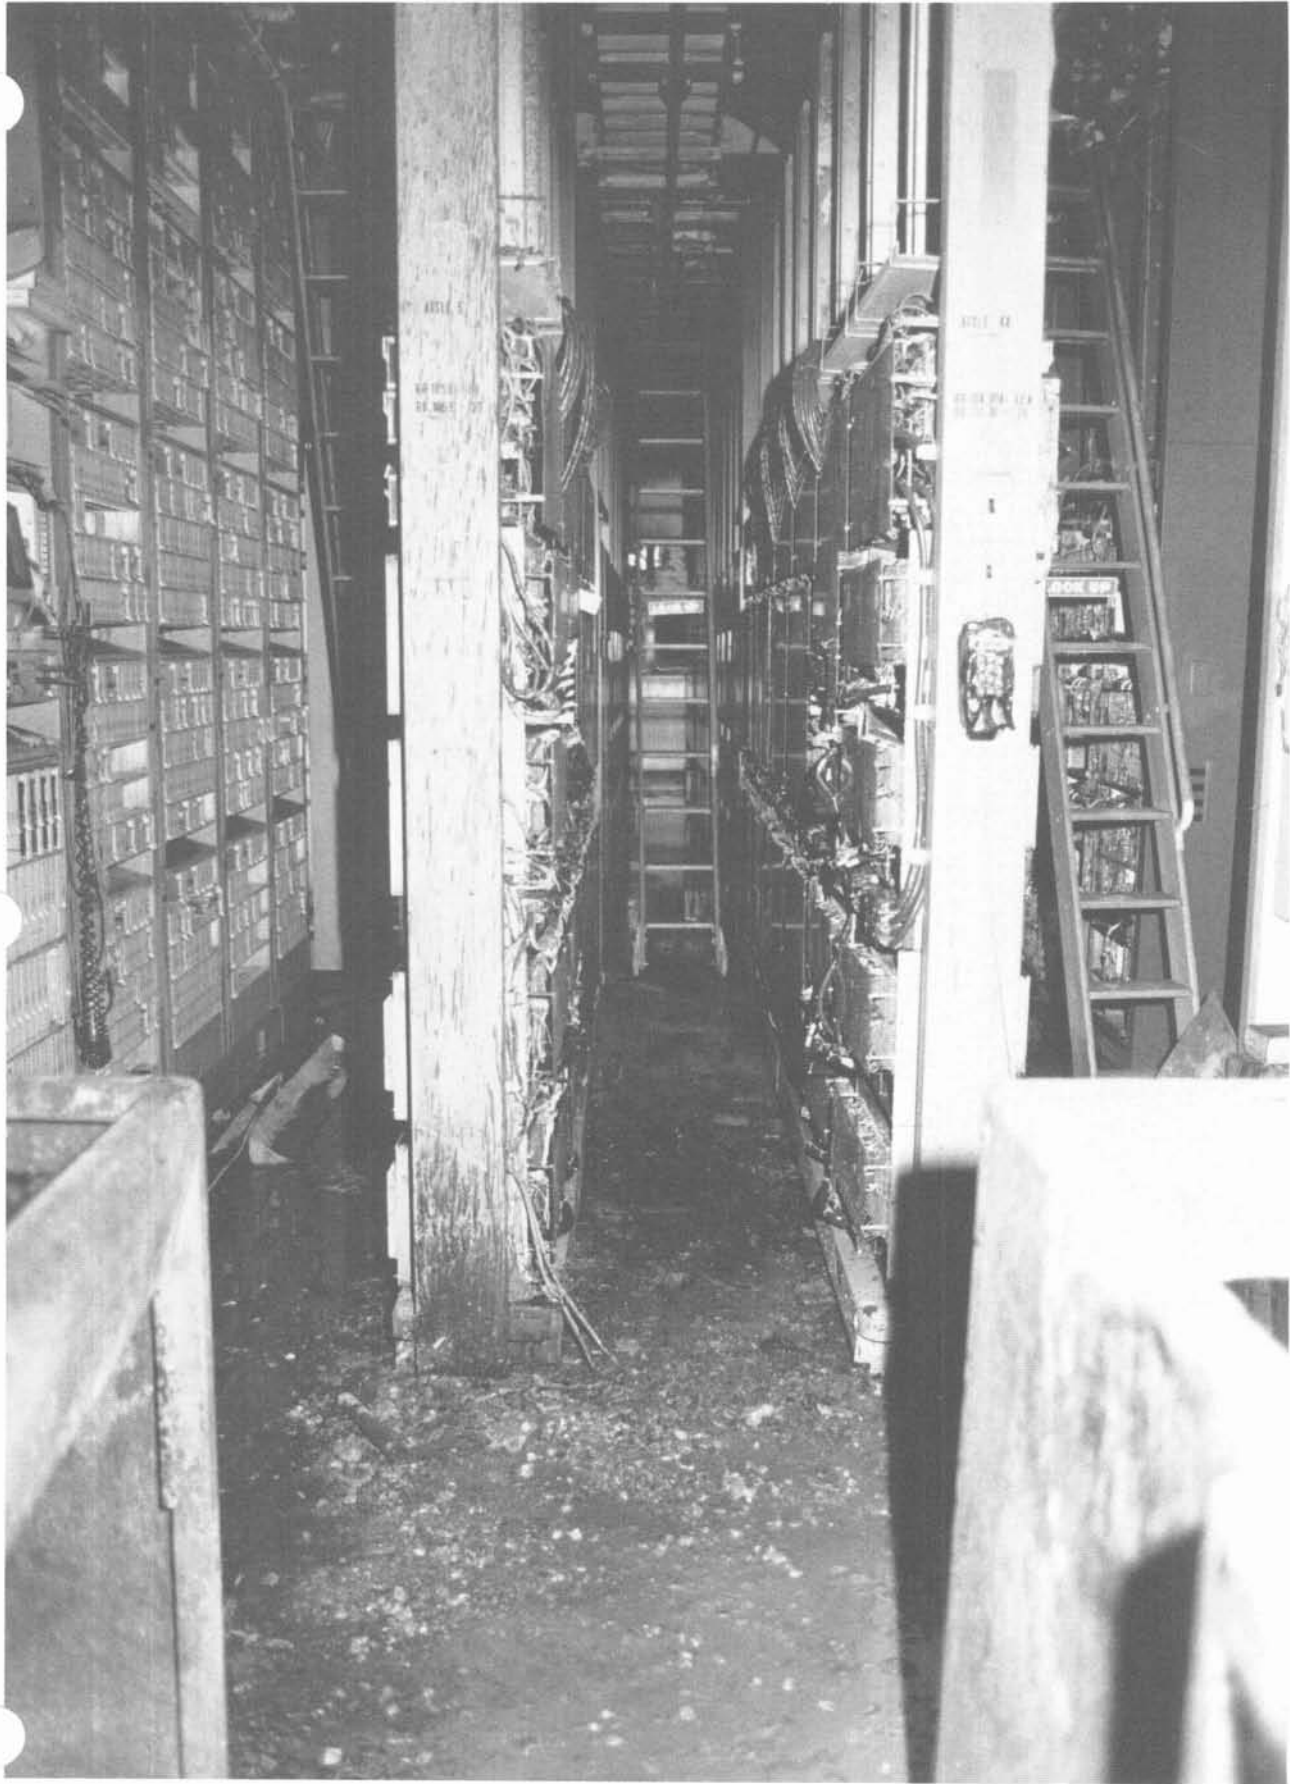
Photograph 3.
Fire damage below cable trays shown in Photograph 2.

mechanisms. This flaming material was observed to be capable of igniting card bin materials below as well. The longer the fire was allowed to burn, the deeper the fire damage to the tray cross-section. Fire spreads fairly rapidly to those areas directly exposed to air, such as the sides of the cable bundle, both ends of the longitudinal sectional, and the exposed cross cables. Even with a twenty-five-minute fire exposure, the jacket materials in these areas were heavily consumed. A general observation is that the thermal radiation from the fire-heated ceiling enhanced the flame spread and resultant growth of the fire.

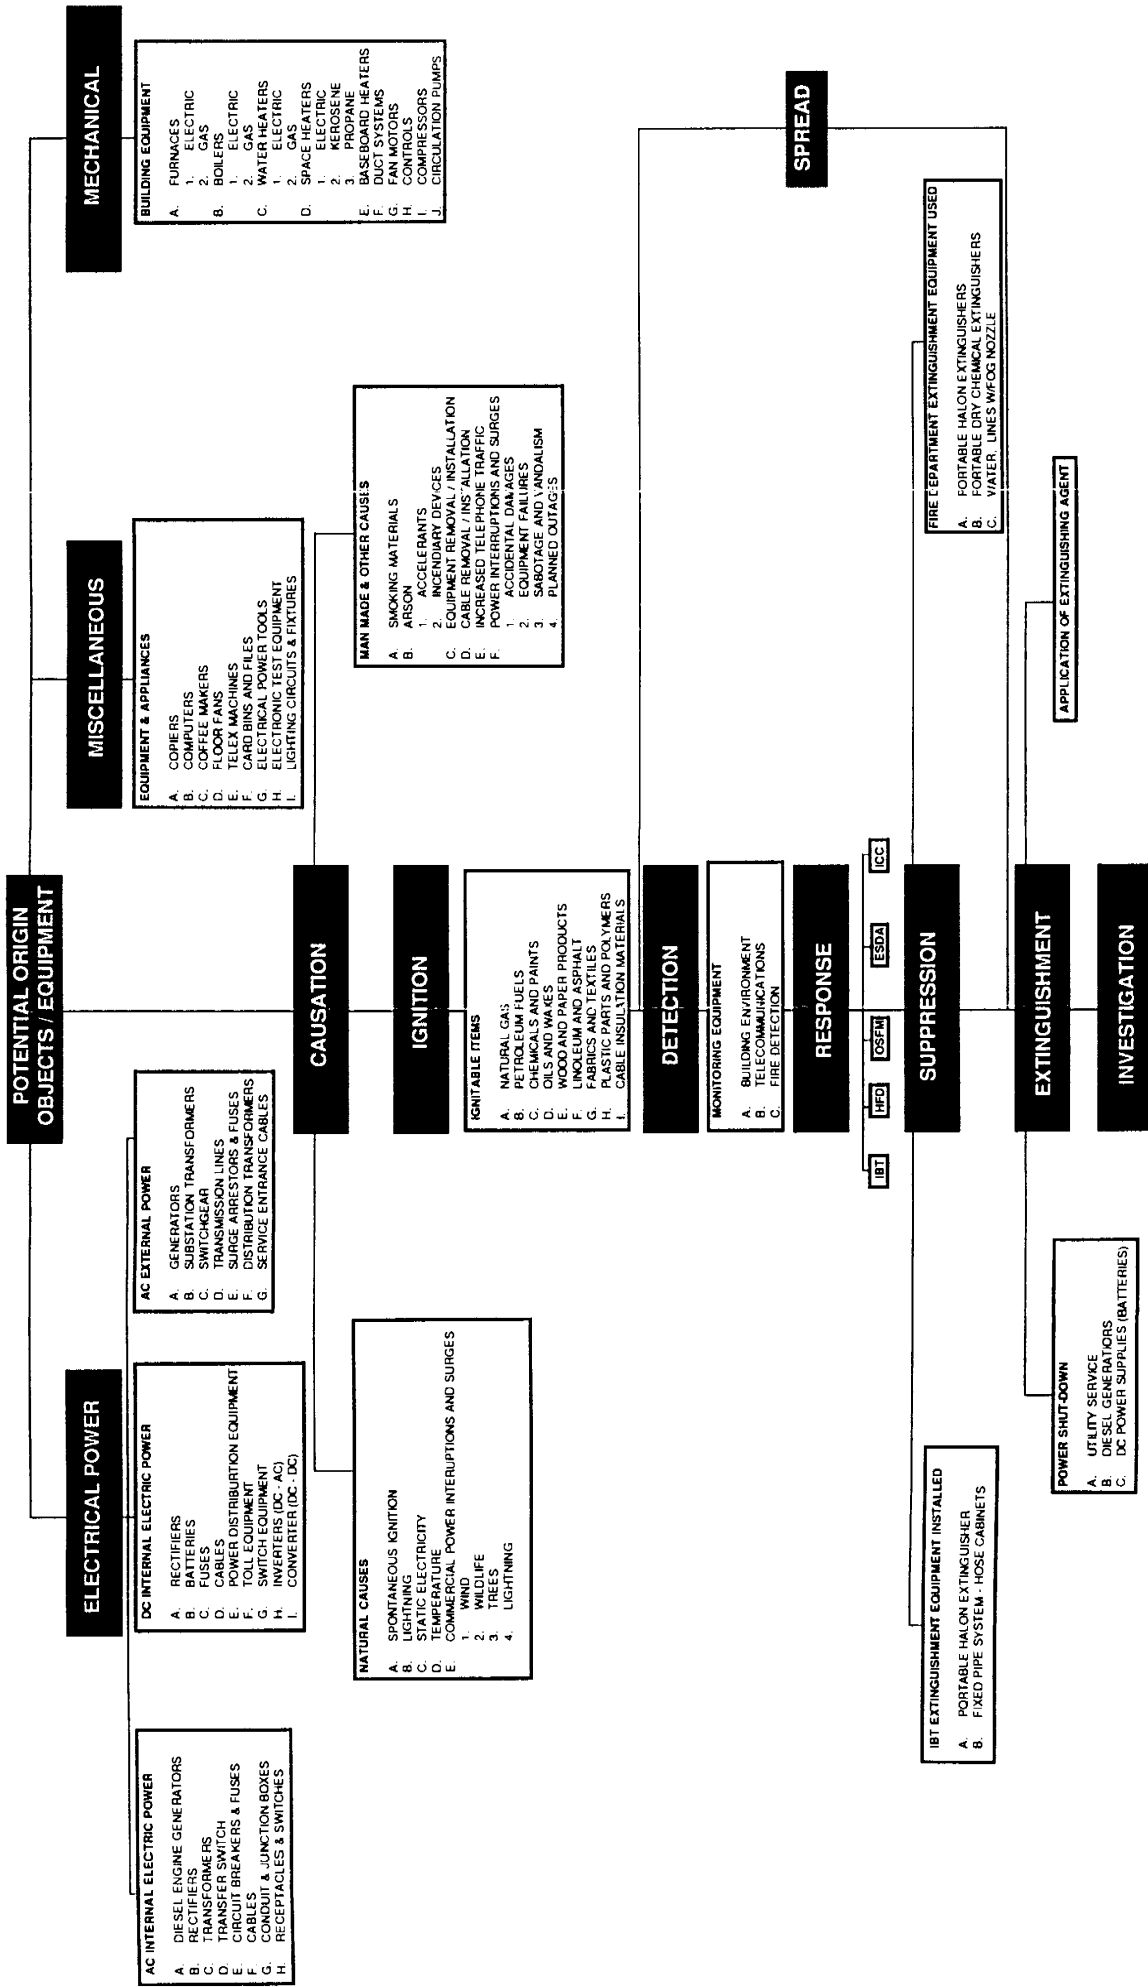
Figure 3

Within each of the eight main areas, more detailed potential causes were listed, as shown on the FALT for this fire, Figure 3. This logic tree method was used by the investigating engineers to isolate all possible contributing factors at the scene of the incident and to determine their relationships to the cause of the fire. Each potential cause listed on the FALT was thoroughly addressed and analyzed during the investigation and either discarded for good reason or followed to a conclusion.

- The fire was accidental in nature and caused by an electrical fault.
- An armored cable contacted a damaged dc power cable.
- A dc power cable was most likely damaged at some time during cable mining operations.
- An exact point of fire origin was not determined.
