The SOL-20 Computer - Restoration & Repairs.

(H. Holden. Dec. 2018)

1) Processor Technology 16KRA memory cards & Delay Lines.

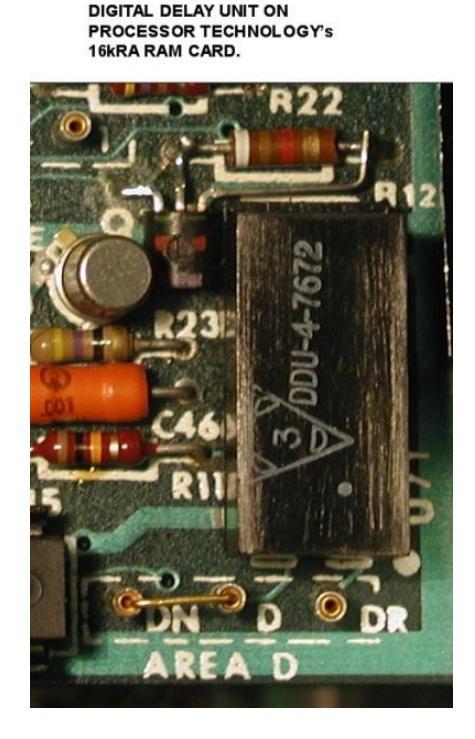
The module sits in a standard DIL socket (but sometimes it is soldered to the pcb) and has the label DDU-4-7672 .The module is powered by +5V and has 4 outputs for a digital delay of 100nS, 150nS, 250nS and 350nS.

The module in one of my 16kRA ram cards spontaneously failed, deactivating the entire card. The question then became what to replace it with?

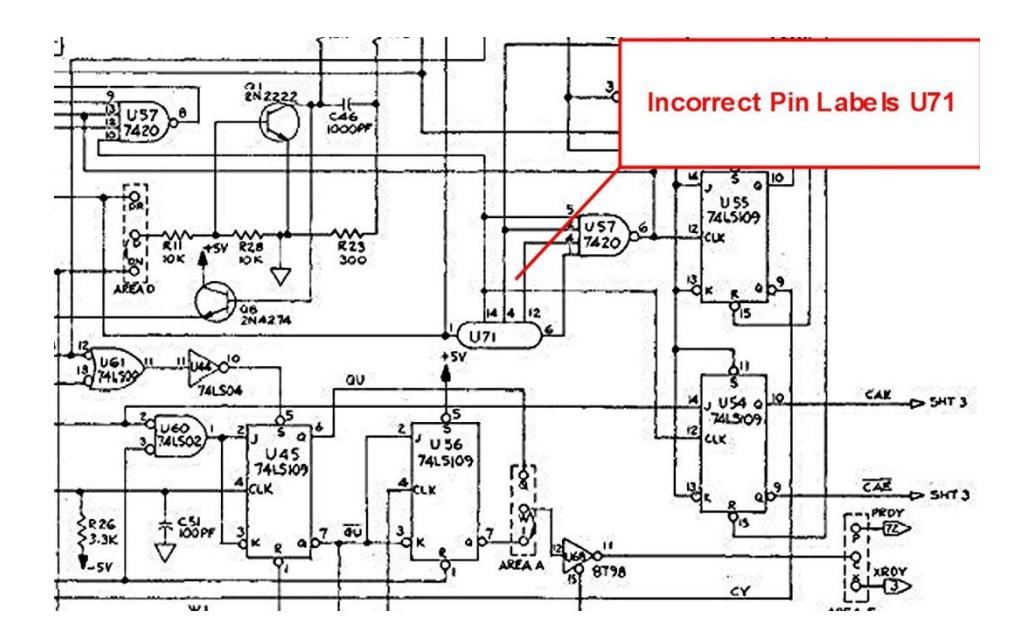
Either of two signals, MC or RC, can initiate a cycle. RC describes a refresh cycle and MC describes a read or write cycle. Misprints: Should be 100nS (pin 12) & 250nS (pin 10). Pin 14 is +5V.

In addition the circuit diagram relating the module's (U71) wiring was incorrect:

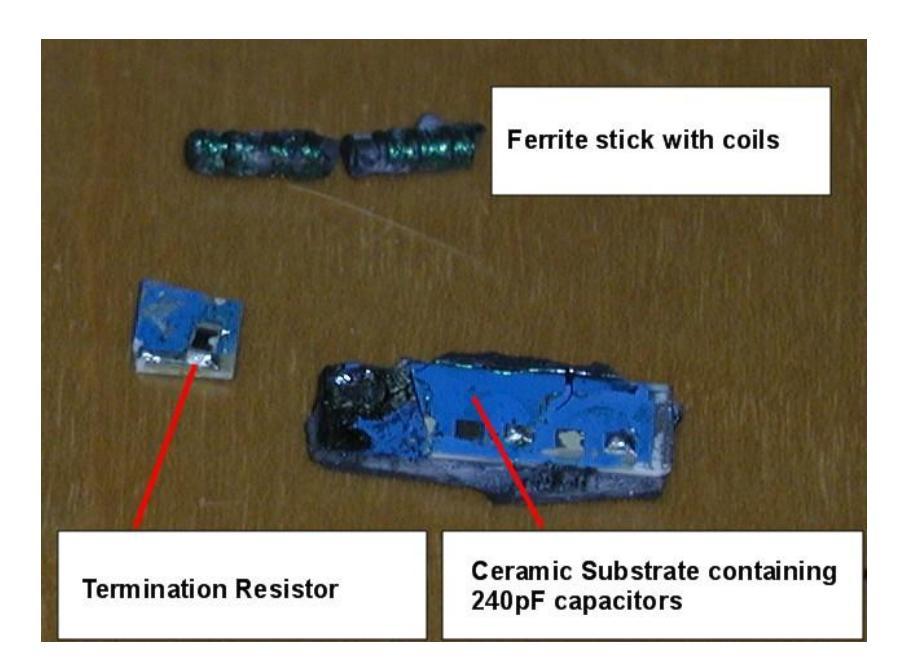
The "Delay Line" was a hybrid/modular design and consisted of a ferrite stick, about 2mm to 2.5mm in diameter (broken in two in the photo) with small shoulders to separate about 7 groups of windings. Taps from the windings fed the approx 240pF capacitors

and the IC input pins. The capacitors were formed on a single ceramic substrate. The surface mount line termination resistor had calibration cut in its surface.

In some places there were some soldering flux residues and some corrosion around the resistor. It appears that the line termination resistor or one of the coil wires may have become disconnected as the probable mechanism of failure. But I could not be certain. However, this is no reflection on the quality of the device, it is 40 years old.

The IC itself that was inside the module with the above components (a 74S04) after removal, tested normally and had not failed.

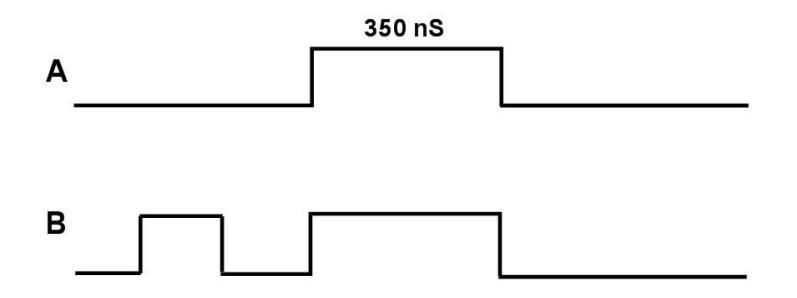
The drive pulse to the input of the delay line has a short period where it is high then low again immediately before the 100nS long input pulse arrives. Due to this the charges on the delay capacitors in my circuit have not settled to a value close to 5V (from the output of the cmos gate driving them). Therefore the delays become shortened compared to the values attained where the input pulse has been low for a long period prior to the leading edge of the input pulse occurring.

On testing the first attempt module, it actually worked in one 16KRA card, but not in another, so this timing error was borderline & unsatisfactory. This is because the time delay is too dependent on the *initial conditions* (state of charge of the capacitors) in the R-C delay network.

The diagram "A" below shows what PT suggested in their diagram, the waveform "B" is similar to what the actual module receives at pin 6:

The implication of the above is that the R-C delay technique used to delay the input pulse cannot work reliably in PT's circuit and explains why the first attempt module I designed failed to be satisfactory.

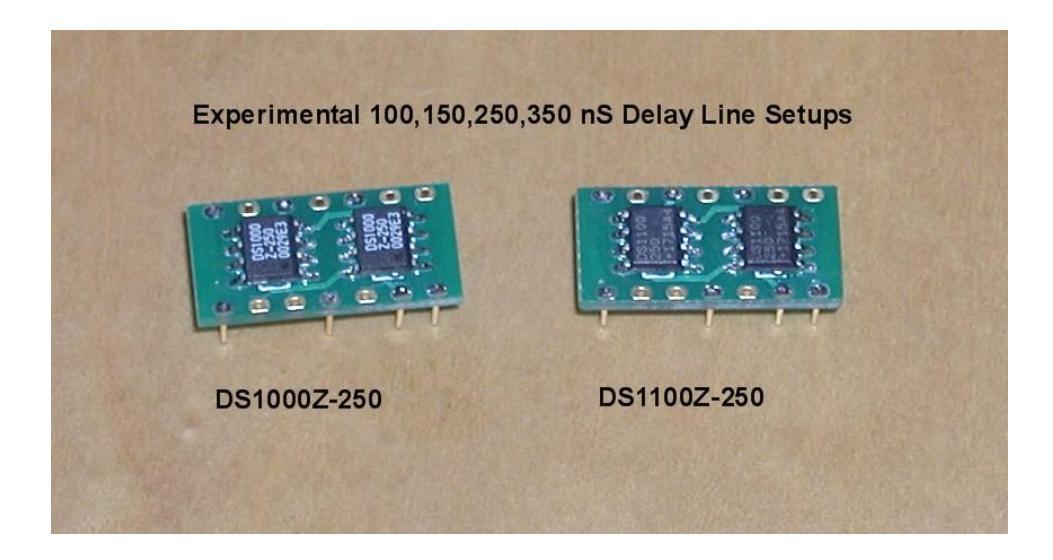
The only difference I could detect with the performance of the DS1000Z vs the DS1100Z is that the power supply voltage (+5V) affects the exact delays a little in the DS1000, but not the DS1100Z (for the reasons outlined above). Both of these restore the 16KRA card back to normal working order, unlike my first two failed attempts.

The photo below shows the completed adapter with the two SOIC packages fitted:

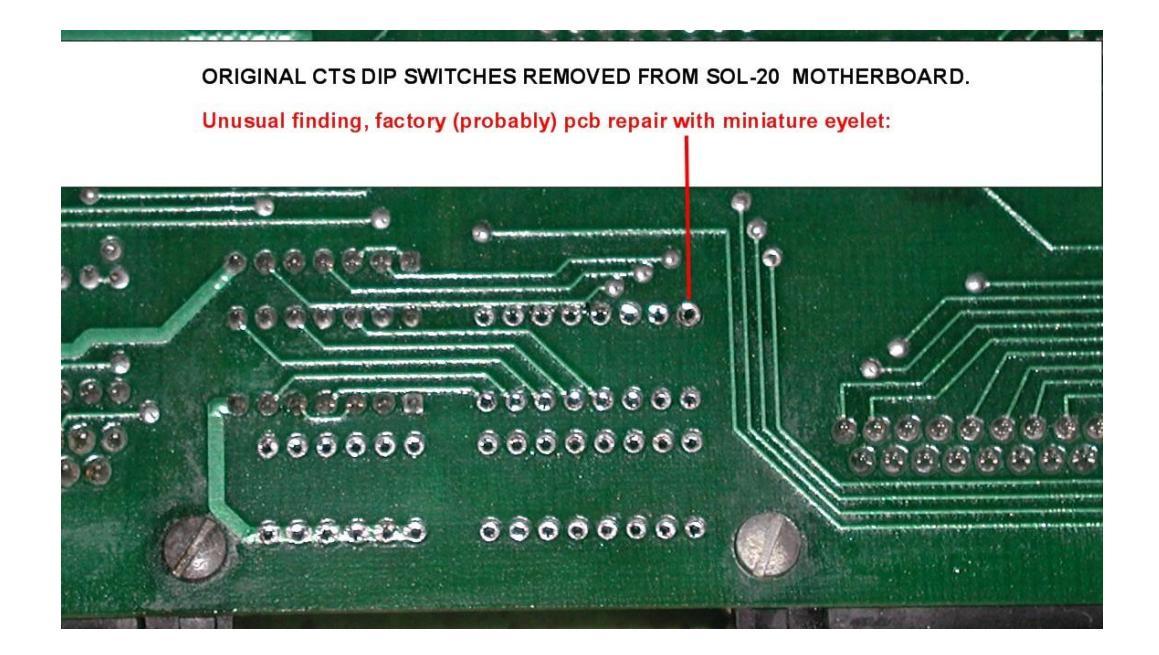
After the switches are removed, clean the pcb with circuit board cleaner and cue tips (cotton buds on a stick). Inspect the PCB, pads and plated through holes very carefully to ensure there is no pad, hole or track damage. The photo below shows the areas on the SOL-20 main board where the DIP switches were removed. I found there was a factory pcb repair. One of the pads/plated through holes had been professionally repaired with a miniature eyelet.

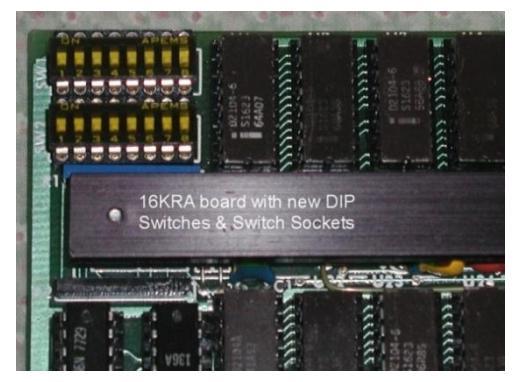
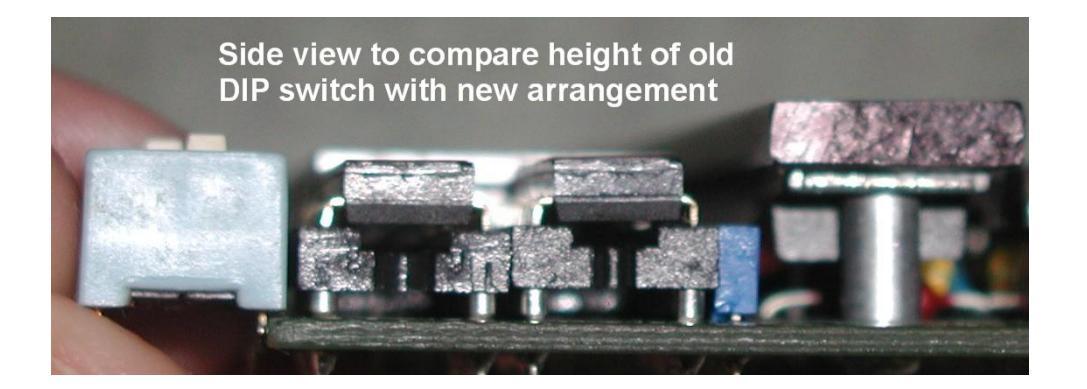
Each switch should be checked for continuity and if it fails has to be replaced. After disassembling the switches and seeing the corrosion in them and finding the surfaces to be a poor conductor, I decided to replace all of the old DIP switches on every 16KRA card and on the SOL-20 motherboard too.

An excellent switch to replace the old DIP switches are a type that has been built into what amounts to a DIL IC housing. These have the same exterior geometry as a DIL IC and they plug into DIL IC sockets. Because they are low profile, the height of these switches and a standard machine pin IC socket are about the same size as the original CTS DIP switch assembly. These switches also have sliding contacts so they are a self cleaning design and using them with a socket means they are easily replaced. On top of this the switch pins are easy to get to from the top pcb surface with a meter to check the switch has continuity. While it is ok to de-solder a DIP switch once from a pcb, it could be harsh on the pcb to have to do it again. So fitting a quality DIP socket to the pcb, where the original DIP switches were, makes it unlikely it will ever have to be unsoldered again. The photo below shows replaced CTS DIP switches with these parts on a 16KRA board:

Good switches for the task are those by Omron or APEMS. The 8 way Omron switch is part number A6D-8103 and the 6 way version is A6D-6100.

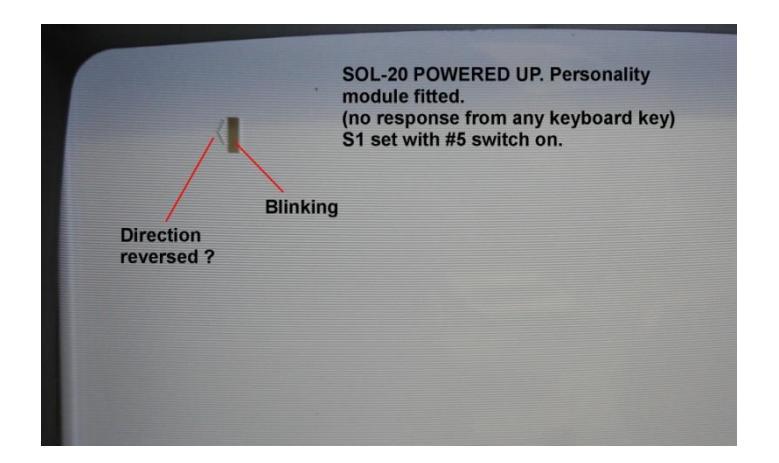
1) Failed Ram (U15) in the video ram bank. This caused some of the characters to be displayed incorrectly and the cursor arrow to appear reversed:

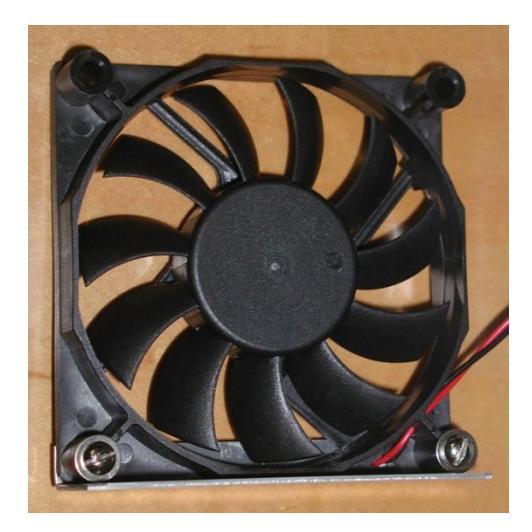
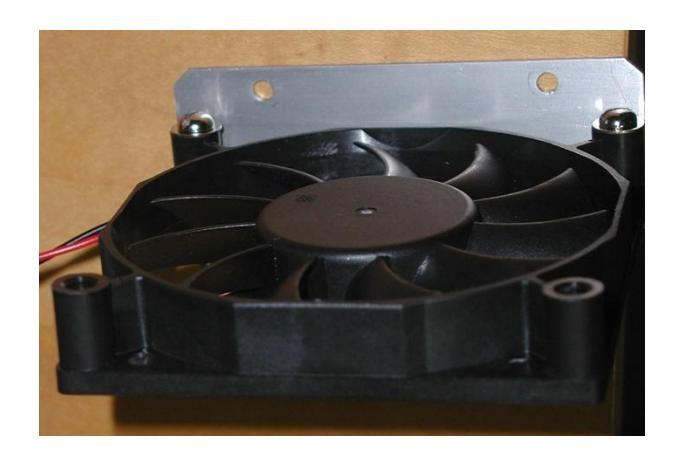
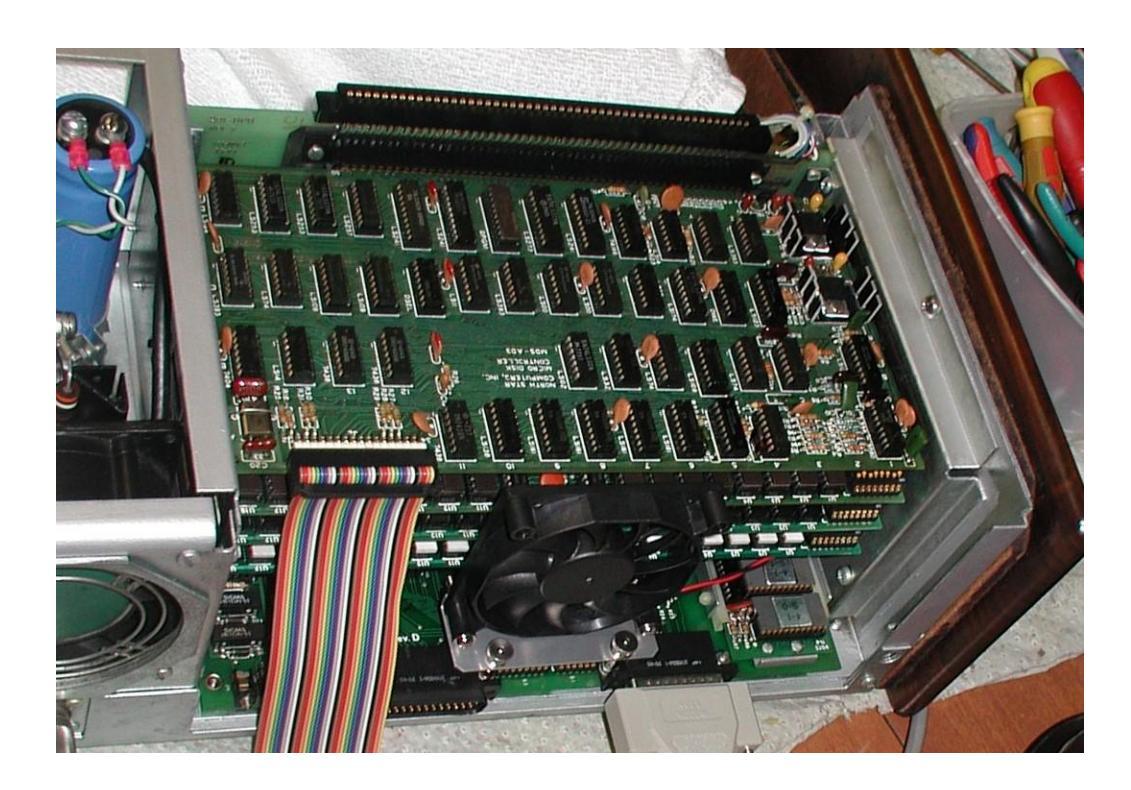
The Sol-20 was built with one cooling fan that blows air out of the case, from the power supply area. This creates a small negative pressure in the case (with the covers on) and air is drawn through the gaps around the keyboard and the rear below the case lid where the serial and parallel connectors are.

It is not necessary to drill any holes in the SOL-20's top cover or anywhere else. (I have seen this done on some SOL-20's to increase the ventilation, but it is a shame to do this and damage the case or metalwork or paintwork). The addition of the fan, on its own, even with the top over on, still increases the convection through the unit and between the S-100 cards. The fan is orientated to blow air between the cards.

The photos below show the fan with a small right angle bracket added. The Micronel fan is a 12V 1.44W unit, $80 \times 80 \times 16$ mm type, RS part number 466-6820. I supplied it from the -16V supply to the S-100 bus and with a 1N4731 4.3V zener diode in series with it to reduce the voltage to around the 11 to 12V mark.

This way the fan is very quickly removed by undoing thumb nuts, to allow withdraw of the S-100 cards or reset the DIP switches. The other end of the fan wiring is on a 2 pin connector plug & socket so it is easy to remove.
