FENDER MI  
CHROMA POLARIS  
CONTROL PANEL  
LEFT SCHEMATIC

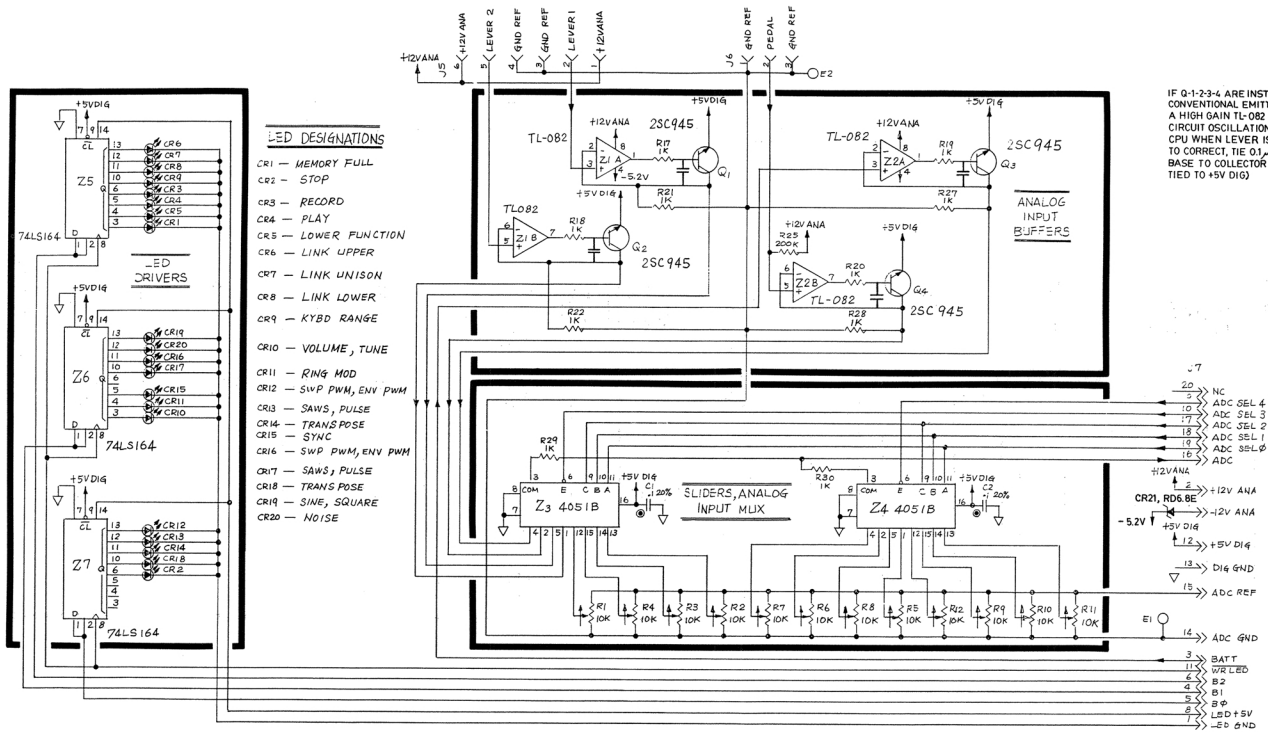
IF Q1-Q3 ARE INSTALLED AS CONVENTIONAL EMITTER FOLLOWERS A HIGH GAIN TL-082 MAY CAUSE CIRCUIT OSCILLATION CRASHING CPU WHEN LEVER IS MOVED. TO CORRECT, TIE 0.1µF CAP FROM BASE TO COLLECTOR (COLLECTOR TIED TO +5V D16)
