## SD Systems 51009 Computer

SD Systems was a popular S-100 board manufacturer in the late 1970's. They also sold a few computer systems, though the sale of computer systems appears to very limited. This paper details restoration of an SD Systems 51009 computer. This computer appears to be a custom product developed by SD Systems for TBS International, a shipping company. The computer is similar to the SDS-100 computer from SD Systems shown at the end of this paper.

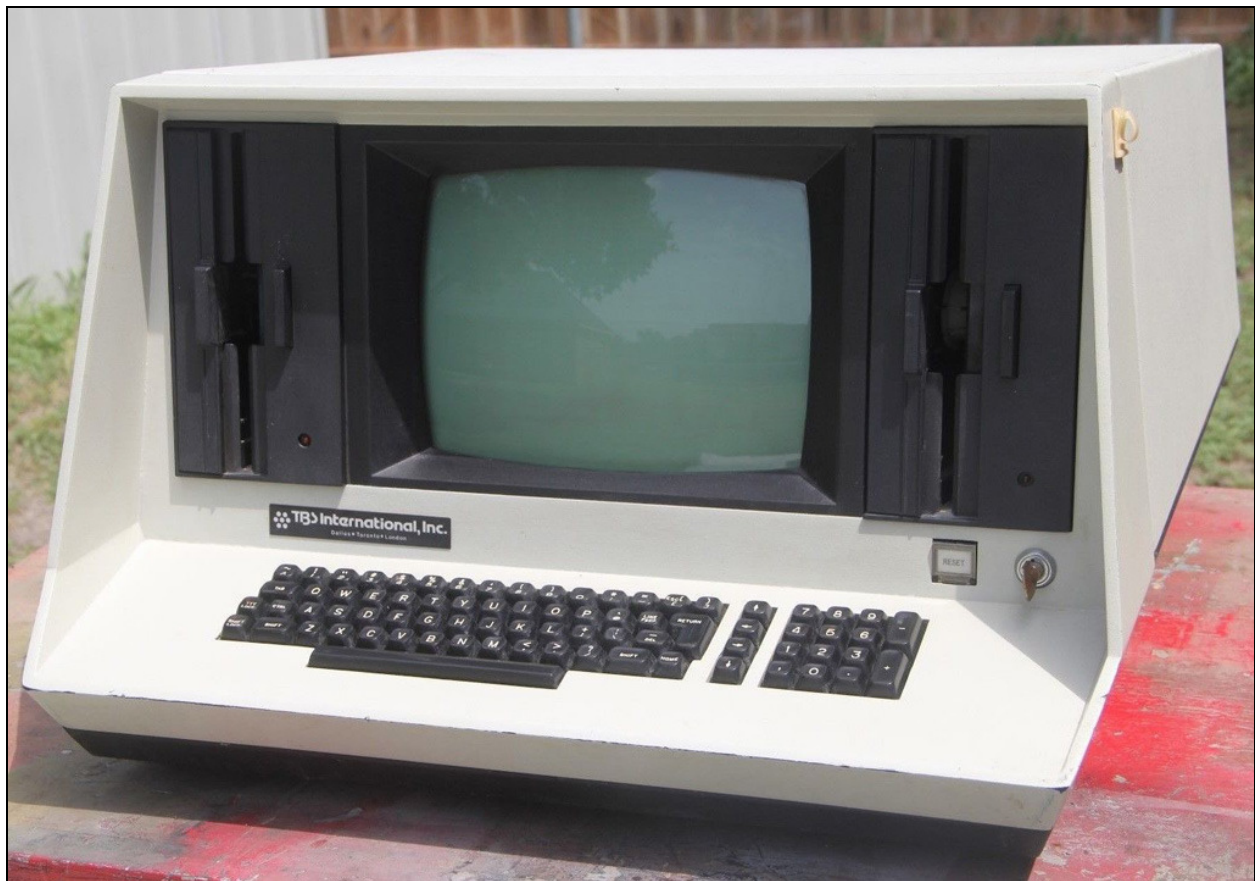
**Original System Front View**

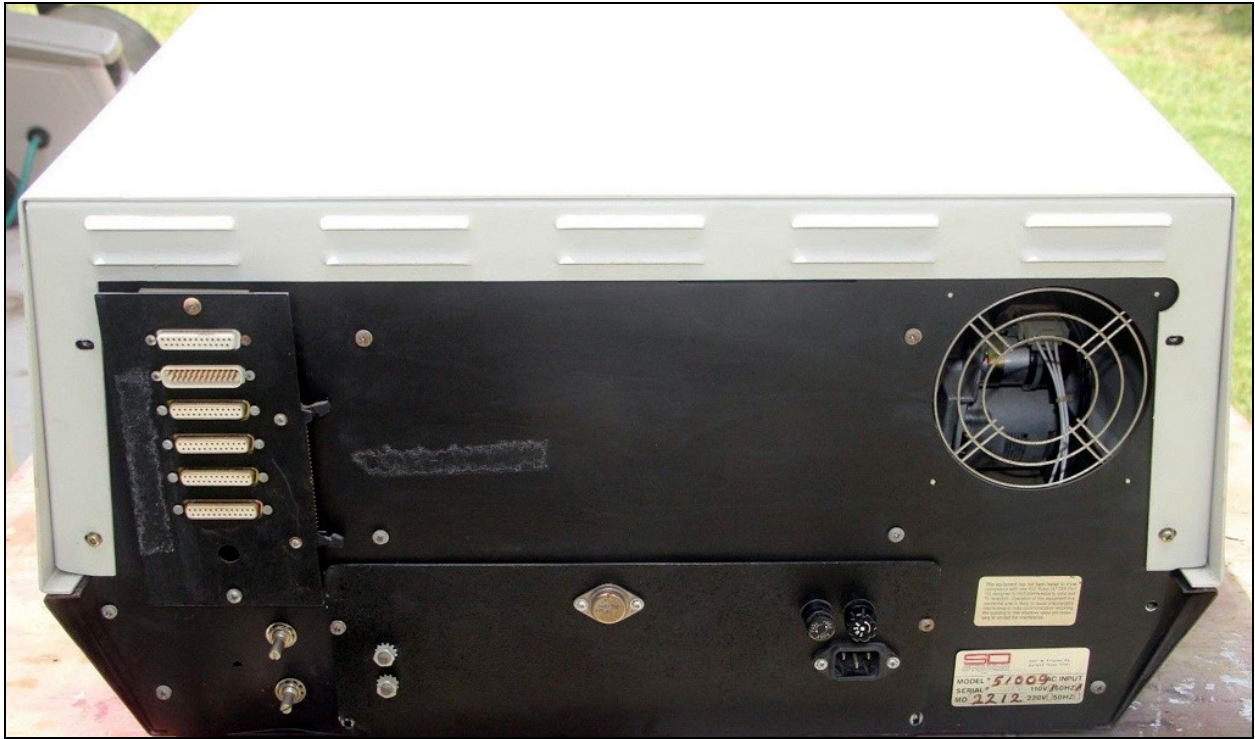
**Original System Rear View**

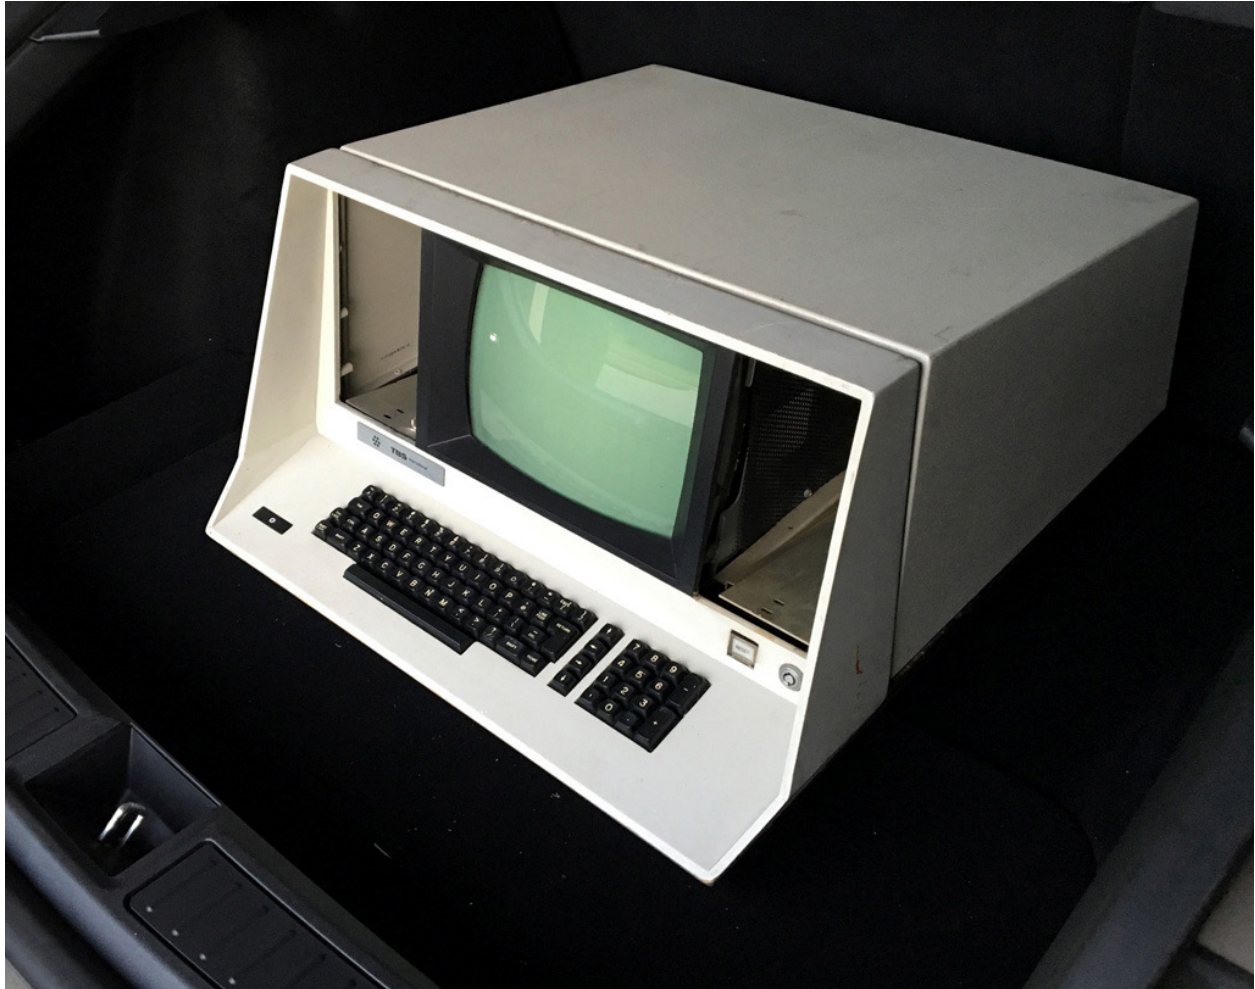
Shown below is the system as purchased in the trunk of my car. Notice the two floppy drives to each side of the 12 inch monitor are not present.

**System as Purchased**

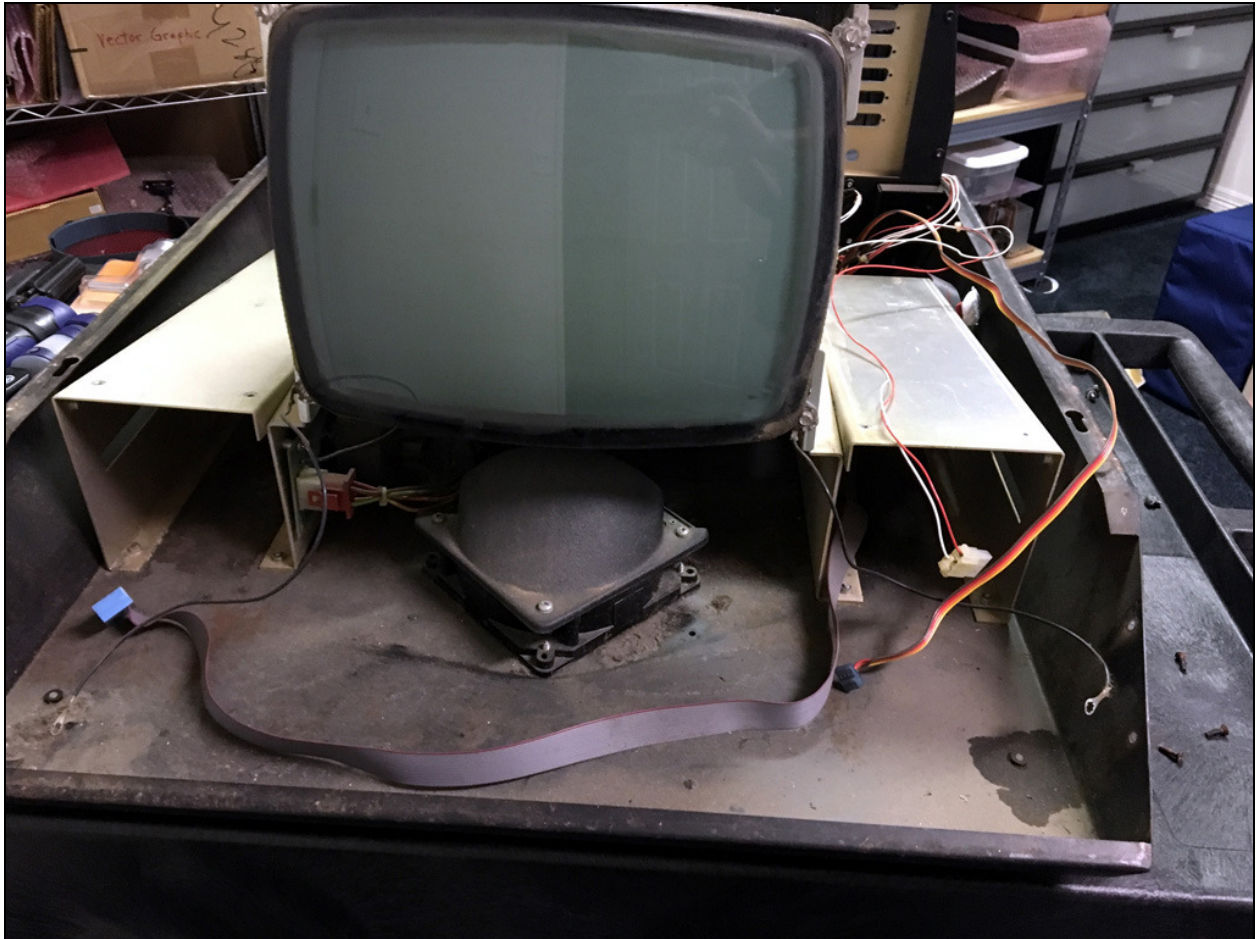
A fan mounted in the bottom of the cabinet blows air towards the back of the system (power supply and card cage area) by using a black plastic deflector. This can be seen in the following picture below the CRT.

The ribbon cable laying in the foreground is for the parallel keyboard. Obviously, the system was dusty and dirty and required some cleaning. The line down the middle of the CRT is just an artifact of reflections in the room.

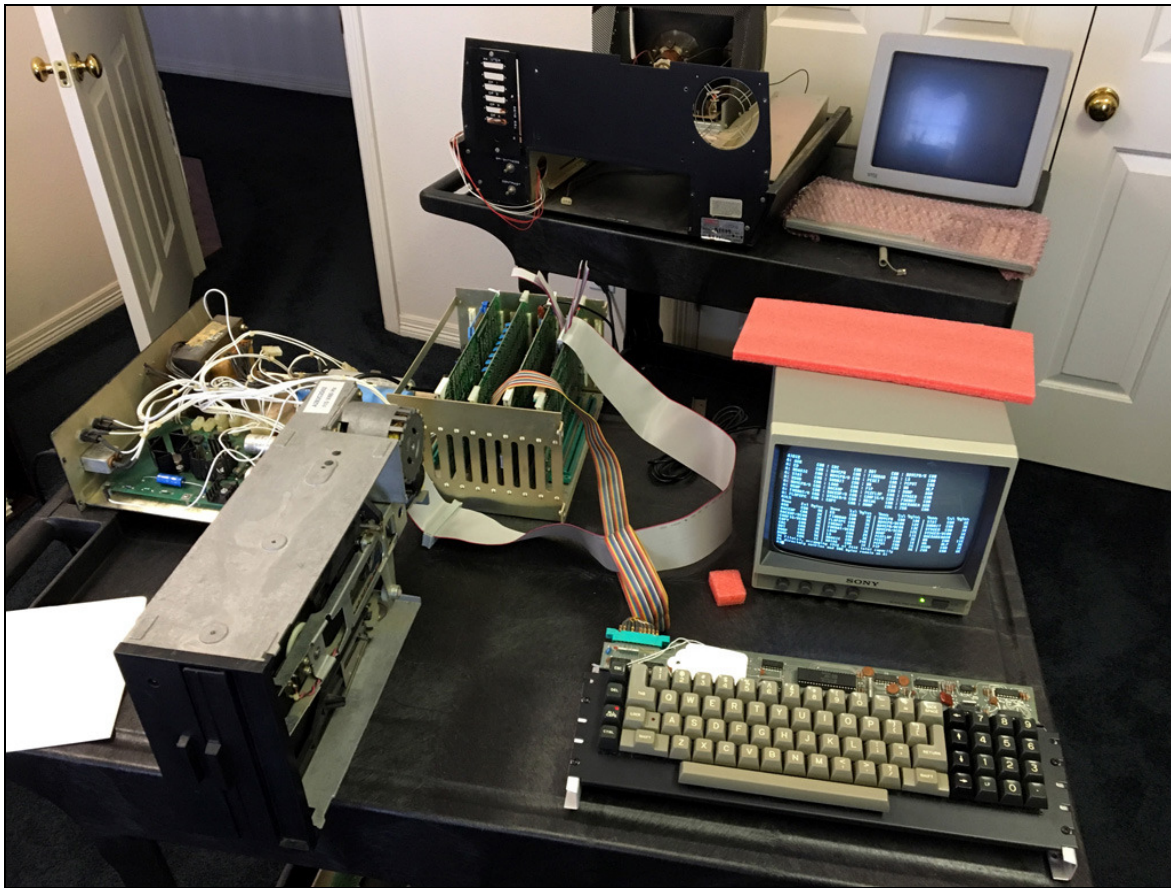
A picture of this system under test and running CP/M 2.2 on a single drive is shown on the following page.

**First Operation using Substitute Keyboard and Monitor**

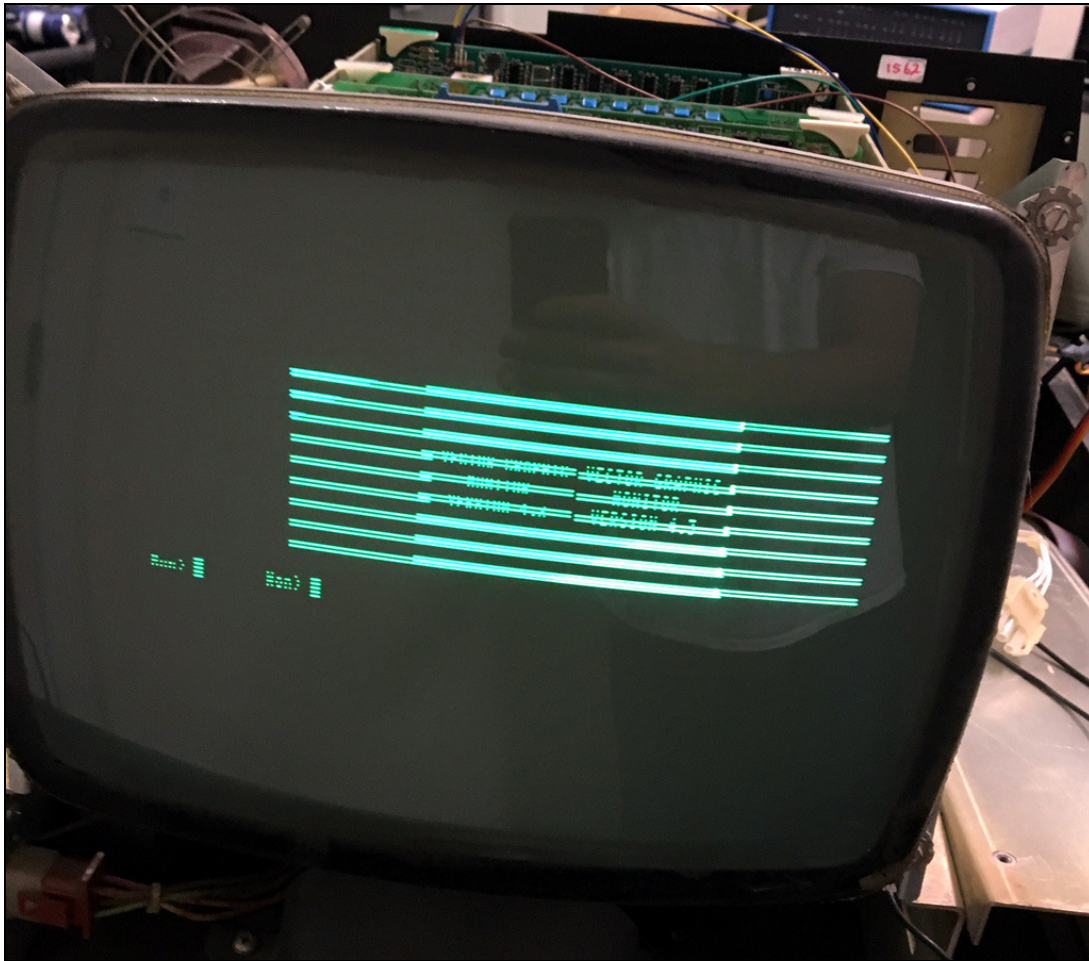
As can be seen in the following picture, there was still a video timing issue to be resolved. No matter how horizontal timing was adjusted on the FlashWriter or on the CRT driver board, the horizontal timing artifact shown in the picture remained.

**Horizontal Video Timing Problem**

Horizontal sync is generated by a 555 timer running in astable mode. I found the 555 was running too fast, causing a 2<sup>nd</sup> horizontal scan to start before horizontal sync was received from the FlashWriter video board. A 1000pf cap is used with the 555 to generate the horizontal timing. I suspected the capacitor was no longer 1000pf due to aging. I demonstrated this was the case by attaching clip leads across the 1000pf capacitor and using my finger as additional capacitance as shown in the following pictures.

Calculations based on the timing I measured showed an additional 300pf or so was required to restore the documented horizontal timing. Since removal of the monitor frame and CRT driver PCB was difficult, I tacked a 300pf capacitor in parallel with the original 1000pf capacitor to give horizontal timing that matched the waveforms shown in the monitor maintenance manual.

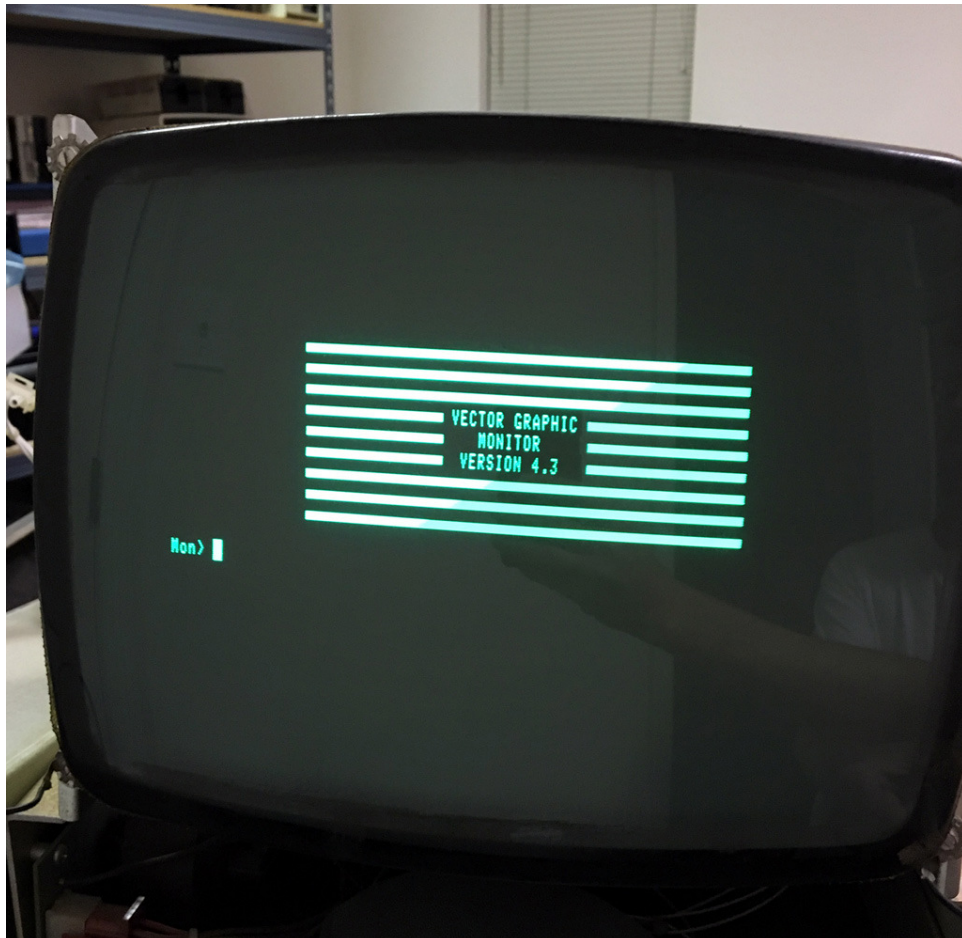
**Good Video with My Thumb "Capacitor" Added**

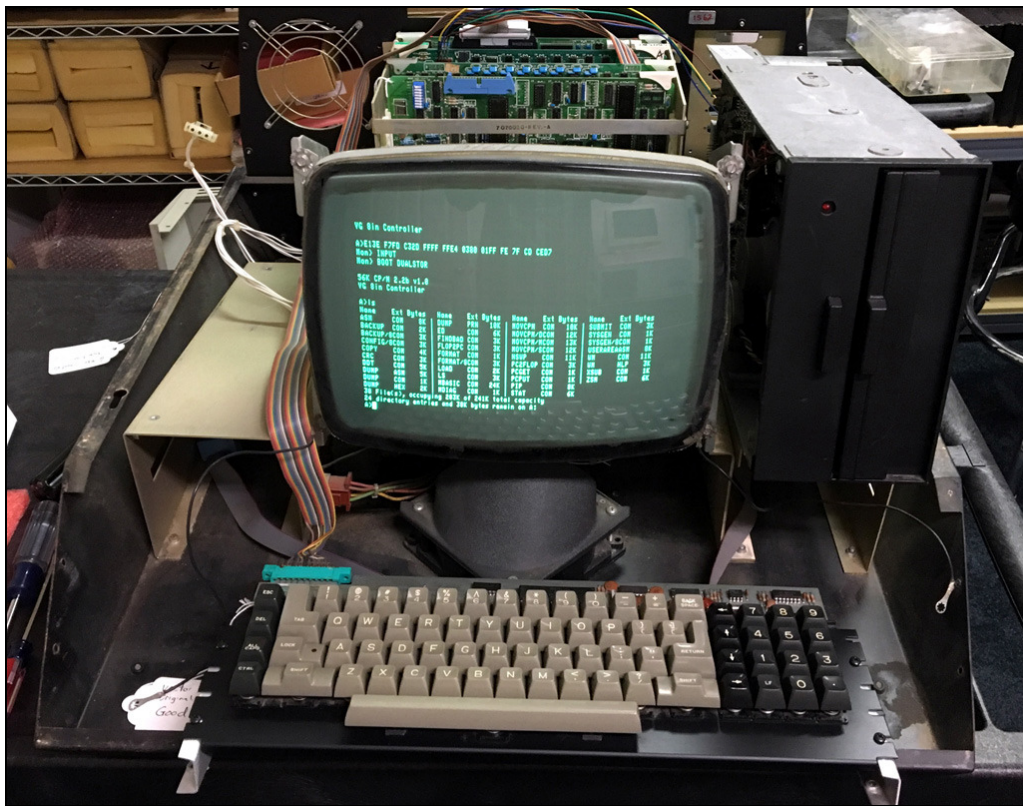
**System Test Before Keyboard Repair (VG Keyboard Used Here)**

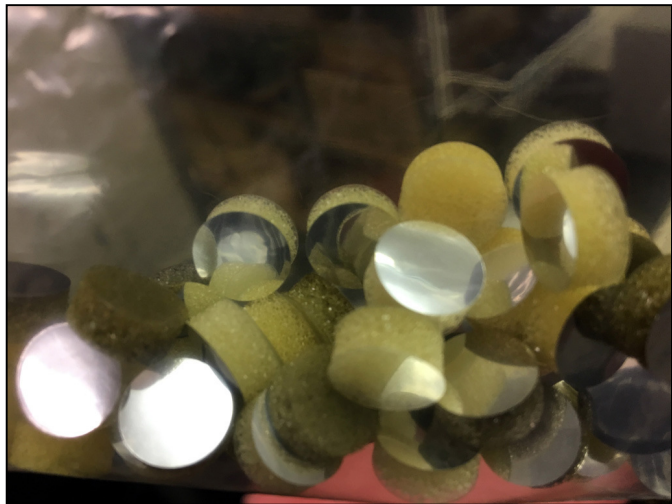
Replacement foam pads for these keyboards are not easy to make. Some are occasionally available on eBay, but for as much as \$2.55 per key. Sun Type 4 keyboards use a newer version of the same pad that does not seem to break down nearly as fast as in the older keyboards. As of 2017, Sun type 4 keyboards are still available on the Internet. A search under the part numbers, 320-1005 and 320-1018, yields results for the Sun Type 4 keyboard. This is not the official model number, but may be a Sun internal part number (the number is present on the product label, but it’s meaning is not identified). The 1018 number is a “French Canadian” keyboard. It seems to be the most readily available. These show up on numerous websites for \$19.98. I think they’re all actually all coming from the same place. I have purchased three of these keyboards and they have all been received in brand-new like condition.

Shown to the right are some of the newer pads pulled from the Sun keyboard (these are in a plastic bag, hence the glare).

After replacing all pads, some keys still did not work. Multiple attempts at fixing the problem positions still did not fix every bad key. I then took fine grit sandpaper (600) and smoothed all PCB “capacitor” pads. Though I had not noticed or felt any sort build-up on these pads, the sanding fixed the remaining keyboard problems.

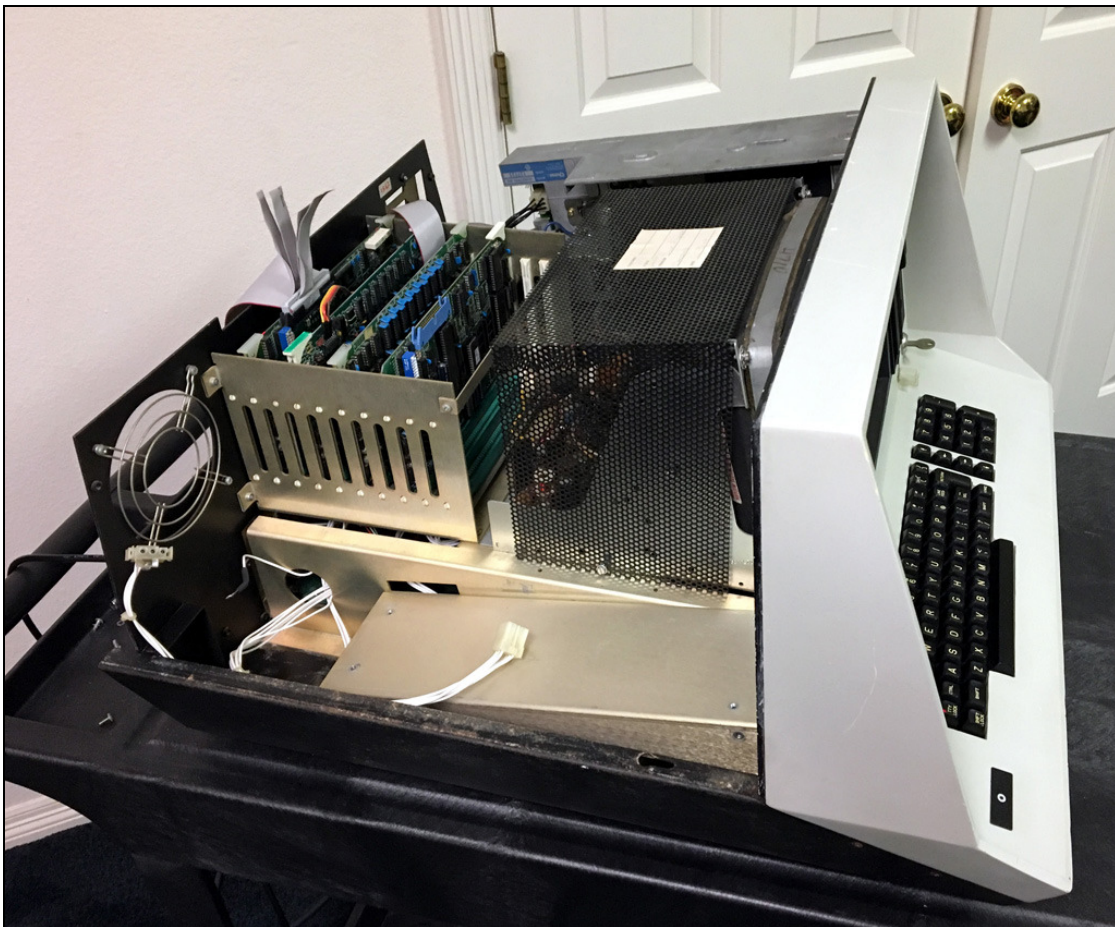
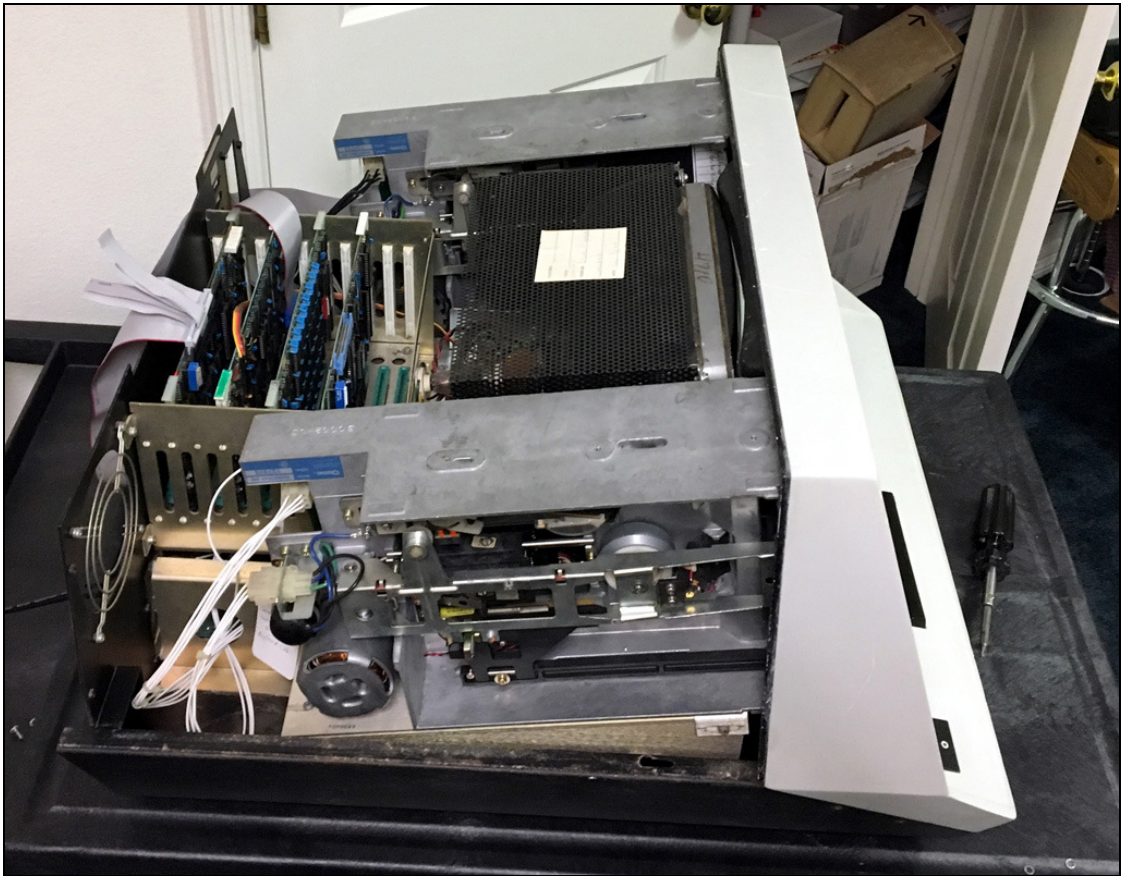
Following are pictures of the system during and after final assembly.

A custom “T” style disk drive cable had to be made since the floppy disk controller is physically located between the two disk drive – one on the left and one on the right.
