Series F

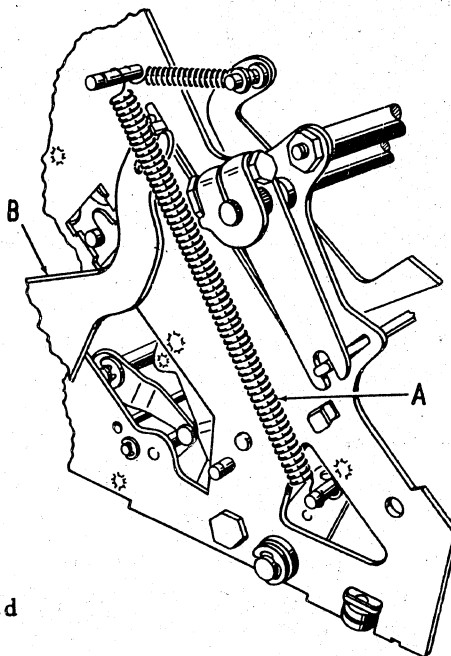
5-WRONG PRINTING caused by a broken restoring spring in the left end of the cipher block mechanism will be prevented by installing longer and more flexible spring A (J X 3), as illustrated. The offset eyes of the spring should be hooked inward to provide clearance between the spring and the type bar restoring arm B.

Spring X80-54 is still used in the right end of the cipher block mechanism in machines with ten or more columns. No spring is required at the right end of the cipher block mechanism in machines of less than ten columns when the improved spring A is installed.

Parts are available.

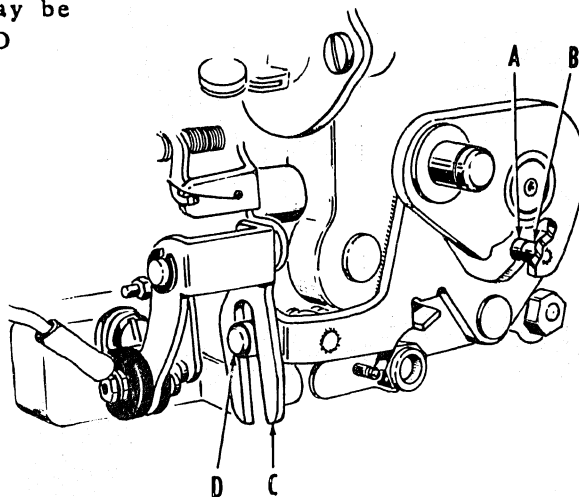
*1-BREAKAGE OF STUD B (81533C) may be caused by an early limit of roll D against the upper end of the fork portion of rocker arm C.*

#### Parts required:

- A 83422 roller
- X5-27 clip
- B 81533C stud

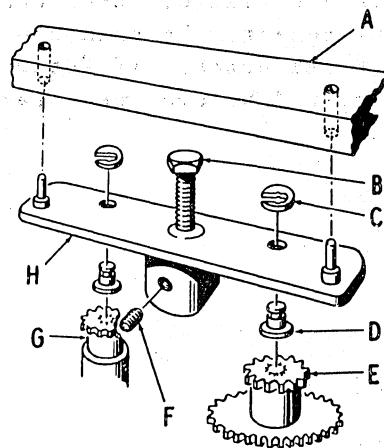
#### 1-IMPROVED ADJUSTABLE THRUST LIMIT FOR TABULATION AND RETURN CLUTCH SHAFT ASSEMBLIES

G AND E maintains the correct depth mesh of gears AA and AC (Plate 2, Symbol Book). Limit plate H (illustrated) is positioned by guide studs utilizing existing holes in the underside of rear carriage rail A. Replaceable limit pads D centered over shaft assemblies G and E are retained by clips C. Screw B limiting against the bottom of the carriage rail is adjusted to provide .003" clearance between the limit pad and the return clutch shaft. The limit pads should be lubricated.

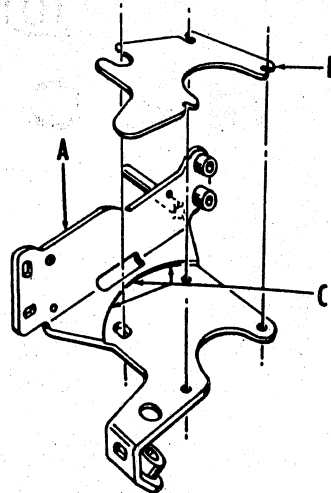
These shims, located between A and the worm shaft assembly, should be used only with the stock corrected brackets which may be identified by the surface mill cut indicated by arrow C.

Since none of these stock corrected brackets will be furnished for service replacement, the shim should be discarded with the bracket if future replacement of bracket A becomes necessary because of wear.

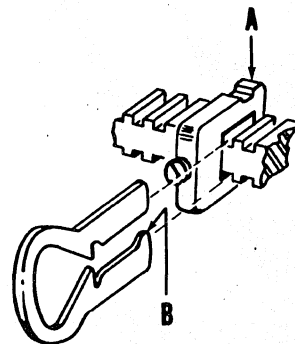
**1-SKIPPING OF THE CARRIAGE THROUGH TABULATOR STOPS IN P400 MACHINES** may be caused by incorrect installation of the stops in the stop bar.

Stop B should be installed with its retaining projection, at the point of the arrow, on the underside of the bar, thus placing its rounded (die side) surface away from contact with the carriage stop bail. The stop should also be firmly supported by brace A.

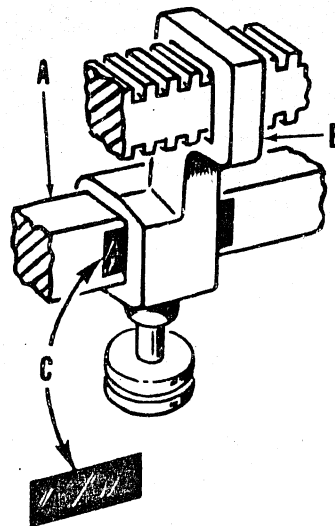
**6-SELECTION OF THE WRONG PRINTING CAMSHAFT POSITION** may result from control bar A being held bowed because of an enlarged opening in center hanger B.

The control bar will be held straight, and all control hangers in correct alignment, by installing shim C (903165 1/4Y) in the opening of the center hanger as illustrated before tightening the screw. Parts are available.

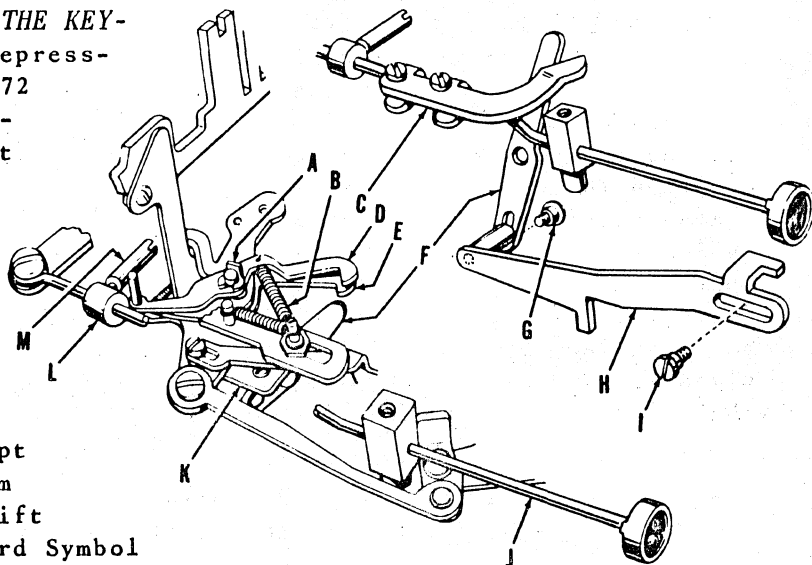
**1-EFFECTIVE LOCKING OF THE KEY-BOARD** from a partially depressed subtract key in Class 72 and Series M200 machines - without causing subsequent hard depression when fully depressing the key to index the power mechanism - will be provided by installing new auxiliary latch D.

The new latch retains arm F in position to lock the entire keyboard (except Clear Multiplier Key) from the time subtract plate lift pawl AB (Plate 30, Keyboard Symbol List) is released until latch E (illustrated) is positioned during the machine operation. The new auxiliary latch may be installed to facilitate adjustment of machines subsequent to Serial No. B46251. Parts are available.

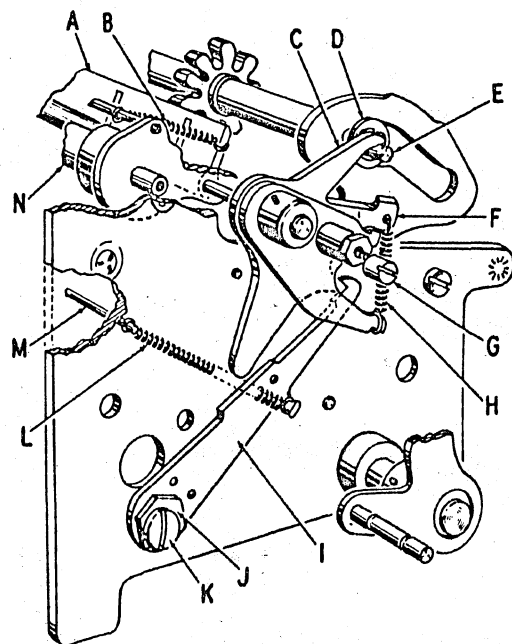
3. There should be .003" clearance between screw G and arm AE (Plate 42).

To adjust - reposition eccentric screw G maintaining the high point forward to prevent interference with AE (Plate 42) on add and subtract operations.

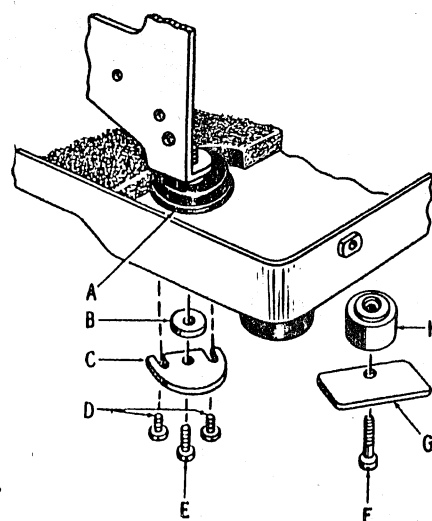
*1-TO PREVENT DAMAGE DURING SHIPMENT*, all styles of currently manufactured Series C machines that include rubber shockmounts A (Mecanogram 575) will be fitted with solid mounts B when packed. The rubber shockmounts will be packed separately and should be installed as directed in Mecanogram 575.

- a. Remove the machine case.
- b. Turn the machine with the base up, and remove and discard the four screws F and plate G.
- c. Disconnect the wires from the motor to the base plug.
- d. Remove the base.
- e. Remove and discard the four solid mounts H.
- f. Assemble the rubber mounts to the side frame feet, entering the full length of the shockmount screw thread.
- g. Reassemble the base.
- h. Reconnect the wires from the motor to the base plug.
- i. Replace the case.
- j. Using a screwdriver in the shockmounts slots (which are accessible through holes in the base) adjust the height of the machine until there is about .005" clearance between the keyboard and the case. (Noise will be transmitted if the case and keyboard contact).
- k. Secure the shockmounts to the base with screws D.

If machines in use - and equipped with shockmounts - are to be shipped, prepare the machine for shipping as described in the second paragraph and as illustrated.

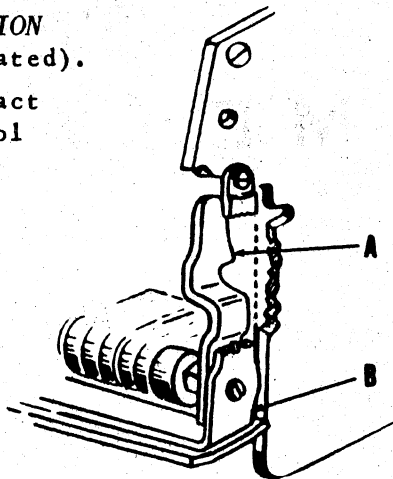
2-PRINTING OF AMOUNTS IN A NON-PRINT POSITION may be caused by twisting of bail B (illustrated).

The bail now contains added arm A for contact with roller shaft CC (Plate 3, Printing Symbol List) to support the right end of the bail during the machine stroke. Bearing screw AE (Plate 6-2, Printing Symbol List) for the right end of the bail is now headless and provides free turning of shaft AH in its bearings.

Protection against breaking of the bail at the hole for spring AP (Plate 6-1, Printing Symbol List) is afforded by eliminating the hole from the bail and attaching a longer detent spring V (Plate 6-2, Printing Symbol List) to an extension on the threaded end of the screw through eccentric N. The spring groove in the stud of detent T is moved closer to the detent for alignment with the longer spring.

The improved bail should be used to provide printing results established by control shaft AH, and for replacement of a broken bail, after which the tests and adjustments given in Plate 6-1, revised 10-4-55, Printing Instruction Book, should be followed. Parts are available.

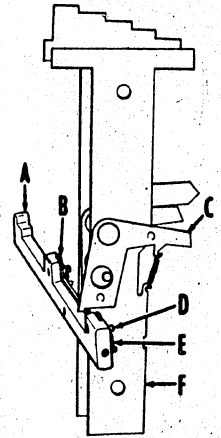
**1-CONTINUOUS MACHINE CYCLES (RUNAWAY) IN SERIES M200 AND CLASS 72 MACHINES** caused by accidental reset of an indexed lift pawl C (Plate 22-1, Accumulation Symbol List) from the initial impact of raise bar AM will be prevented by spring-cushioned auxiliary bar B (illustrated) and re-designed lift pawls C.

The auxiliary bar, which is under tension of springs E, cushions the initial impact of the bar against lift pawl C and provides positive locating of the pawl over the raise bar. As the pawl locates fully over the raise bar, the auxiliary bar raises into the milled recess in the lower surface of the lift pawl to hold the pawl from accidental reset throughout the machine cycle.

When continuous machine cycling is experienced during multiplying or subtract operations, hook AN (Plate 22-1) should be removed and the following parts installed:

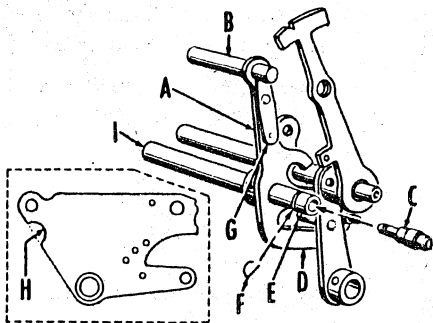
NOTE: To avoid damage to springs F, do not insert trunnions C into shaft I until the shaft is in the machine. Install as follows:

- Remove the keyboard. Remove shaft B. Remove index wires No's. 4 thru 8 in column one. Move the subtract lever to subtract position and advance the machine to the last step of the forward stroke. Drop all sectors to 9 position.

- Remove the motor bar attachments from the front outside area of the right side frame to provide an opening for the repair assembly.
  - Disconnect links K and H (Plate 85-1, Accumulation Symbol List) from the lower left extension of the worn assembly, and break the extension away from its hub.

- Cut the shaft of the worn assembly in two with a hacksaw blade, and remove the pieces.
  - In early machines, cut a notch in the full stroke segment retaining plate to the approximate outline shown at H (illustrated) for clearance of the repair assembly when it is being installed. Half-round file Kit 243 may be used.

- Remove the left arm from the repair assembly. The taper pin in the arm is lightly driven for easy removal.
  - Install the repair assembly through the right side of the machine, and in the process, reassemble the left arm, previously removed, on the assembly as it nears its working location. Position stud E through the opening in arm D.

- When the repair assembly is in working location, replace the taper pin in the hub of the left arm. Support the hub and set the pin firmly.
  - Insert a trunnion C into each end of the repair assembly, after the pin has been set in the hub.

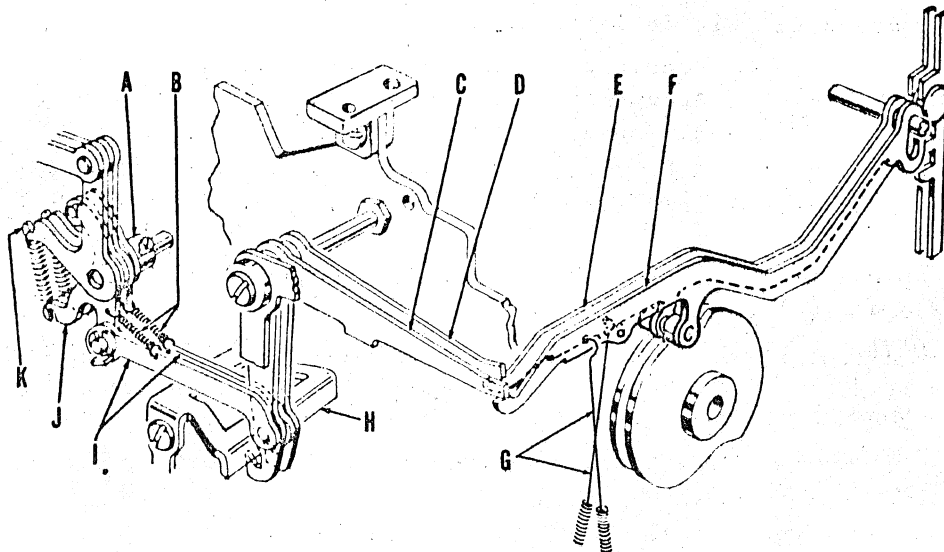
**1-ERRATIC SKIP OR RETURN RESULTS** may be caused by a tendency of bellcrank C or D to float out of position during keyboard indexed accumulator "B" total or sub-total operation. This floating action can bring the latching point of the bellcrank in line with the lower edge of latch plate H, preventing the plate from lowering to hold the index of lanes 1 thru 5.

Positive control may be obtained by installing heavier springs B and installing new sensing levers E and F which have springs G located closer to the right side frame preventing upward motion of bellcranks C or D as the sensing camshaft is rotated with no control pins active. Parts are available.

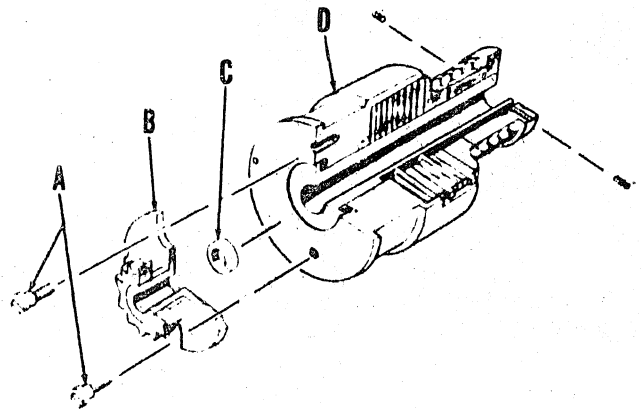
resulting in partial or sluggish return of the register pinion assembly will be eliminated by installing the improved clutch assembly illustrated. Installation of the improved assembly will also overcome excessive clutch slipping.

The improved clutch contains felt discs for better friction quality and has a bronze bearing C for free turning of the clutch on its shaft.

1-71373D	D, Illustration	Clutch assembly
701377	C, Illustration	Bronze bearing
1-701306A	B, Illustration	Gear to drive take-up spindle
71626 (2 req.)	A, Illustration	Screws to hold gear B to clutch D

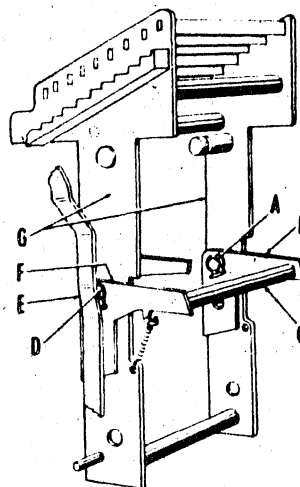
9-THE SUBTRACT BASKET ASSEMBLY (illustrated)  
- in Sterling Series M700 and M800 machines -  
has been improved by riveting both flipper pawls B and F to shaft C.

This improvement reduces the possibility of the subtract plate pawl sagging and being contacted by raise bar BG (Plate S-50-1, Accumulation Symbol List) during the first cycle of a subtract operation - in Class 78 new wide base and Series M800 machines. Should this condition occur, the basket assembly would be raised and the machine would lock because of simultaneously attempting to index and restore bail BJ (Plate S-50-1). The basket assembly could also be raised from other machine operations, thereby resulting in incorrect printing and totaling.

Pawls B and F (illustrated) in the improved assembly are retained on the studs in side plates G by clips A and D (21 No. 2).

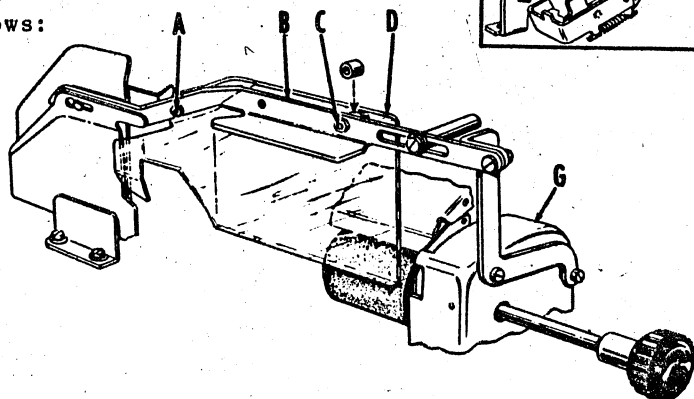
**1-WRONG PRINTING AND ADDING IN STYLE 1010304, BILL RECEIPTING MACHINES** - caused by the form guard and guide 16 (Plate 40, Carriage Parts Catalogue) interfering with movement of type bars - will be eliminated and form handling will be improved by installing the new guard and guide illustrated. Install as follows:

- Remove the tear-off blade and install spring anchor E for spring F formerly hooked to the tear-off blade. The spring extension should be bent upward for minimum clearance with cover G.
- Install the new guard and guide as shown.

It is desirable to have slight tension of the lower edge of plastic guard D against the platen. Loosen screws A and C and move the guard to the right or left as required.

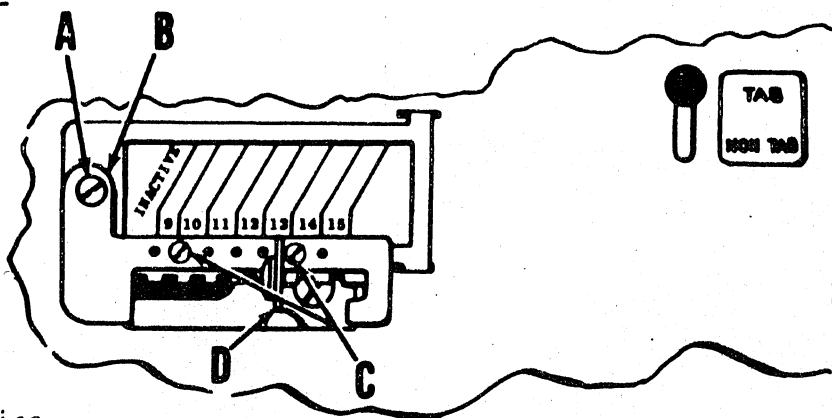
**1-SELECTION OF DIFFERENT COLUMNS** for the Multiplying Factor Mechanism will be made easier by installing limit plate B (705155 1/4). Use screw A (705503 1/2). When other than either extreme position of lever D is required, install limit screw C (709508) according to need.

Screws C will be included with the accessories for each machine when shipped from the factory.

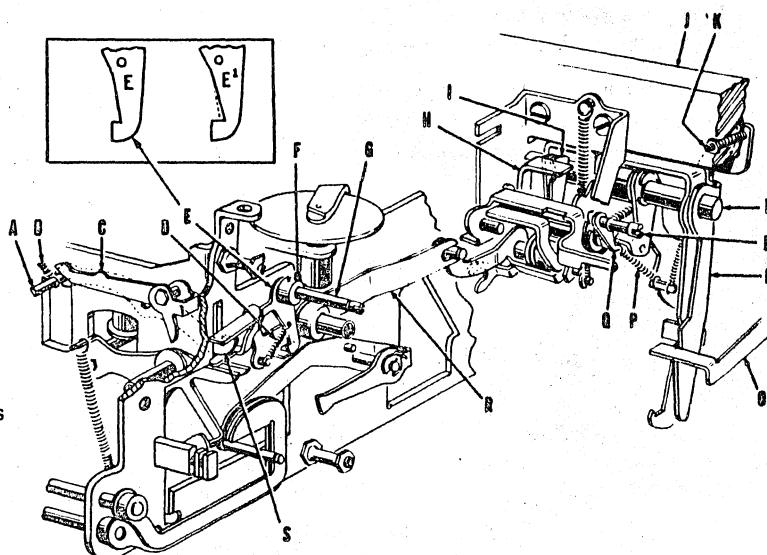
1. Test - There should be not more than .010" passing clearance between the formed ear of lever H and the rearward edge of interlock I as lever R is lowered slowly to its tripped position.

To adjust, bend the rearward projection of lever R.

2. Test - There should be .010" to .015" passing clearance between the formed ear of arm O and the step of interlock N when the drive is tripped as lever R is lowered slowly to its tripped position.

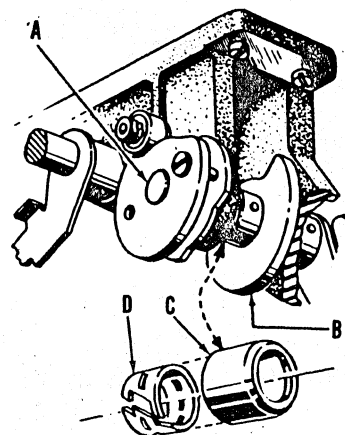
*1-FAILURE TO AUTOMATICALLY TOTAL THE CROSSFOOTER IN NO SPACE STROKE TOTAL BANK MACHINES* may be caused by insufficient movement of arm CA (Plate 43-1, Accumulation Instruction Book) to meet the plug gauge test (Adjustment No.1). When the setting of eccentric CB for maximum throw does not provide sufficient movement, the reason may be worn bushings for shaft A (illustrated).

Bearing retainers C (201307B) and bearing inserts D (201307 1/2) may be used as replacements where worn bearings are encountered. The tapered ends of the retainers, with the inside retaining rims, should be positioned toward central cam B so that the bearing inserts will be held in the desired locations.

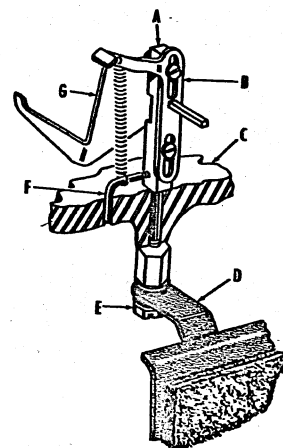
**1-FAILURE TO SUB-TOTAL OR NON-SUBTRACT, SERIES M800 MACHINES, OR TO NON-CLEAR SUBTRACTOR, SERIES M700 MACHINES,** may be due to bind in lever G and slide B (illustrated) caused by accidental turning of post A (Plate 32, Keyboard Symbol List) when loosening or tightening front retaining screw E (illustrated) in the drive housing cover D.

Post A is now prevented from turning by replacing the spring stud in the post with spring anchor F (702511 1/4) which extends into a hole through machine base C. The hole is located by using the spring anchor installed in the post as a template. Use drill Kit 260 No.38. The new spring anchor should be installed the first time the typewriter is removed.

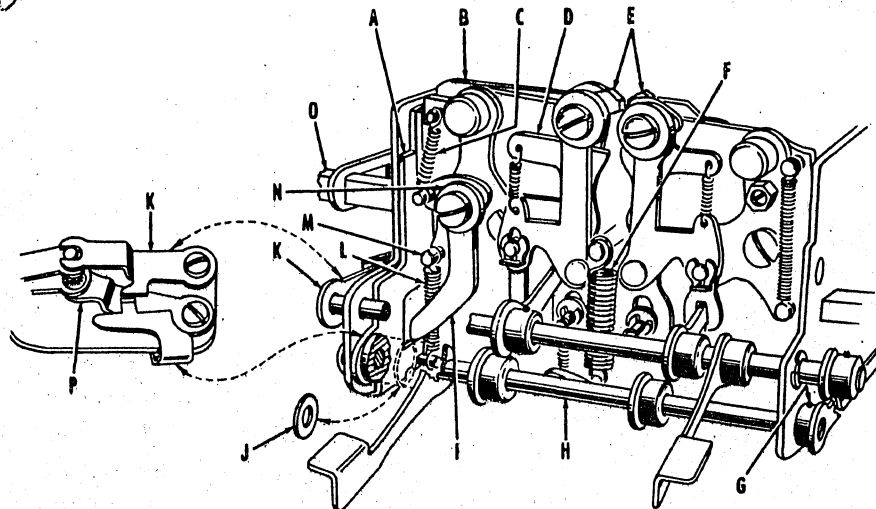
**1-MACHINE OPERATION WITH CONTROL PINS AND TAPPETS OUT OF ALIGNMENT**  
will be prevented by installing the recoil blocking mechanism illustrated.  
It functions as follows:

As a tabulator stop separates bumpers E, stud M disengages latch I from blocking arm A, releasing the latter to limit against the right bumper. As the bumpers are closed by spring F, the blocking arm is moved into position between the bumper and the gear box side frame by spring L - preventing reseparation of the bumpers.

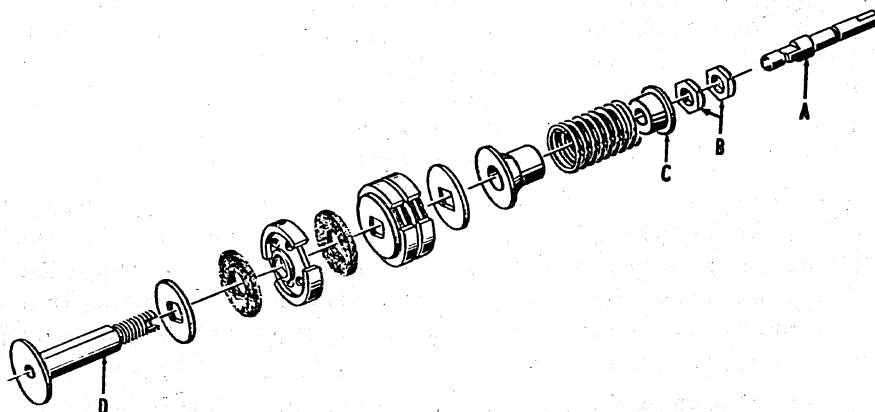
**1-CARRIAGE DRIVE CLUTCH 1FG13-1**, equipped with oiled felt disks in place of carbon disks for improved power transmission, is available for Field installation.

The clutch is factory gauged to provide 15 lbs. to 20 lbs. of force on dynamic test with nuts B (illustration) tightened to cause longer flanged collar C to limit against the shoulder of spindle D. Note: It is recommended that the factory setting be left undisturbed. Before replacing these clutch assemblies because of low output, it should be determined that all mechanisms driven through the clutch are on test and lubricated.

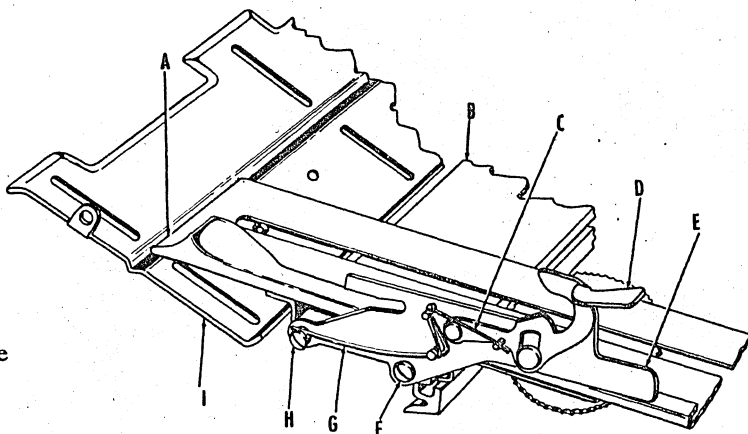
Spring anchor stud FA118 in register right side frame BD for torsion spring P is lengthened, reduced in diameter and made without a spring groove. These changes in the stud prevent a cramping of bracket AI by the additional coils wound onto spring P as the higher numbered registers are selected.

Stronger spring 681 1/8 replaces spring BB (Plate 40-4) use X85-12 clip.

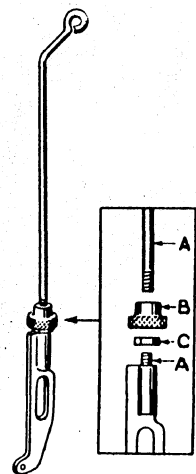
**3-FAILURE TO SELECT THE CORRECT HAMMER BLOCK POSITION** may result from a broken rod R (Plate 6-1, Printing Symbol List).

The broken rod may be repaired when the break is in the threaded portion above the lock nut by replacing the full size nut with half nut 46 1/4 (C, in illustration) and installing knurled nut 73381 (B, in illustration) to hold the broken sections together.

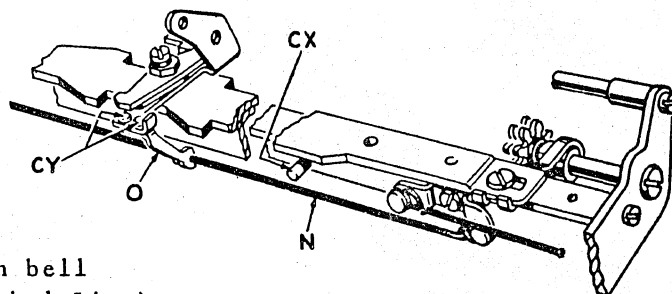
**1-STRAIGHT TRAVEL AND LONGER LIFE OF DRAW CORD N** (illustrated) will be afforded by removing stud CX in all except Style M222 machines and adjusting guide O to align with the cord.

In Style M222 machines, which require contact of the stud with bell crank Y (Plate 9-1, Printing Symbol List), the stud may be shortened sufficiently to permit aligning the guide and installing a new bell crank 1-706231B that has been redimensioned to compensate for the shorter stud. Protect rivets CY when adjusting guide O.

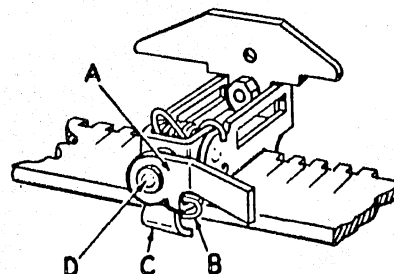
1A-73214A and 1-73214C No. 2 (P and Q, Plate 26-1B, Carriage Symbol List) from the control bar on currently manufactured machines is prevented by a newly designed retaining clamp C.

The improved retaining clamp contains release lever A that pivots freely on rivet D. Lever A is held inactive (horizontal) by spring B and must be manually raised to vertical position to release the retaining clamp.

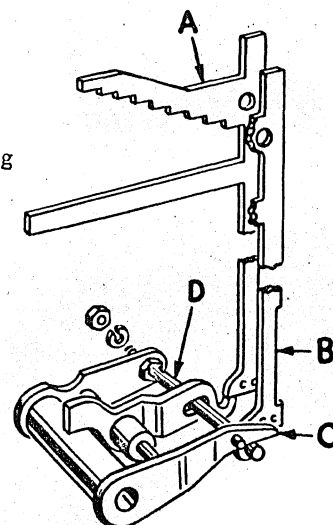
The riveted shaft in assembly AF (Plate 22-3, Accumulation Symbol List) has been replaced by eccentric shaft D (illustrated) to provide a range of adjustment of the index plate. The eccentric shaft should be located to insure central positioning of the formed lip of the adding rack on the active step of the index plate.

Machines having the multiplying factor to print controlled from a lever on the front writer panel require assembly C (1C-704305A) and new raise bail 1-704914A No. 6 which has an additional milled surface for clearance of the new assembly.

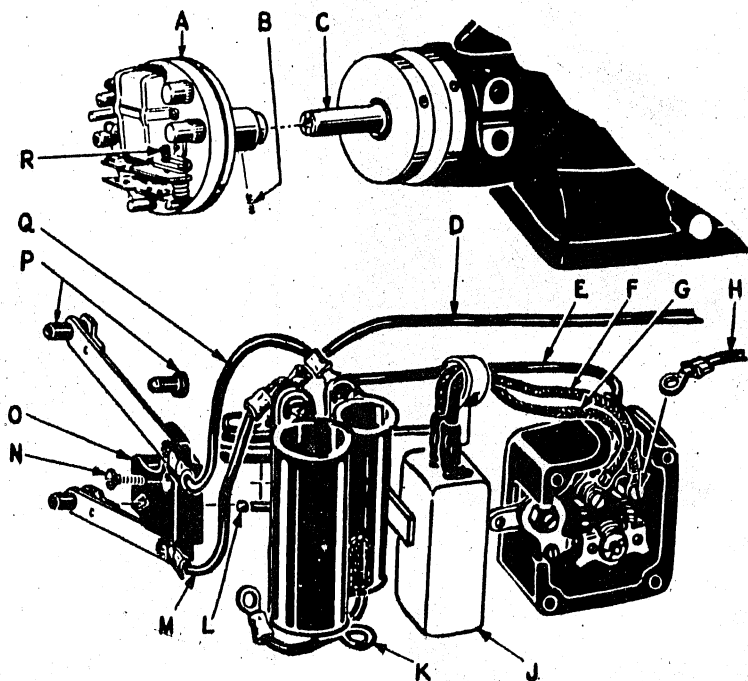
- Governor A on shaft C. The assembly is retained by two set-screws B - one with a cup end (X60-176) and one with a cone end (X60-177). With the governor placed to the limit shoulder on shaft C, tighten one screw to mark the shaft. Using a Kit 270 No.31 drill, bore a cone-shaped hole at the mark to the depth of the cutting surface of the drill. Tighten the cone-ended screw in the hole and lock the assembly with the cup-ended screw.

An alternate method is to mark shaft C as above and file a small flat area on the shaft. When this method is used, two cup-ended screws (X60-176) are required.

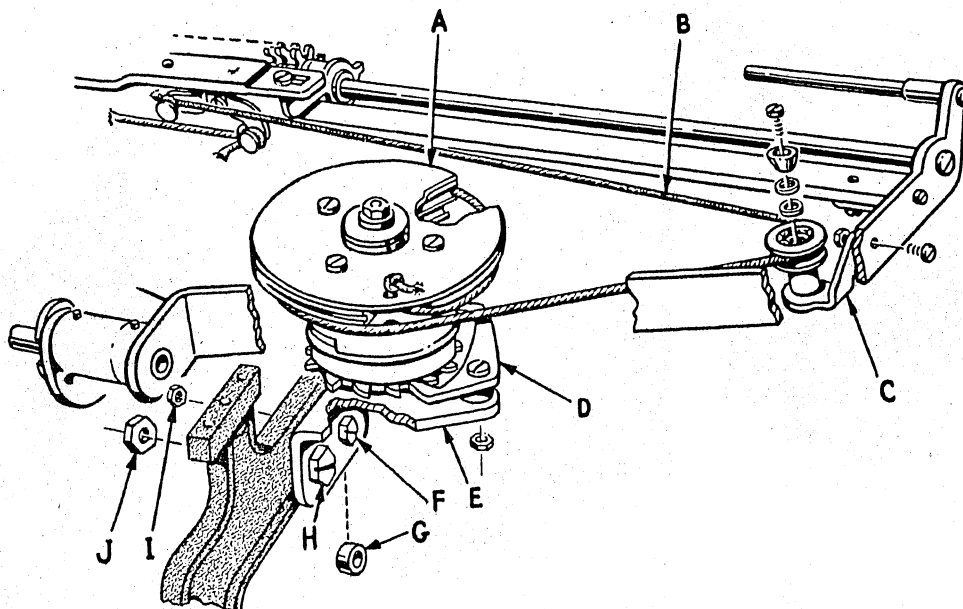
**1-WRONG REGISTER SELECTION, INCORRECT ADDITION, OR LOCKS IN THE REGISTER SECTION** may result from sluggish escapement of the register pinion assembly and vibration of shafts AN and W and blade V (Plate 8A, Accumulation Symbol List). These conditions will be minimized with new style spring barrel assembly A (illustrated).

The new assembly provides uniform spring tension on the register pinion assembly in all positions, and reduces vibration because weight has been shifted from the register assembly to the machine side frame. It may be installed in older machines as follows:

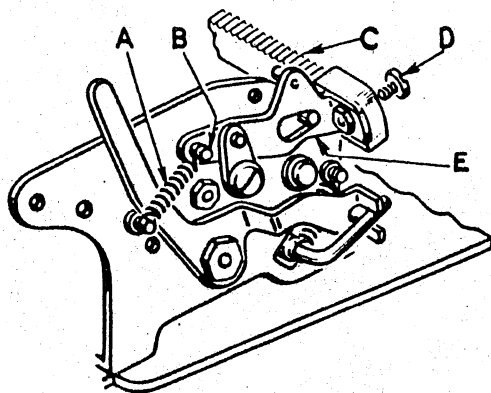
**2-PLASTIC TEAR OFF BLADE C FAILING TO RESTORE IN NA-2 CARRIAGES** after being moved forward for insertion of paper may be caused by stud B and spring A contacting the machine case.

The stud is now shorter and the spring has smaller diameter coils to insure clearance with the case and free action of the blade assembly. The condition may be remedied in earlier machines by either filing the stud or replacing slide E (1-903205L - 3 7/8) and installing smaller diameter spring A (X80-88).

**4-INSERTION OF HEAVY OR MULTIPLE FORMS** in NA-2 carriage may require installation of guide 1-83152 1/8 No.2 (No.10, Plate 41, Carriage Parts Catalogue) to prevent contact with the ribbon. Remove the ribbon feed arm limit screw or stud from the carriage bottom plate and install the guide using two screws 7356 1/2.

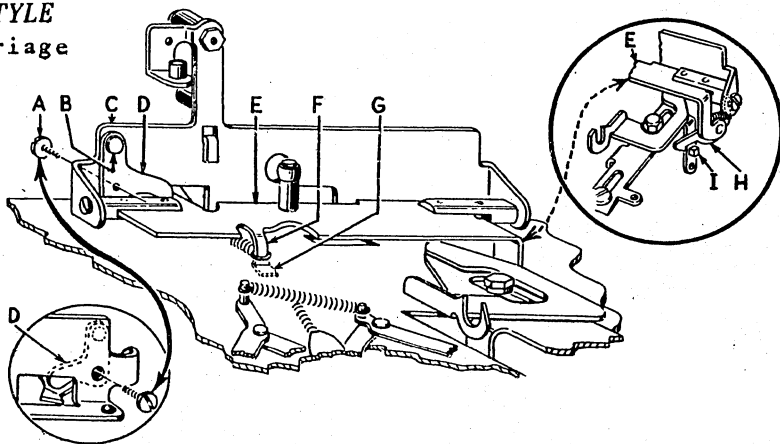
**1-FAILURE TO TABULATE, STYLE B CARRIAGES** (Plate 27, Carriage Parts Catalogue), may be caused by a broken extension (illustrated dotted line at G) of spring anchor F which positions tabulating bail E at normal.

Bail E is now constructed without the extension (solid line of F), and a new adjustable limit D is assembled as shown.

Limit D may be installed when the extension is broken by removing a spring stud in plate C to permit use of rivet B.

The new limit is positioned with screw A to allow square stud I to reposition under latch H with latching lead at the end of the return machine stroke following a carriage tabulation.

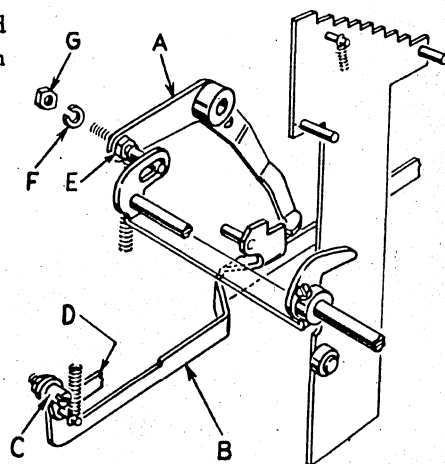
**1-CONTINUOUS CYCLING OF A CLASS 72 OR M200 MACHINE AFTER A SUBTRACT OPERATION** may be caused by failure to latch eccentric stud C (702662) in back of latch D during the subtract operation.

Rocker arm A (1-704124B No.3) - in currently manufactured machines - contains eccentric stud E (1503A Fte. 717), lock washer F (1097 3/4) and nut G (46). The eccentric stud provides a ready means of adjusting the restoring of slide B, during a subtract operation.

The eccentric stud, lock washer, and nut should be used to replace the riveted stud in rocker arm A in Field machines that have the above condition.

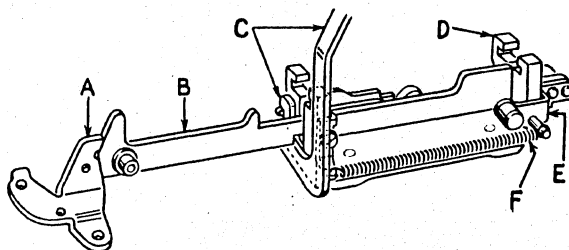
**3-BREAKING OF ERROR KEY SLIDE SPRING ANCHOR E** caused by contact with casting D has been corrected by extending limit plate A (702227) upward. The new limit maintains clearance of the spring anchor and casting D and should be installed in wide base machines during the next regular inspection.

**Test:** Register interlock slide C should move freely in the cutout of the error key slide.

To adjust, bump limit plate A forward or backward to align the cutout in the error key slide with the register interlock slide.

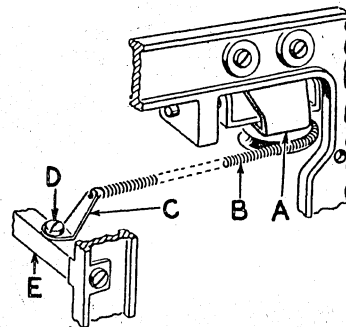
**1-PREATURE RESET** of the Pence intermediate keyboard stop in machines of Sterling construction having the Repeat of Items Mechanism will be avoided by installing longer spring 706804 in place of spring AU1 (Plate 3, Keyboard Symbol List). The new spring reduces overthrow of the intermediate keyboard during the machine operation.

Pulley assembly A (illustrated) replaces the spring anchor originally used on the left side frame of the machine. The outer end of the spring is attached as shown to spring anchor C on square bar E at the rear of the machine.

This arrangement will also improve escapement of the intermediate keyboard when indexing amounts. It may be installed in any 14 digit capacity machine where either of the above troubles is experienced, providing no other mechanisms are contained that would cause mechanical conflict.

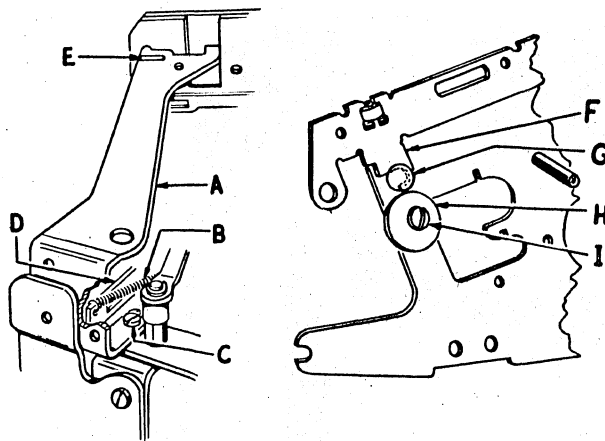
Machines of current manufacture have eccentric disk H and screw I to serve the same purpose as the bracket.

Machines without either arrangement should be equipped with the support brackets.

**Method:** Remove spring clip Q (Plate 110-2, Symbol List) and assemble the support bracket using screw 12055 3/8 in place of screw R. Open adjusting slot E (illustrated), if necessary, to remove all play between the keyboard assembly and the stud in the right side frame. Hook spring O (Plate 110-2) in guide bracket D (illustrated).

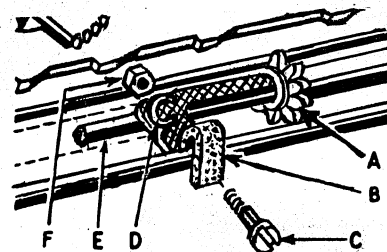
1-REGISTER LIMIT B (709181), screw C (709543), lock washer D (1097 3/4) and nut F (46) replace the limit combinations shown in Charts 1 and 2 (Plate 17-1, Accumulation Symbol List).

With the last desired register in active position, the limit is assembled as illustrated to prevent further escapement of the register pinion assembly.

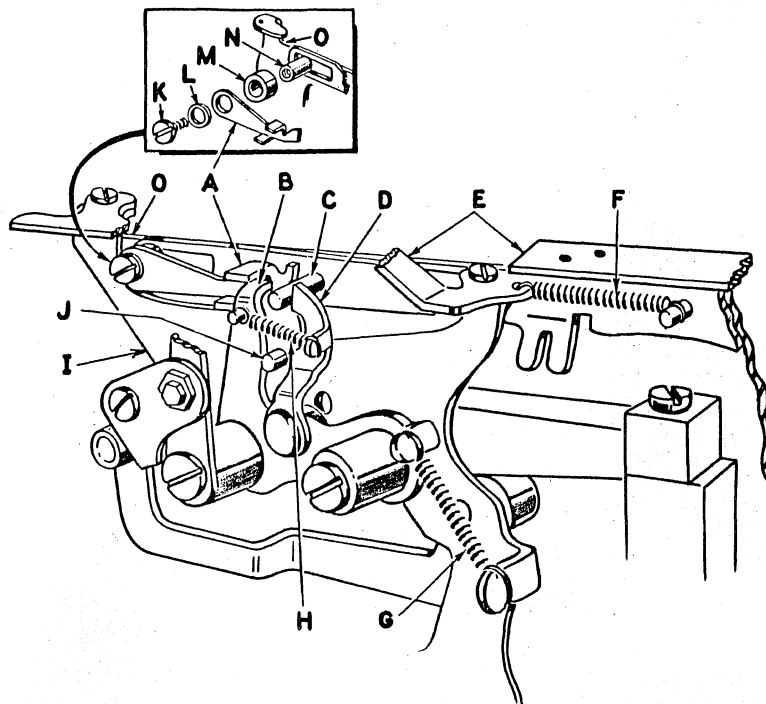
1-A CONTINUOUS RUNNING MOTOR caused by accidental movement of register return slide E which closes the motor switch without engaging the register return clutch will be prevented by installing detent A.

The new detent controls the movement of slide E so that it may be moved only by key depression or carriage control.

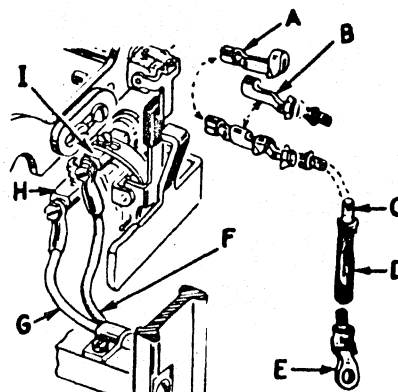
**3-BROKEN OVERDRAFT WIRES F OR G** near terminals I or H may be repaired using repair assembly C (1-79706Z) which includes parts A, B, C, D and E, thus eliminating replacement of the complete assembly AG (Plate 38, Accumulation Symbol List).

To install, clean the broken end of wire F or G and insert it in the tubular end of knife connector A, flatten the tubular end until the wire is held firmly. Then position plastic tube D over the joint formed by knife connectors A and B and connect terminal E to terminal H or I.

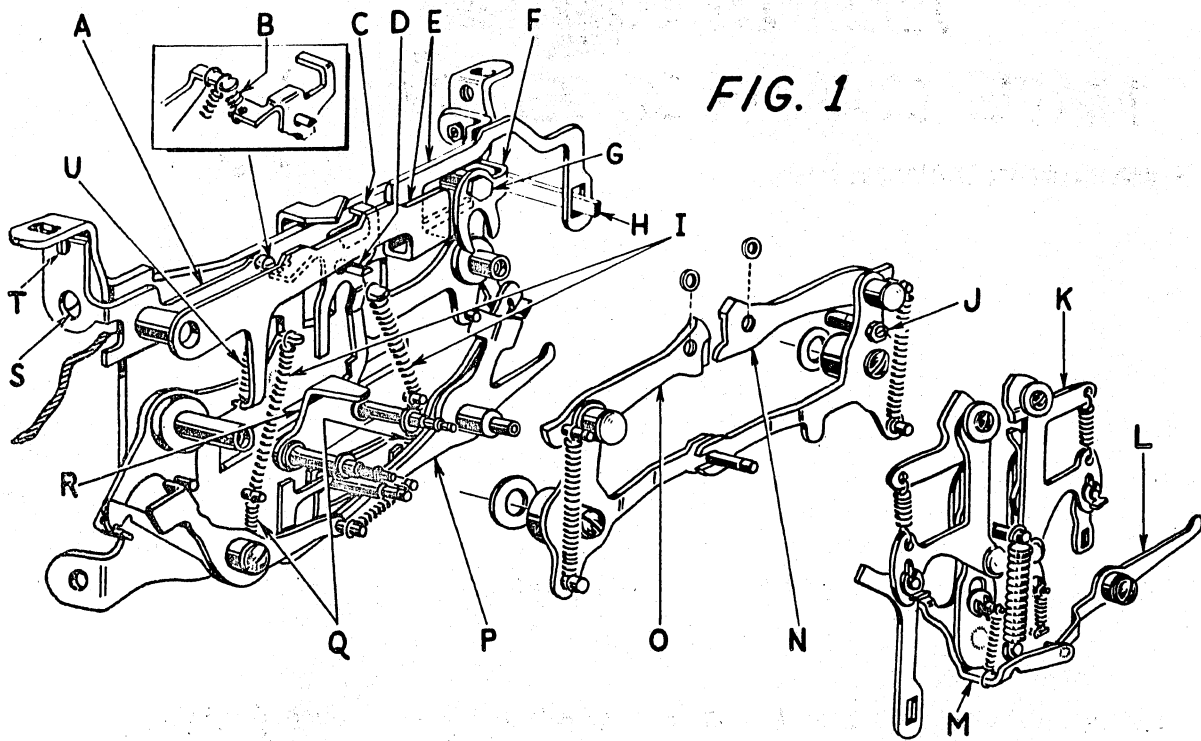
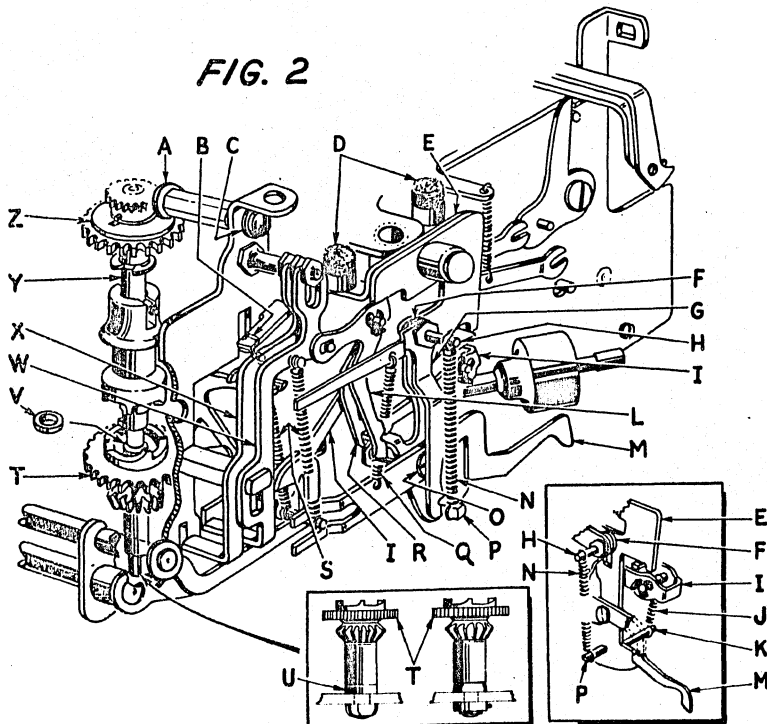
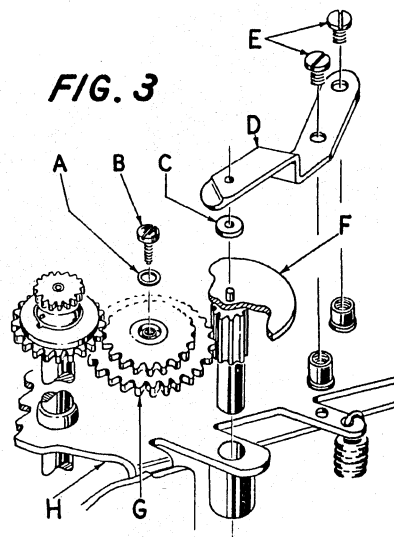
*CONTROL OF CARRIAGE TRAVEL WILL BE IMPROVED AND SELECTION OF CARRIAGE POSITIONS WILL BE MORE POSITIVE THROUGH INSTALLATION OF ONE OR MORE NEW AND REDESIGNED PARTS —*

**1-ALIGNMENT OF CONTROL PINS OVER THE SENSING TAPPETS** before the drive is tripped will be provided by auxiliary delay timer C (Fig.1) which pivots on flat bottomed stud D. Timer C lengthens the time between settling of a tabulator stop and releasing of the drive trip bail by the interlock mechanism.

Interlock actuating arm F is now connected with eccentric stud J by a fork to enforce synchronizing of its action with the movement of bumpers N and O. The upper edge of the interlock arm has been raised for contact with the lip of auxiliary timer C.

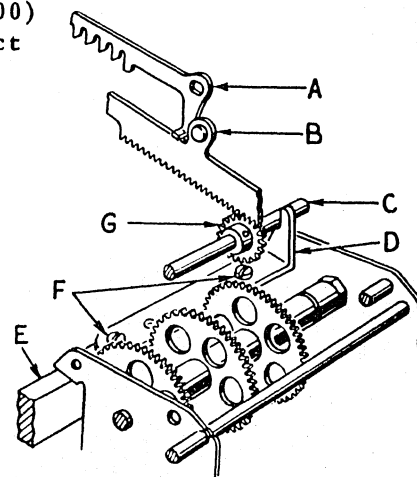
**1-WRONG REGISTER SELECTION** (Series F300 and F500) resulting from failure of gear G to retain correct mesh with rack B may be caused by insufficient support of the lip on index plate A. The lip may be bent downward for minimum clearance of rack B to insure safe meshing of the teeth.

Where the journal on shaft C has worn the right side frame, brace D (406127Z) should be installed on bar E under screws F (72584). Washers 187 Fte. 207 may be used to position brace D upward if necessary. Order for actual need only.

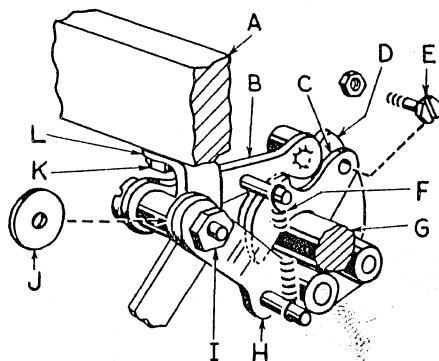
**1-FAILURE OF THE DRIVE TO TRIP FROM A MOTOR BAR DEPRESSION** may be caused by an incomplete machine cycle that results in failure of the roll of assembly Z (Plate 56, Symbol List) to drop off the high dwell of cam AE. Shaft assembly AD is thereby prevented from restoring to normal to permit movement of trip shaft assembly AT. Drive trip failure may also be caused by an overthrow of the machine cycle setting up a severe bite between bail J and clutch dog B - with the result that bail J fails to release clutch dog B when the latch bail is dislodged from the lip of bail J.

The detent action of arm BD (B, in illustration) has been improved by the following changes:

1. Spring anchor arm H (1-401140), pivoted on shoulder nut I (3434) has been added to permit use of heavier spring F (73816). Washer J (613 1/2) provides proper spacing of arm H for clearance with adjacent parts. The new spring anchoring arrangement, by applying pressure to opposite sides of shaft G, avoids distortion of the shaft assembly from the tension of spring F.
2. Auxiliary cam C (401160Y) provides detention of the machine against overthrow and is attached to cam D with screw E (404616) and nut 46.
3. Spring F should be aligned on the stud of detent B with the spring groove on the stud of spring anchor arm H.

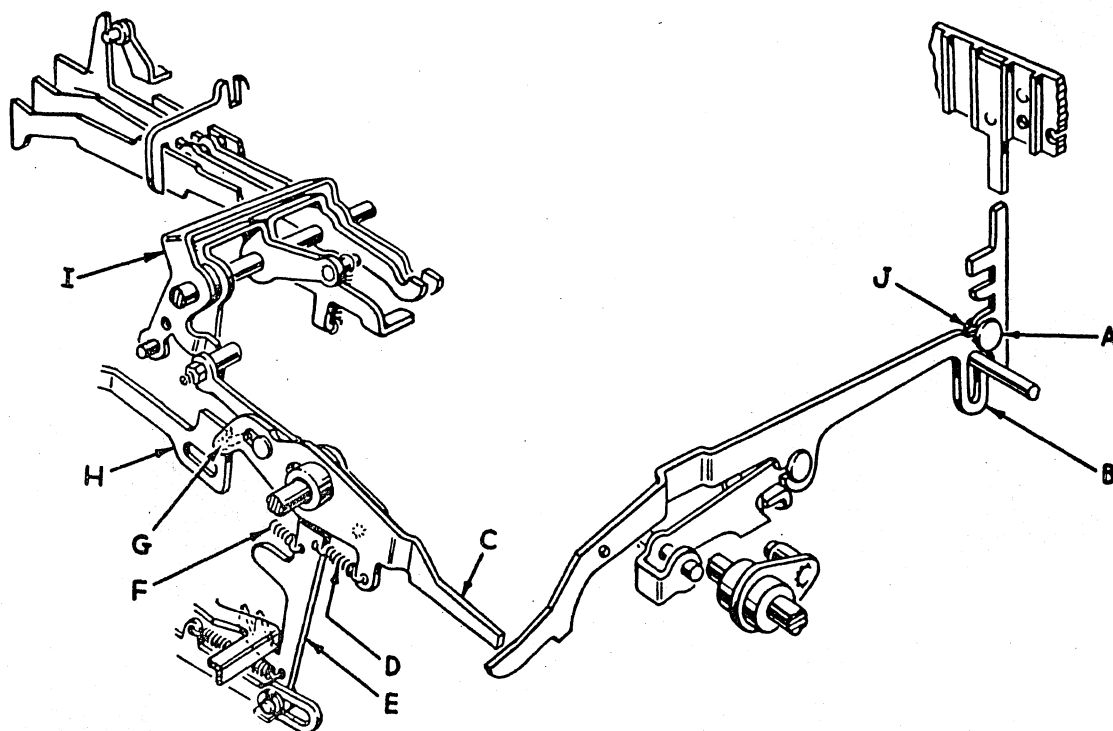
1-BREAKAGE OF BELL CRANK ASSEMBLY AJ (Plate 18-1, Symbol List) or the illustrated flanged rivet A (405521) and its washer J (405115 No.1) in sensing lever B may be caused by heavy tension of broken joint spring AK (Plate 18-1).

The illustrated bell crank assembly E (11-404183B No.8) and link H (404265B) are designed as follows to overcome the above condition:

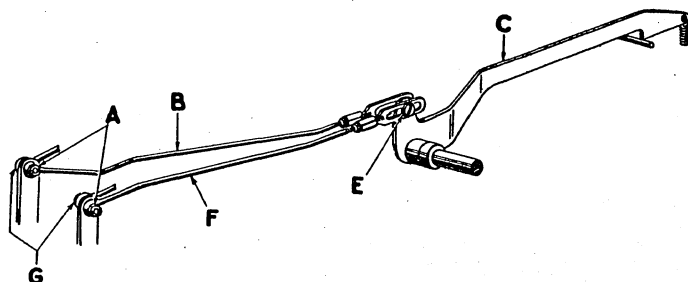
OPERATION on M700 machines containing symbol bail latch N (Plate 33, Printing Symbol List) may be caused by inadvertently depressing the minus balance key and failing to use the error key prior to depressing the balance or sub-balance key. If the above takes place, symbol bail V (Plate 33) will be latched in an indexed position by latch N (Plate 33) causing the minus balance to print.

Machines beginning with serial number M4490D contain newly designed symbol bail latch C which is inactivated when a balance or sub-balance key is depressed thus eliminating the above condition.

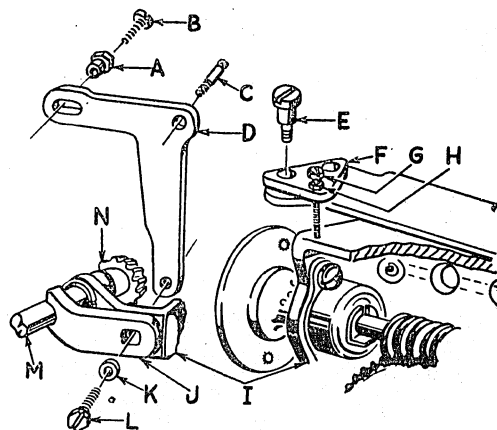
**2-CROSSFOOTER MESHING HOOK 1-409128A** (AT, Plate 44, Symbol List) now has stock removed from its upper surface where contacted by bell crank AW for add and non-add positions. The change provides sufficient tolerance to permit adjusting the hook for (1) safe hold of the pocket in its upper arm over the square stud in the control slide during a subtract function without jeopardizing the safe hold of the lower arm during an add function; or for (2) clearance of the square stud by both arms during a non-add function.

Use only the new hook for replacement.

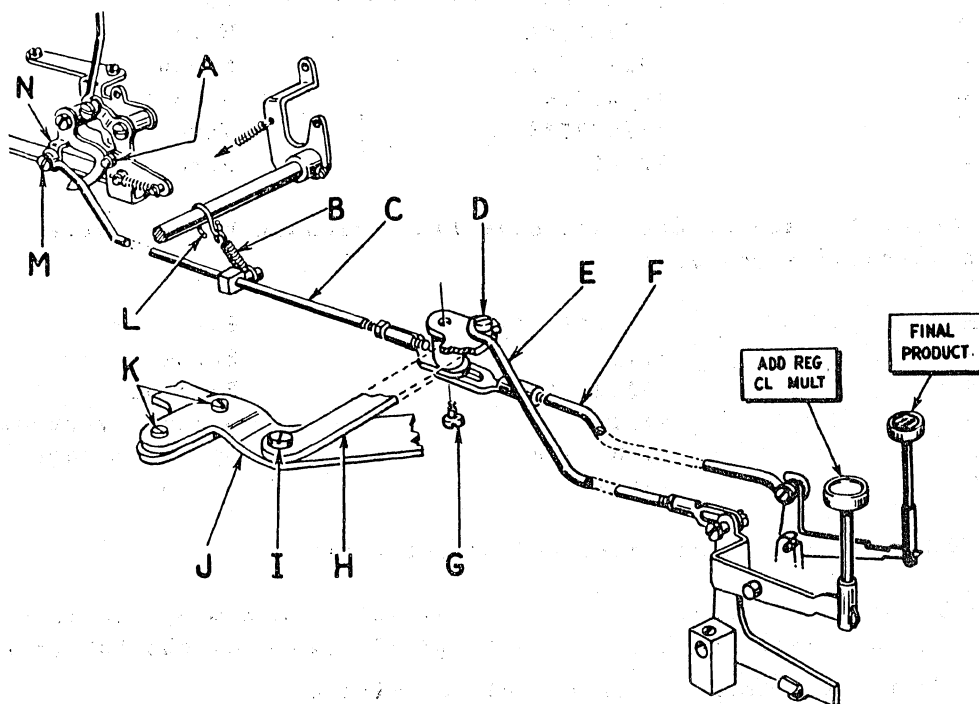
**1-TWISTING OF EXTEND CLEARING BAIL BRACKET B** (Plate 19-1, Keyboard Symbol List) - on new wide base Class 72 machines containing the Non-extend of Specified Columns Mechanism (Plate 18-2) - may be caused by failure to reset channel bail assembly BQ (Plate 18-2) to the right far enough to insure safe hold on the feet of vertical extend arms A (Plate 18-2) when an extend clearing key is depressed.

Depression of an extend clearing key should reset the channel bail assembly to the right, through wire E or wire F, before it is rocked upward. When the bail is not reset before it is rocked upward, some of the detent arms of the vertical extend arms may remain seated in their respective retaining racks CF (Plate 19-1) thus causing the extend clearing bail bracket to twist as the bail is driven rearward during the forward stroke of an extend clearing operation.

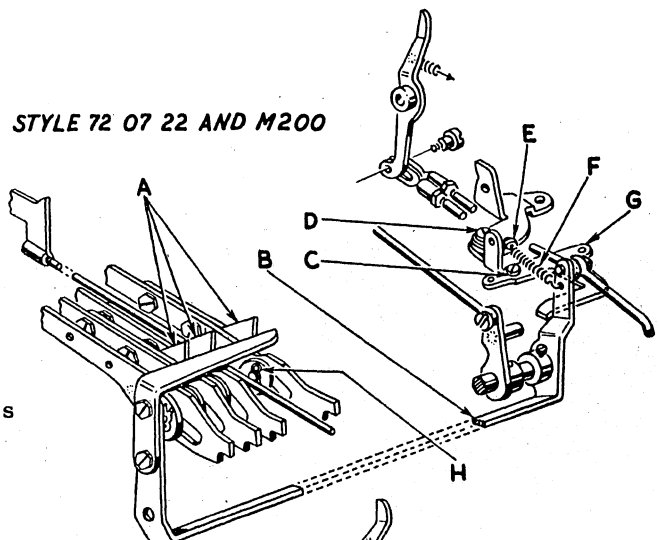
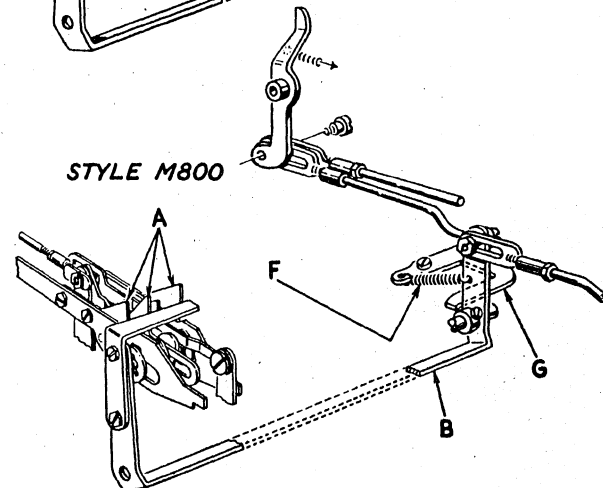
**1-EASY DEPRESSION POWER RESULT MECHANISM** failing to produce either a crossfooter or register total may be caused by tabulating bail B limiting against a finger A - on any of the horizontal links. This condition could prevent the horizontal link from dropping to engage stud H.

Hook spring F to the hole in the left end of limit G.

To adjust - all styles: With the machine normal, position limit G so that bail B has slight clearance in front of fingers A.
