Series F

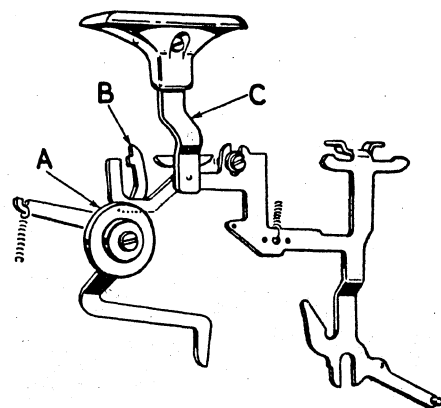
**1-BENDING OF THE MOTOR BAR ASSEMBLY** (CE, Plate 108-2, Symbol List) is prevented and alignment of the minus keystone (B, Plate 108-2) with the forward end of the motor is insured on Class 9, not minus balance machines, by installing flanged guide roll A (X10-72). New latch B (1A-94140 1/2A), with the outer hub removed, is also required.

The forward projection of the motor bar should be adjusted to trip the drive with additional depression of the minus key after the minus key has been latched down. Field installation should be made when bending of the motor bar assembly is encountered, or when the minus keystone misses the forward projection of the motor bar.

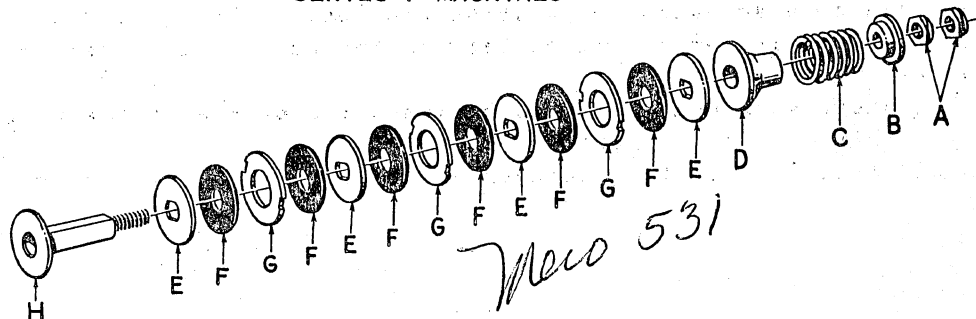
**1-CARRIAGE DRIVE CLUTCH 1Z-408013** - equipped with chrome-plated steel and carbon disks to prevent rusting and provide improved clutch performance - is assembled as illustrated.

- When installing the improved clutch, the following should be observed:
- Clutch drum W (Plate 2, Symbol List) should be changed if the keys for the driven disks show wear.

- The clutch should deliver minimum pull of 5 1/2 lbs. and maximum of 6 lbs. Preferably the complete clutch should be installed as a unit when making a replacement because of unsatisfactory performance of an earlier style clutch.

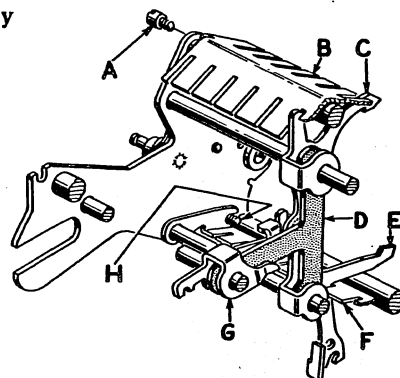
**1-COMPLETION OF THE RELAY CARRY IN REGISTERS "A" AND "B"** in currently manufactured Series P400 machines is assured by using stronger springs 681 in place of springs 83883 (I, Plate 123-3; Symbol List) on carry racks H. A weaker spring 71806 is used in place of 10085 in the last adding column. This change in the last adding column requires a lighter spring 44808 (G) on the last carry pawl latch F.

The use of stronger springs, 681, on the carry racks makes it necessary to support shaft S (Plate 123-3), to insure raising carry rack latch M sufficiently to release the carry rack on a direct carry. As shown in the accompanying sketch, brace D is installed inside the formed bearing of upper and lower carry pawls C and E, and carry pawl latch G. It is installed in column 6 of 10 column machines or column 7 of 13 column machines.

The heavy springs on the carry racks require stronger springs A on register detents C (Plate 96-1A) to prevent rebound of the registers when the carry racks are reset on total operations. Use spring 69804 for 10 columns or less adding capacity or spring 703819 for 11 to 13 columns capacity.

These changes should be incorporated into Field machines when failure of the relay carry is encountered.

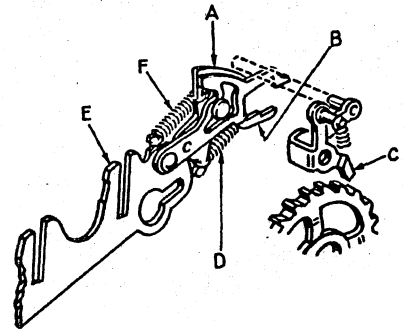
The new index slide contains cam A which is riveted to latch B and held in its raised position by springs F and D. Cam A when depressed by actuation of the drive pawl, increases the spring tension on latch B sufficiently to hold the latter fully indexed on the tie strip regardless of the drive pawl's position on the drive gear teeth.

A longer stud has been added to the drive pawl to actuate the cam of the new index slide. Check for safe clearance between the stud in the new drive pawls and the motor brackets (AM, Plate 22) when installing.

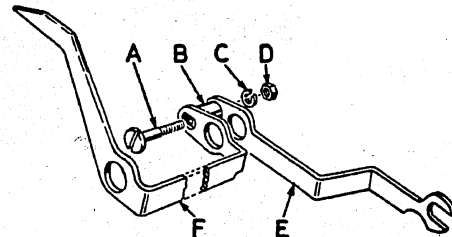
*69-1  
acc*  
**2-LOSS OF THE AUTOMATIC COUNT**-in Styles 301707 and 261709 machines-due to loosening of lever F has prompted alteration of hub B (by drilling the hole of the hub all the way through) so screw A (52519), washer C (1097 3/4), and nut D (46) may be used to more securely hold the levers in position.

*82  
corr*  
When difficulty is experienced in maintaining adjustment of the levers in earlier machines, the same result may be secured by drilling through hub B, using a No. 29 drill.

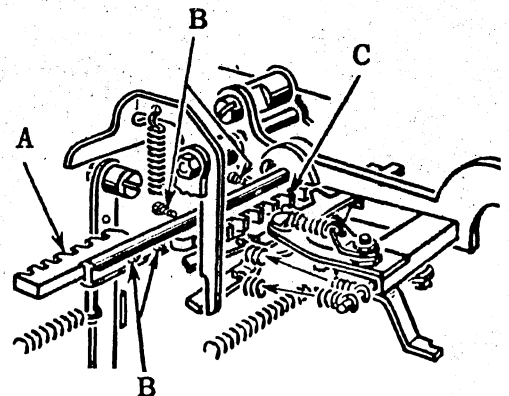
**3-CROSSFOOTER PINION LIMIT RACKS A AND C** in currently manufactured machines are attached with two screws B in place of one to insure permanent tightness.

In machines of earlier construction when difficulty is experienced in maintaining tightness of racks A and C, a new cross-footer assembly may be installed.

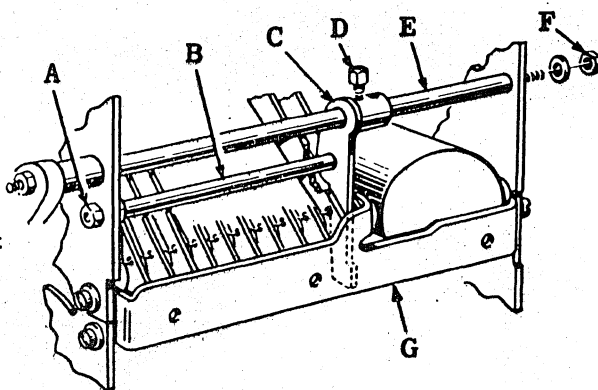
Machines containing 12 pitch adding sectors also require installation of flat-sided set collar 1-84364 on shaft B since 12 pitch sectors have a different lower outline than 10 pitch sectors. This information should be added to Mecanogram 423.

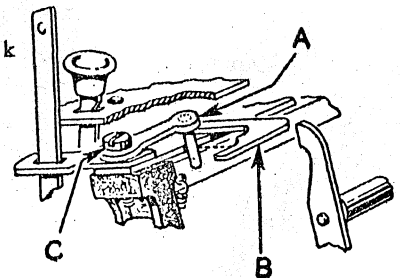
2-NON-INDEXING OF A MACHINE OPERATION, with a motor bar depressed in No Space Stroke Total Bank Posting Machines, may be due to locking of slide B under the cam (J, Plate 62-1, Keyboard Symbol List) at the end of the previous return stroke. This condition may be corrected by installing limit A (1-202165). Use screw C (9251 13/16).

Install limit A at the next attention.

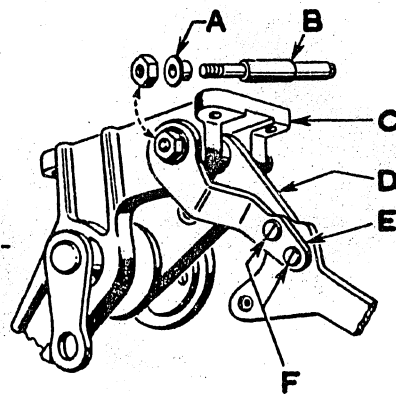
*1-CARRIAGE OPENING LEVER 1-201107 NO.3* (BD, Plate 81-1, Carriage Symbol List) now has bracket 1-201107 1/8 (E) added to its upper forward end to insure full carriage opening.

Installation of the improved construction requires replacement of the following parts: casting C (1-201665 No.5) which has the countersink deepened at the hole for shaft B; lever D (1-201107 No.3) which has threaded holes added for attaching bracket E; bracket E (1-201107 1/8), as described; two screws F (3361 1/4A); bushing A (201341) which fits into the deepened countersink of casting G to provide a bearing for bracket E; and shaft B (201504 No.3) which has added length because of bushing A being added to the assembly.

The improved parts should be used where proper adjustments of the carriage opening mechanism cannot be secured by ordinary means, or where the adjustments do not remain permanent.

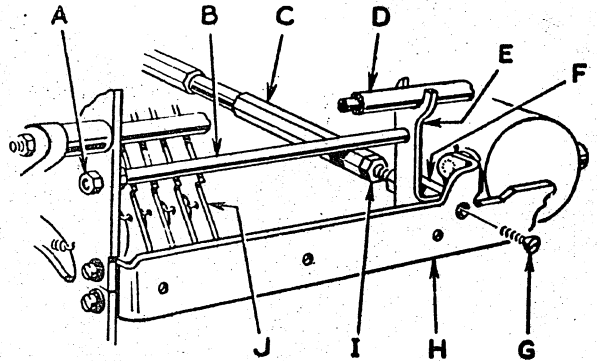
The following method for installing shaft B in Field machines is suggested:

1. Remove auxiliary cam 81116 3/4 (B, Item 2, Mecanogram 389) if previously installed.
2. Place shaft B in the hole provided in the left side frame, and install nut A loosely.
3. Loosen lock nut I.
4. Remove screw G.
5. Screw part F into post C far enough to permit the installation of bracket E.
6. Place bracket E between bushing D and brace H, as illustrated.
7. Place the right end of shaft B in the hole provided in bracket E.
8. Install longer screw G loosely.
9. Screw part F downward to a snug fit against bracket E.
10. Tighten screw G.

Installation requires the following parts: eccentric shaft B (84550 Style 13), nut A (45), bracket E (84103 1/2 Style 13), and longer screw G (89568 1/4 Style 13).

**Adjustment:** With the machine normal, rotate shaft B to a snug fit against sectors J. Hold shaft B in this position with a wrench, and tighten nut A.

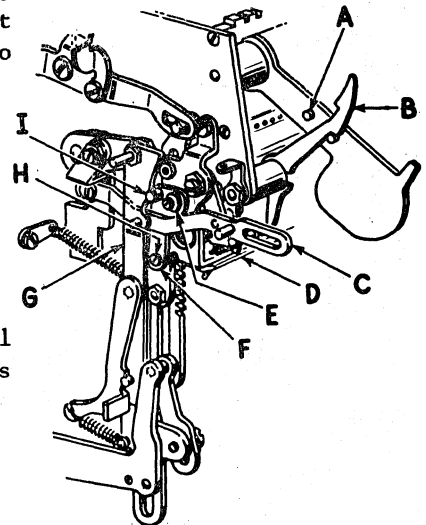
Link C, of the Rotary Calendar Disabling Mechanism, is redesigned to clear bracket F.

Replacement of either the bail (L, Plate 6) or the link (AF, Plate 6) in Wide Base machines in the Field requires installation of the following parts: link C (1-707107 No. 2), bail D (1-707148A), eccentric and screw E (71361 and 74502, respectively), bracket F (1-707148 1/4), link G (1-707122A), and screw H (74533).

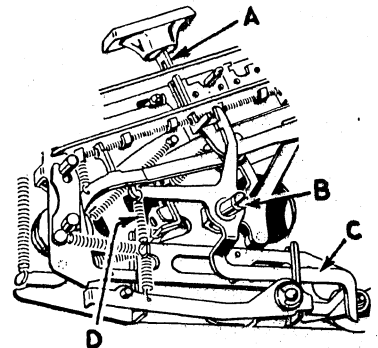
1-LATCH C (1-94140 1/2A) is now used in currently manufactured Class 9 machines having the minus key in position 3-0, and may also be installed in Class 9 Field machines of the same construction. The new latch holds the minus key A depressed to prevent the arm (AL, Plate 108-2, Symbol List) from prematurely lifting the latch (AC, Plate 108-2).

Premature lifting of the latch (AC, Plate 108-2) may permit partial rocking of the tumbling section during a minus operation. This action may result in forward movement of the lower wheels and subsequent failure to move the carry pawls (N, Plate 111, Symbol List) far enough to lift the latches (C, Plate 111) during a mixed relay and power (direct) carry.

Installation of latch C (electric machines requires the removal of latch CH, Plate 108-2, Symbol List) in Field machines requires the following parts: latch C (1-94140 1/2A), spring D (81810), and screw B (84518 Style E).

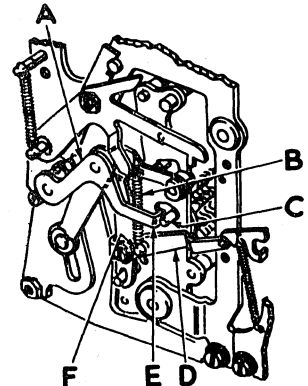
Insufficient support of the tumbling section during a minus operation may permit the lower wheels to rock forward, and may result in failure to move the carry pawls (N, Plate 111, Symbol List) far enough to lift the latches (C, Plate 111) during a mixed relay and power (direct) carry.

**Adjustment:** With the tumbling section in subtract position, lip E should have minimum clearance in front of shaft C.

To adjust, bend lip E.

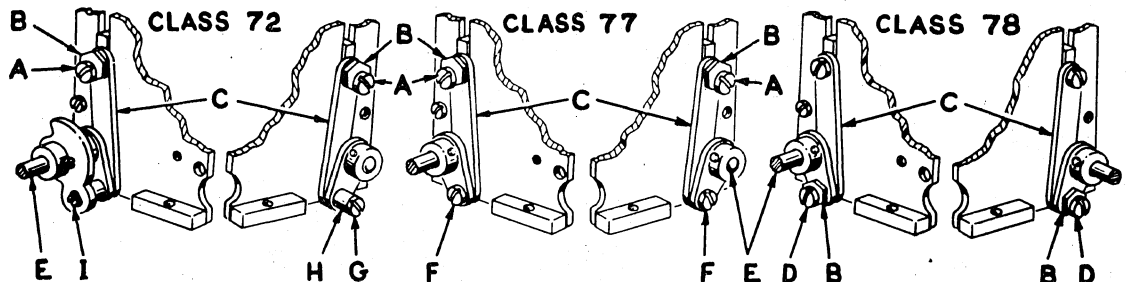
**ECCENTRIC B** (704300 1/2 NO. 2) now replaces the eccentric (U, Plate 22-1, Accumulation Symbol List) in all currently manufactured Classes 72 and 77 machines, beginning with Serial Nos. B131300 and B97868, respectively, and is placed in the upper end of link C. In Class 78 machines, eccentric B is still being used in the lower end of link C. Screw G (702589) also replaces the screw (AJ, Plate 22-1) in all currently manufactured Class 72 machines.

Use of the eccentrics provides a means of adjusting the throw of the raise bar (AM, Plate 22-1) so that the lugs on the adding racks align centrally with the steps of the limit plates (A, Plate 22). The eccentrics are now placed in the upper ends of links C so that any adjustment which may be made to alter the throw of the raise bar will not change the throw of the cam shifter (W, Plate 25), and also will not change the relation of the clearance cut in links C with power shaft E.

When replacing the eccentrics and the screw (U and AJ, respectively, Plate 22-1) in Class 72 machines prior to Serial No. B131300, the following parts are required: two eccentrics B (704300 1/2 No. 2), two screws A (704589), screw G (702589), roll H (406320), and screw I (704588).

When replacing the eccentrics (U, Plate 22-1) in Class 77 machines prior to Serial No. B97868, the following parts are required: two eccentrics B (704300 1/2 No. 2), two screws A (704589), and two screws F (74501).

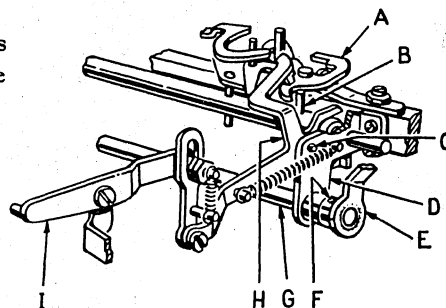
1-TABULATING SHAFT LATCH H (1-705237 1/2A) now replaces the latch (BB, Plate 19-2, Carriage Symbol List) in all currently manufactured Class 78 machines and in Style 72 07 22 machines with power result keys, and may also be installed in Field machines of these same classifications. The new latch has a formed projection which prevents pawl A from latching on stud B should a key or motor bar which indexes the Automatic Tabulating Mechanism be used when manual control button No. 51A is set in the non-tabulating position.

This prevents tabulation from a following non-tabulating operation with the manual control shifted to a tabulating position.

Installation of the new latch in Field machines also requires that new lever I (1-705128 1/2 No. 2), screw C (79503), and a new bracket D (1-75217BR) be installed. To install the new bracket, remove shaft assembly G from the machine, and remove arm E by removing pin F. Replace the old bracket with the new bracket and re-pin arm E to the shaft. Install the shaft assembly in the machine.

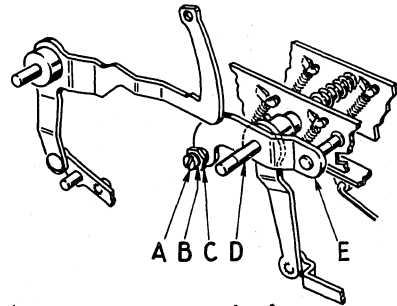
1-A NEW LIMIT STOP, which limits the downward travel of the sub-total key, is being installed in currently manufactured machines containing the latest Symbol Indexing Controls (Plate 8-3, Printing Symbol List) and may also be installed in Field machines similarly equipped. This new limit prevents overthrowing of the Symbol Indexing Mechanism and assures printing of the correct symbol, even though excess pressure is applied to the sub-total key during a sub-total operation.

To install - remove the washer on shaft D, and assemble bracket E (62227 1/2), eccentric bushing C (209302), lock washer B (1097 7/16), and screw A (74523), as illustrated.

After the sub-total key has been adjusted in the regular manner, index the sub-total key and turn eccentric bushing C until it has light contact on the keystem.

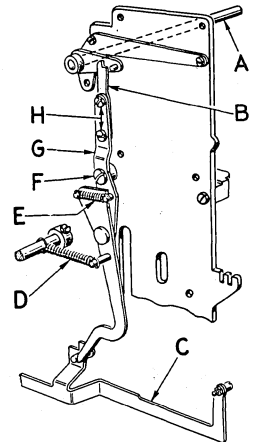
**1-NORMALIZING SHAFT ASSEMBLY A (11Z-704050) AND NORMALIZING ARM ASSEMBLY G (1-704215)** may be used in place of the shaft assembly (U, Plate 6-1, Accumulation Symbol List) and the cam assembly (BI, Plate 6-1) in Field machines containing the Four Position Printing and Adding Control Mechanism and the Multiplier Factor to Print Mechanism. The new parts safeguard against trapping the adding racks by more effectively holding the non-add bails (AO and CO, Plate 6-1) inactive during multiplying or subtracting operations.

Installation requires the following parts: shaft assembly A (11Z-704050), spring D (74808), spring E (8082A), screw F (704536), and arm assembly G (1-704215) which includes limit B (704215 1/4) and screws H (7356 1/2).

Adjustment requires a minimum clearance between limit B and the stud in the arm of normalizing shaft A when power indexing slide C is released through depression of a multiplier key or the subtract key.

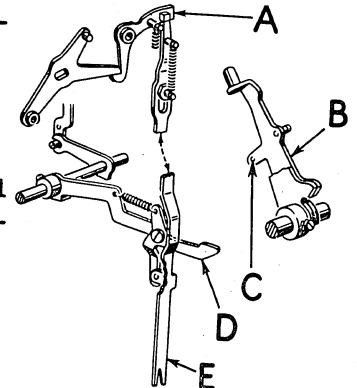
**4-HOOK PAWL D (705284B)** replaces hook pawl 705284A (AC, Plate 21, Carriage Symbol List) in Class 77 machines containing the Selective Column Tabulating Mechanism, to assure a more positive release of the Register Shuttling - In Mechanism during a selective tabulating operation.

Installation of a new hook pawl D requires the installing of a new latch 1-709127 No. 2 (V, Plate 21 - A, in illustration) and a new arm 1-701150A No. 1 (AK, Plate 42, Accumulation Symbol List - B, in illustration). Latch A has a clearance cut added for increased travel; and arm B contains stud C which releases hook pawl D from under the stud in arm E during a forward machine stroke.

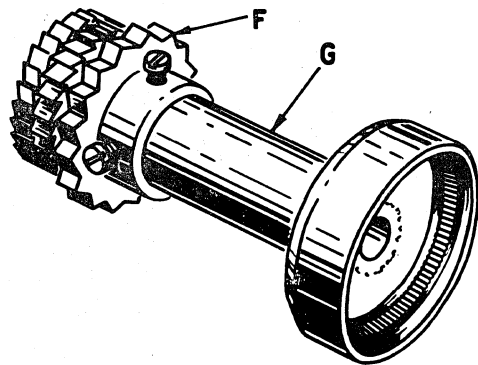
**2-FORM SPACERS - VARIABLE G (61Z-83364 - FOR RIGHT-HAND 1/6" FORM SPACING - AND 71Z-83364 - FOR LEFT-HAND 1/6" FORM SPACING)** are now available for installation on Field machines.

These new assemblies contain sharp toothed star wheel F which improves the detent action of the detent arm (BB, Plate 29-3, Symbol List) when forms are rapidly inserted or withdrawn from around the carriage platen.

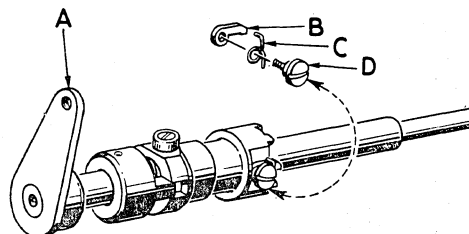
**1-DRIVE CLUTCH SHAFT ASSEMBLY 1A-71007** (J, Plate 3, Power Symbol List - A, in illustration) -- in all Series M machines after Serial No. B 11583 - now contains pawl B (701257), spring C (701808), and screw D (701573), which provide a more secure drive clutch engagement and help to assure that two cycle operations do not lose a stroke. Partial meshing of the teeth of the two clutch members is averted since pawl B, through spring C, yields if the clutch members do not properly mesh and is enabled to move into the next tooth space, thus holding the members to the same speed and permitting them to fully engage.

When installing a new clutch shaft, use the improved worm shaft that contains a polished worm (see Mecanogram 320, Item 1) and ascertain that the bronze worm wheel is not worn in any way. The drive should be drained of all old oil and new lubricant added. Also, install pin 71571A in place of plug 71571B which is located in the drive housing toward the right end of the clutch shaft.

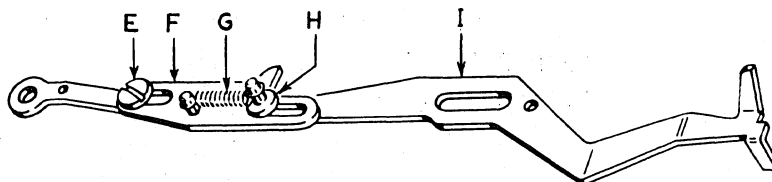
**2-SLIDE ASSEMBLY 1-702223 NO. 4** includes slide 702223 No. 4 (similar to CR, Plate 20, Carriage Symbol List) and also replaces the latter on all Class 77 machines.

The new slide assembly, primarily designed for machines with Selective Column Tabulation, contains a spring joint which reduces the possibility of losing the adjustment of the collar (CQ, Plate 20) should a typewriter key be depressed along with the selective column tabulating key.

Parts included in the new assembly are slide I (702223 No. 4), slide F (1-702224 3/4), spring anchor screw H (253 9/16 No. 2), spring G (200812), and screw E (253 11/16).

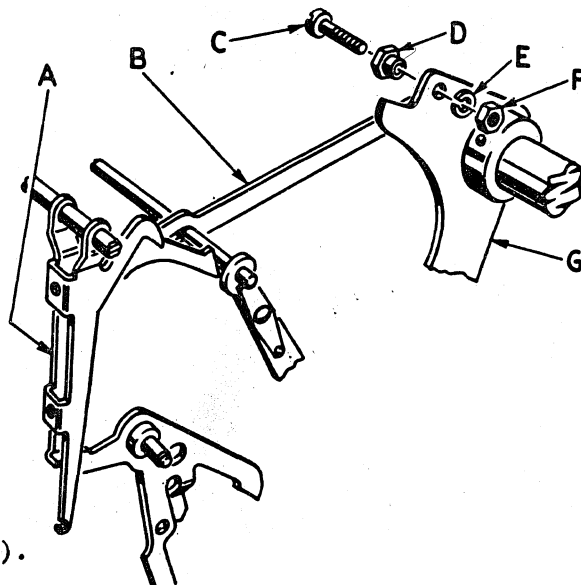
1-THE CARRY RESET MECHANISM (illustrated) is now available for Field replacement of the Carry Reset Mechanism (Plate 85-1, Accumulation Symbol List), contained in No Space Stroke Total Bank Posting Machines, to provide a more positive reset of the crossfooter carry pawls.

Parts required for the replacement are carry pawl resetting link B (200208 1/2Z), eccentric bushing D (209302), screw C (79587), lock washer E (1097 3/4), nut F (46), and latch A (411 1/8R No. 3).

Installation may be accomplished as follows:

- a. Remove the toggle (O, Plate 85-1).
- b. Replace the carry pawl latch in the first column with latch A.
- c. Attach link B to arm G (T; Plate 1), as illustrated.

To adjust the new mechanism, turn eccentric bushing D so that carry pawl latches A have slight clearance with the forward projection on the carry pawls as the crossfooter adding wheels are being meshed with the adding racks; and limit on the projection of the carry pawls prior to the tripping of a 9 to 9 carry.

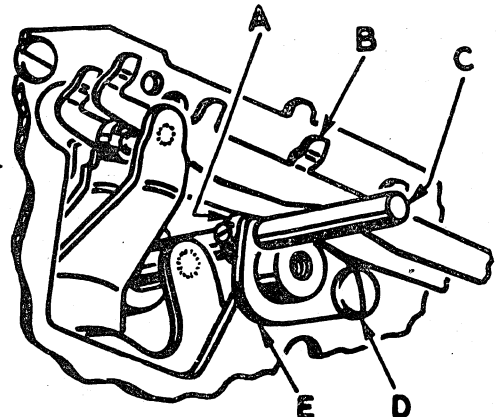
2-SHAFT C (86020) (BV, Plate 40, Symbol List) has been reinstated in currently manufactured machines containing 8 columns or less and may be installed in Field machines (containing 8 columns or less) to assure printing and accumulating 8 when an 8 key is depressed.

Installation requires the following parts: for hand machines -- shaft C (86020), set collar A (1-73314), bracket E (86143A), and screw D (10056); for electric machines -- shaft C (86020), bracket E (86143A), screw D (10056), and stop 86144 (BE, Plate 40).

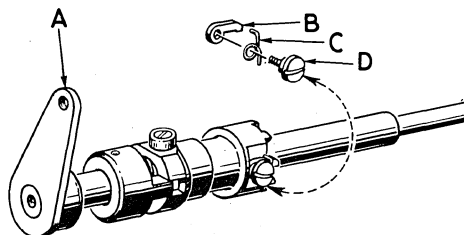
*Mec 353*  
1-DRIVE CLUTCH SHAFT ASSEMBLY 1A-71007 (J, Plate 3, Power Symbol List - A, in illustration) -- in all Series M machines after Serial No.B - 11583 -- now contains pawl B (701257), spring C (701808), and screw D (701573), which provide a more secure drive clutch engagement and help to assure that two cycle operations do not lose a stroke. Partial meshing of the teeth of the two clutch members is avoided since pawl B, through spring C, yields if the clutch members do not properly mesh and is enabled to move into the next tooth space, thus holding the members to the same speed and permitting them to fully engage.

When installing a new clutch shaft, use the improved worm shaft that contains a polished worm (see Mecanogram 320, Item 1) and ascertain that the bronze worm wheel is not worn in any way. The drive should be drained of all old oil and new lubricant added. Also, use plug 71571B in place of pin 71571A, which is located in the drive housing toward the right end of the clutch shaft.

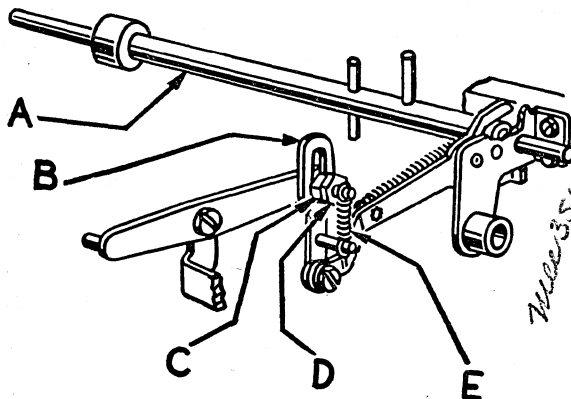
2—**LINK 1-705136** $\frac{1}{2}$  (BH, Plate 19-2, Carriage Symbol List—B, in illustration) is now made with a slot in its upper end to provide a broken joint which permits shaft A to restore to normal—at the end of a carriage tabulating operation—if the tabulation control button in position No. 51A is shifted to a non-tabulating position while shaft A is active.

Other parts required for the installation of link B are spring anchor screw D (71614), eccentric C (75342), and spring E (10180).

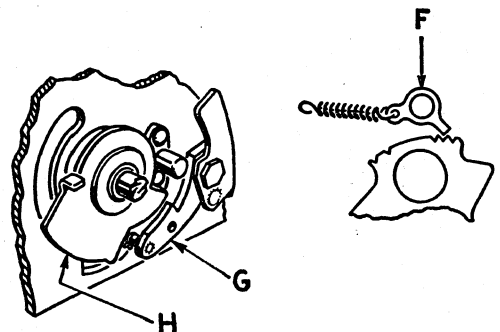
7—**FULL STROKE PAWL F (1-84121A NO. 2)** should be replaced—at the earliest opportunity—with pawl 1-84121 No. 2 (B, Plate 128-1, Symbol List) to prevent breakage of the clutch assembly (AX, Plate 132) on Field machines containing parts G and H.

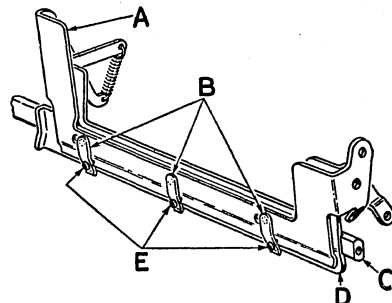
The new retainer A has been modified by locating friction plugs 93909 (E) in the lowermost portion of fingers B to provide a more secure clamping of the passbook when the latter is located in the lower printing line position; and shaft C has stock removed from behind guide D to provide clearance between the friction plugs E and the type bars.

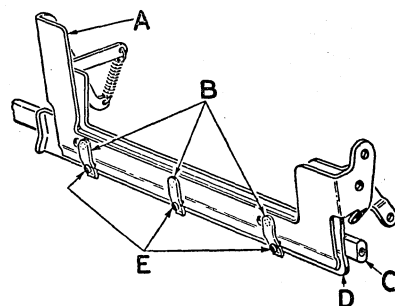
The new retainer A has been modified by locating friction plugs 83909 (E) in the lowermost portion of fingers B to provide a more secure clamping of the passbook when the latter is located in the lower printing line position; and shaft C has stock removed from behind guide D to provide clearance between the friction plugs E and the type bars.

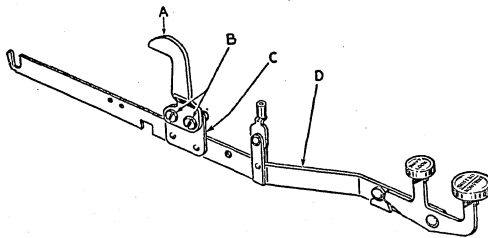
**1—HOOK A (75110 $\frac{1}{4}$ )** may be assembled to bracket C of platen shifting keylever D—when using a non-smudging ribbon—in order to prevent a partial imprint of the upper case type. Use two screws B (73611).

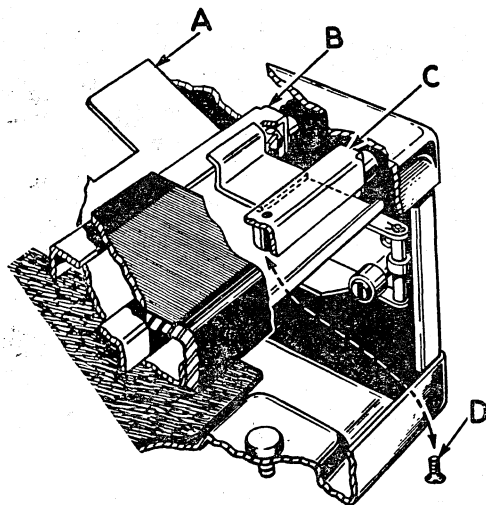
The new shield A prevents the limiting of the bill weights (I, Plate 142, Symbol List) against brace B when the bill compartments become overloaded—which limiting results in failure of the cash drawer to fully open.

Installation requires the following parts: shield 1-15126A (A), brace 11-15120 $\frac{3}{4}$  (C), and two screws 2859 $\frac{7}{8}$  (D).

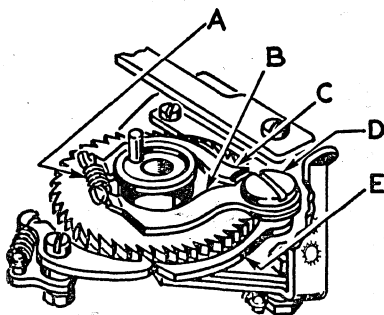
*1—A NEW CROSSFEED RIBBON FRICTION ASSEMBLY*, consisting of arm 205104L (B), arm 205104R (C), spring 4487 (A), and screw 205545 (D), replaces flat friction spring 205104 No. 3 (AG, Plate 38-1, Printing Symbol List) for improved ribbon tension control on machines containing the Crossfeed Ribbon Mechanism, Improved (Plate 38-1).

To install, remove the old friction spring and replace its screw. Replace the outer screw of right and left fingers E with screw D, which also retains the arms B and C, and affix spring A.

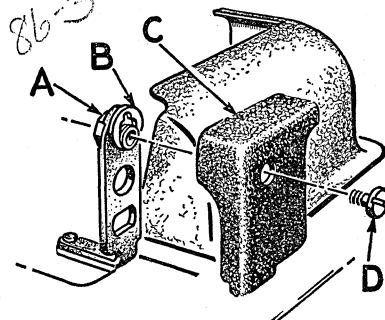
*4—CONSECUTIVE NUMBERING DEVICE COVERS 84665 NO. 2 (FOR BLACK MACHINES) AND 84665A NO. 2 (FOR GRAY MACHINES)* (C) have been modified to permit their removal without first removing the carriage and machine case.

Installation of cover C on Field machines requires the following parts: nut 84355 (A), clip 21 No. 6 (B), cover 84665 No. 2 or 84665A No. 2 (C), and screw 957 $\frac{1}{2}$  (D).

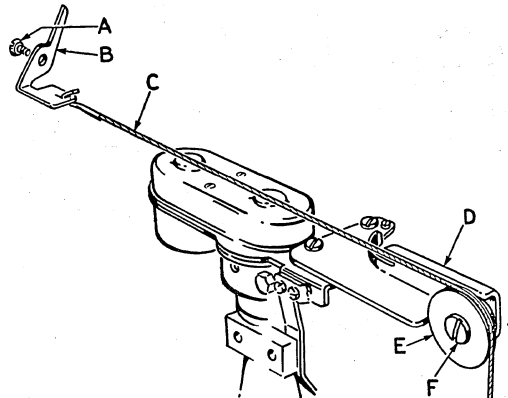
1—STEEL CABLE 1-203701 (12") (15") (18") (C) is available for use in Field machines containing an exterior spring barrel (G) to reduce drawband breakage.

The following parts are required for installation: screw 2859 $\frac{3}{4}$ " (A)—use nut 46, anchor 203118 $\frac{1}{4}$ " (B), cable 1-203701 (12") (15") (18") (C), bracket 1-203185 $\frac{1}{2}$ " (D), screw 3450 $\frac{1}{16}$ " Style 9 (F), and wheel 203303C (E).

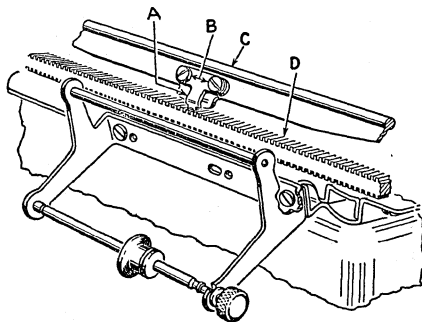
**2—UNIVERSAL CARRIAGE STOP 83215 $\frac{3}{4}$  (A)** may be installed on bail C to provide a means of limiting the carriage on any tooth of rack bar D.

Installation of stop A requires two 7357 $\frac{1}{2}$  screws B.

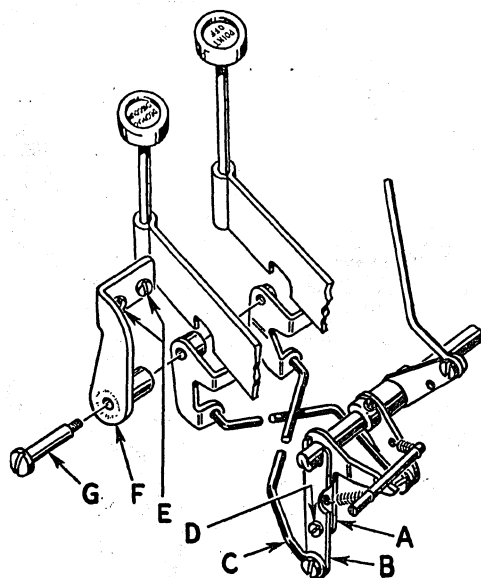
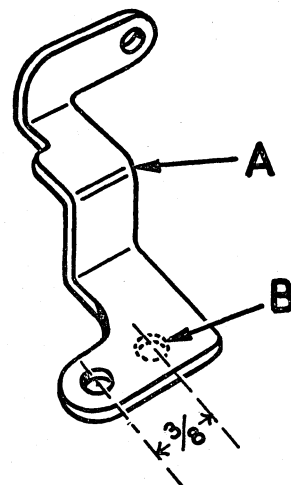
2—**BRACKET 1-702127 $\frac{1}{2}$  (F)**, used on New $\frac{1}{2}$ Wide Base Class 72 Machines, is now made of heavier stock to reduce bending when the point-off key is depressed; and auxiliary arm 72223 $\frac{1}{2}$ Z (B) may be attached to the right side of bellcrank A with screw 74533 (D) to afford a lighter depression of the point-off key.

Installation of auxiliary arm B requires the re-forming of wire C in order to clear the shaft (W, Plate 7, Accumulation Symbol List).

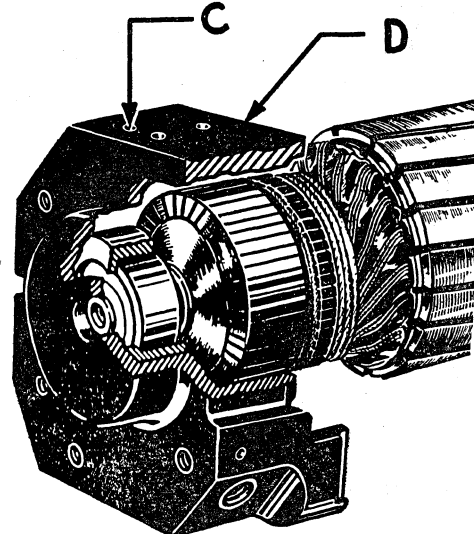
3—**MOTOR END CAP 1AZ-4366 (D)** now contains tapped hole C to permit the installation of condenser bracket A when replacing the motor end cap and the armature (as described in Item 3, Mecanogram 305) on non-split-field motors in Field machines.

Installation of bracket A requires the drilling of a new hole at point B (as illustrated) using a No. 17 drill.

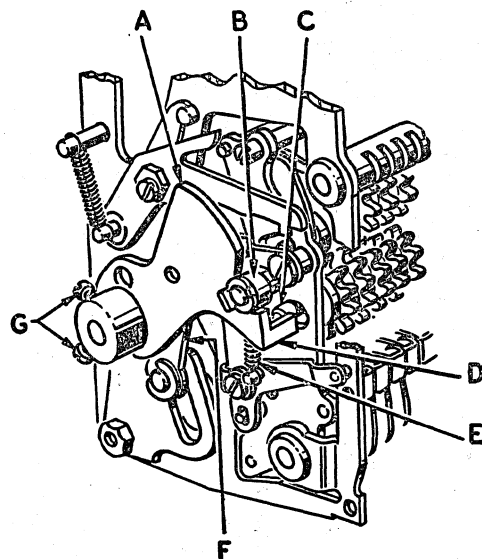
Insufficient support of the tumbling section during a minus operation may permit the lower wheels to rock forward, resulting in a failure to move the carry pawls (N, Plate 111, Symbol List) far enough to lift the latches (C, Plate 111) during a mixed relay and power (direct) carry.

3. Lip D should clear the lower eye of spring E during a machine operation.

**To adjust,** close the eye of spring E.

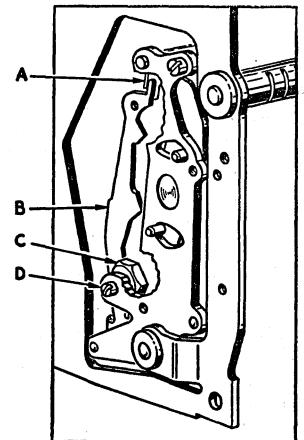
This new line finder prevents the tearing of forms—which are not held rearward by the tear-off blade (CB, Plate 29, Symbol List)—while the carriage is tabulating or being shifted.

Before installing this line finder, the lower right end of the guide (A, Item 5, Mecanogram No. 299) should be bent rearward (against the line finder) to provide clearance between the guide and the left ribbon cap.

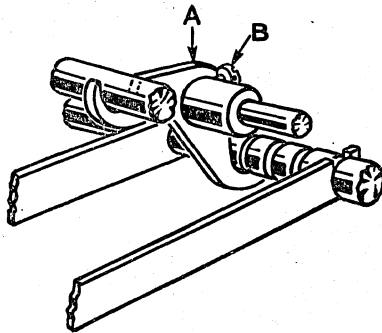
**1—BRACE 1-705145½ (A)** is now being used on new Wide Base Machines to provide additional support for the shaft (Q, Plate 24-1, Printing Symbol List) in order to reduce weaving of the shaft (when the Rotary Calendar Mechanism or the Four Period Mechanism is machine actuated) which may result in light or non-uniform printing of the date type or the four period type.

To install the brace, loosen the collars on the shaft (Q, Plate 24-1) and move the shaft to the right sufficiently to permit positioning the brace with its lower hook between the "J" and the "U" keylevers. Screw 70512 (B) holds the brace in position.

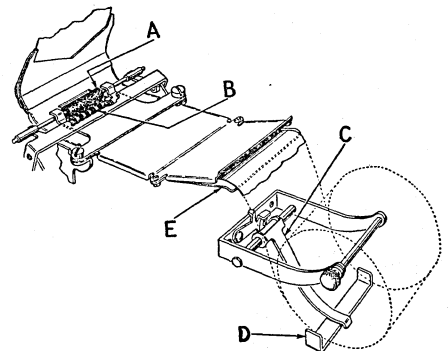
Pressure finger (C) now has a paper guide (D) spot-welded to its rearward extremity to insure the proper alignment of the roll paper as it enters the paper chute.

Installation of the new pressure rolls requires the lower tally roll guide (E) which is specially designed for their accommodation.

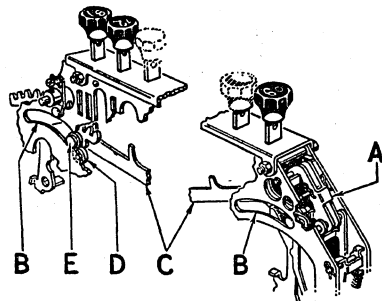
**1—LIMIT STOP ASSEMBLIES 1-56112½Z (A)** are available for installation in the columns of electrically operated Class 5 Machines in which the partition plate slots B have become worn. These assemblies provide a normal (rearward) limit for the index links C, thus eliminating the need for replacing the worn partition plates.

The partition plates in machines of current construction contain studs D which limit the rearward movement of shoulder stud E; thereby providing a positive limit for the index links C, and eliminating the wear of the partition plate slots.

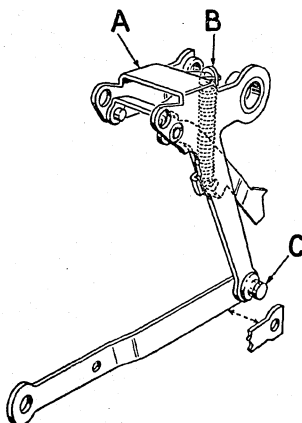
**4—DASHPOT ARM ASSEMBLY 11-88100B (A) (E, Plate 129, Symbol List)**, which has been altered in design and contains new spring 1-88800B (B), is now available for the replacement of the dashpot arm assemblies (all styles) in Field machines.

Installation of arm A in early machines requires an opening in the right side frame (R, Plate 126, Symbol List) to provide a clearance for the bearing C.

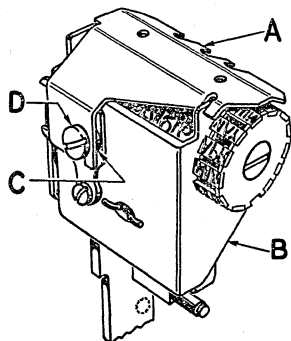
3—**SHIELD 86130¼** (A) is now assembled on the "Consecutive Numbering Device—Rotary" B of Styles 10 10 59, 10 10 60, 10 10 61, and 10 10 261 Machines. The shield safeguards against the turning of the rotary wheels while inserting rigid forms into the carriage form chute.

This new shield A may be installed in Field machines—between washer C and new screw 9052½ (D), as illustrated.

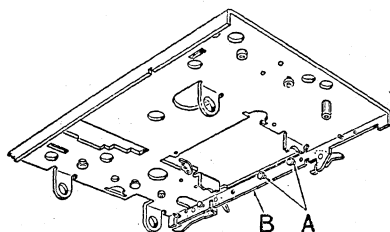
**1-83151½B** (C) (D, Plate 33, Symbol List), now contains fingers (B) and soft friction plugs 83909 (A). Fingers (B) have been added

to prevent an unwanted smudge or imprint on the passbook; and the soft friction plugs (A) prevent the passbook from slipping.
