The SOL-20 Computer - Restoration & Repairs.

(H. Holden. Dec. 2018)

1) Processor Technology 16KRA memory cards & Delay Lines.

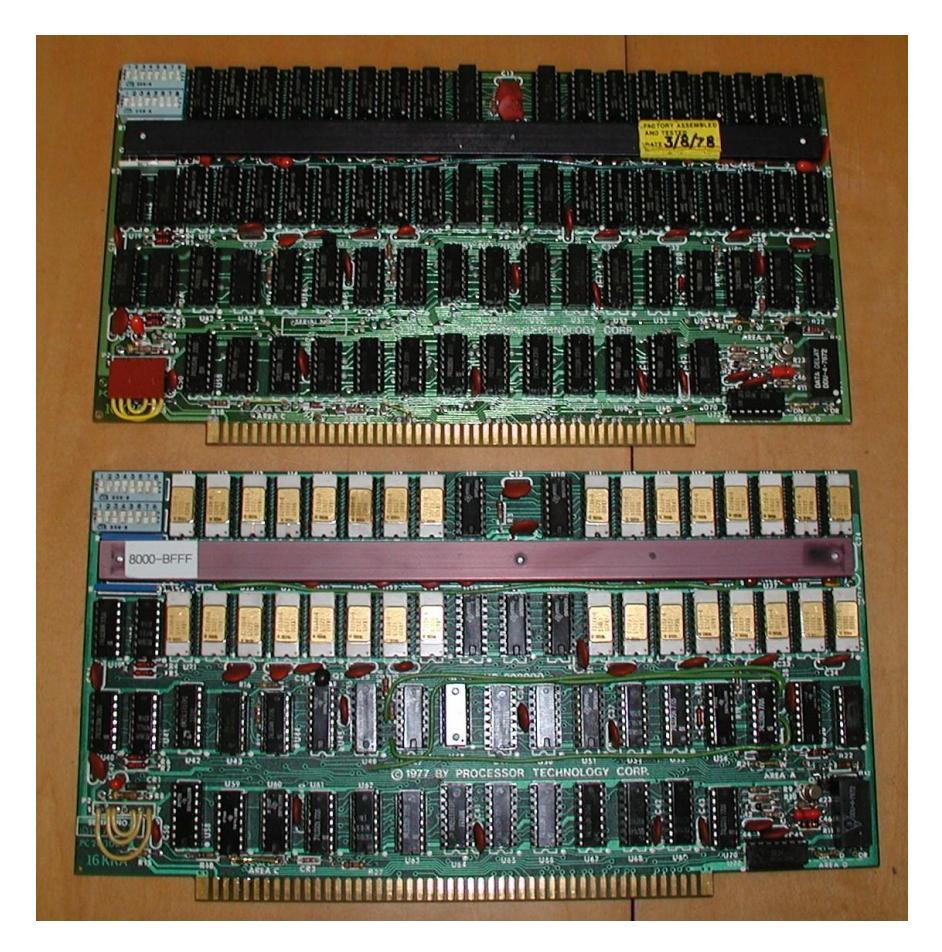
The Processor Technology (PT) 16KRA SRAM card is a very early example of an S-100 bus RAM card, typically used in computers such as the SOL-20. An example of two of these is shown below:

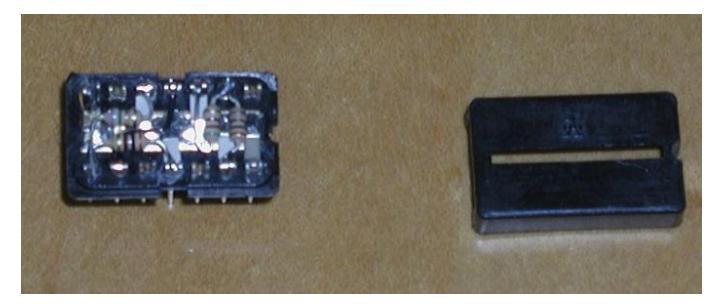
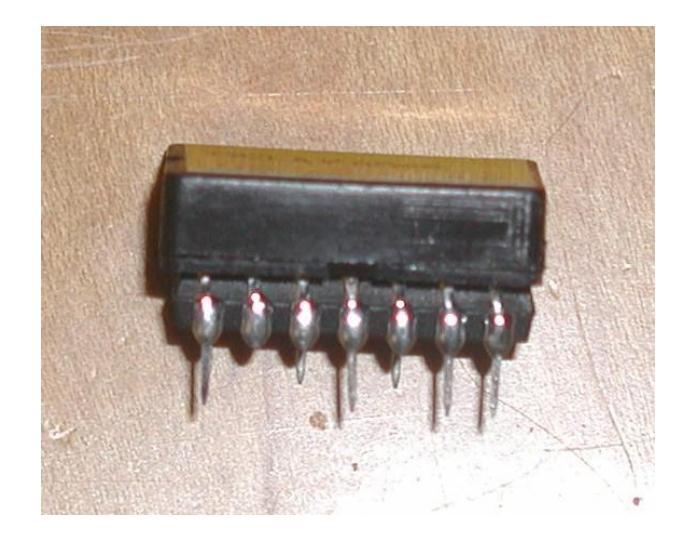
FIRST ATTEMPT AT A REPLACEMENT MODULE

The module performed flawlessly *on the signal generator and scope* and I was able to get the delays within about 5nS of the specified values using a well calibrated Tek 2465B scope. And it would have worked, if the waveforms were those specified in the Processor Technology drawing in the 16KRA manual.... but they are not !

On testing the first attempt module, it actually worked in one 16KRA card, but not in another, so this timing error was borderline & unsatisfactory. This is because the time delay is too dependent on the *initial conditions* (state of charge of the capacitors) in the R-C delay network.

As noted the surface mount capacitors were soldered in first, then a small brass strip to complete the connection to pin 7 and the link wire between pins 4 and 9. Then the resistors were added and the dust cap fitted and the arrangement then soldered to the IC:

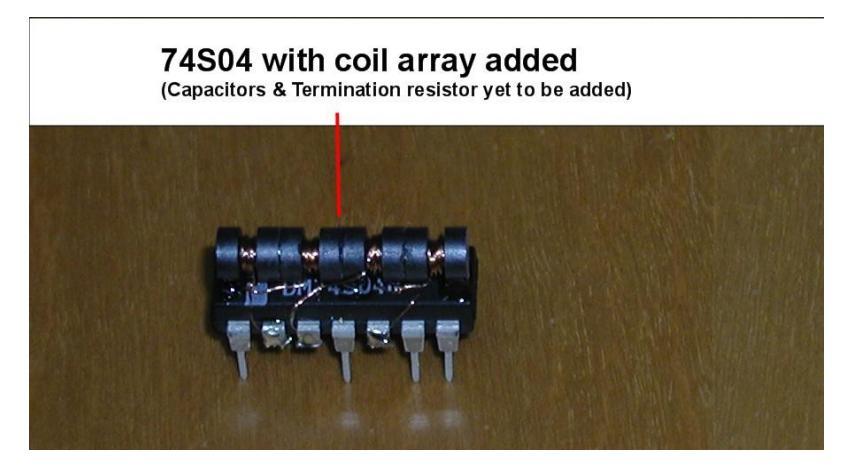
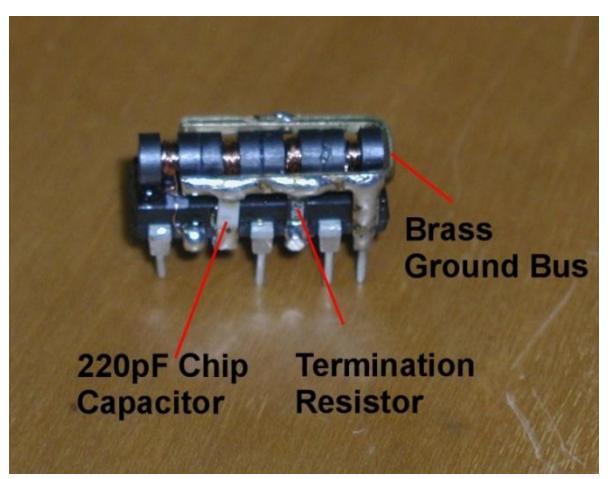
Module 2:

I used 220pF chip tuning capacitors added to this and a 200R chip termination resistor. It was very difficult to get the delays simultaneously correct and quite time consuming to make even one replacement module and I was not completely satisfied that it reached the performance of the original modules. After attempting this design, it gave me great respect and admiration for the designers of the original module.

I also made an experimental L-C delay line with an inductor, capacitors and termination resistor & 74S04 IC to resemble the original method. The four ferrite sections were scavenged from transistor radio 455kHz IF transformers and glued together to make a ferrite stick:

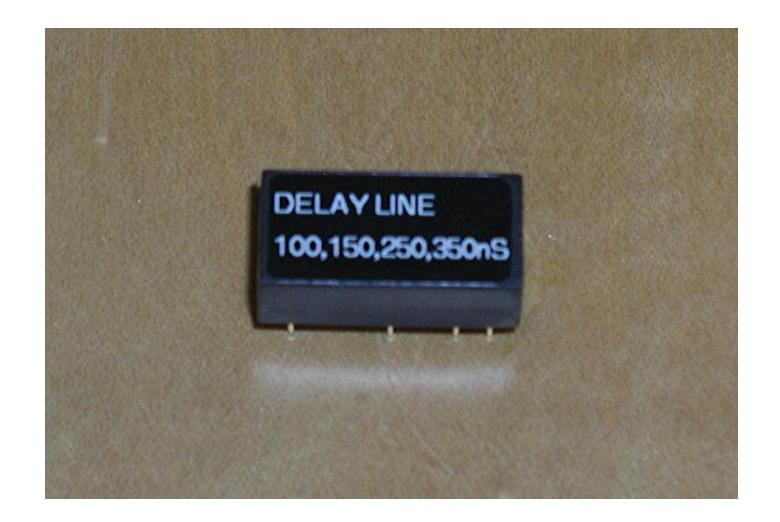
The only difference I could detect with the performance of the DS1000Z vs the DS1100Z is that the power supply voltage (+5V) affects the exact delays a little in the DS1000, but not the DS1100Z (for the reasons outlined above). Both of these restore the 16KRA card back to normal working order, unlike my first two failed attempts.

Once I had made the delay line on the custom adaptics and tested it, there was the issue of appearance. I wanted the module to look about the same as Data Delay Devices's original module. Therefore a housing or cover would be needed. I found that the housing on a 7 way black CTS DIP switch was about the same size. So I removed one from a switch, sealed the 7 rectangular holes with epoxy resin and painted the top. It was then glued over the adapter and labelled. I had specifically made the adapter pcb to be 9 x 19mm with this idea in mind. The photo below shows this:

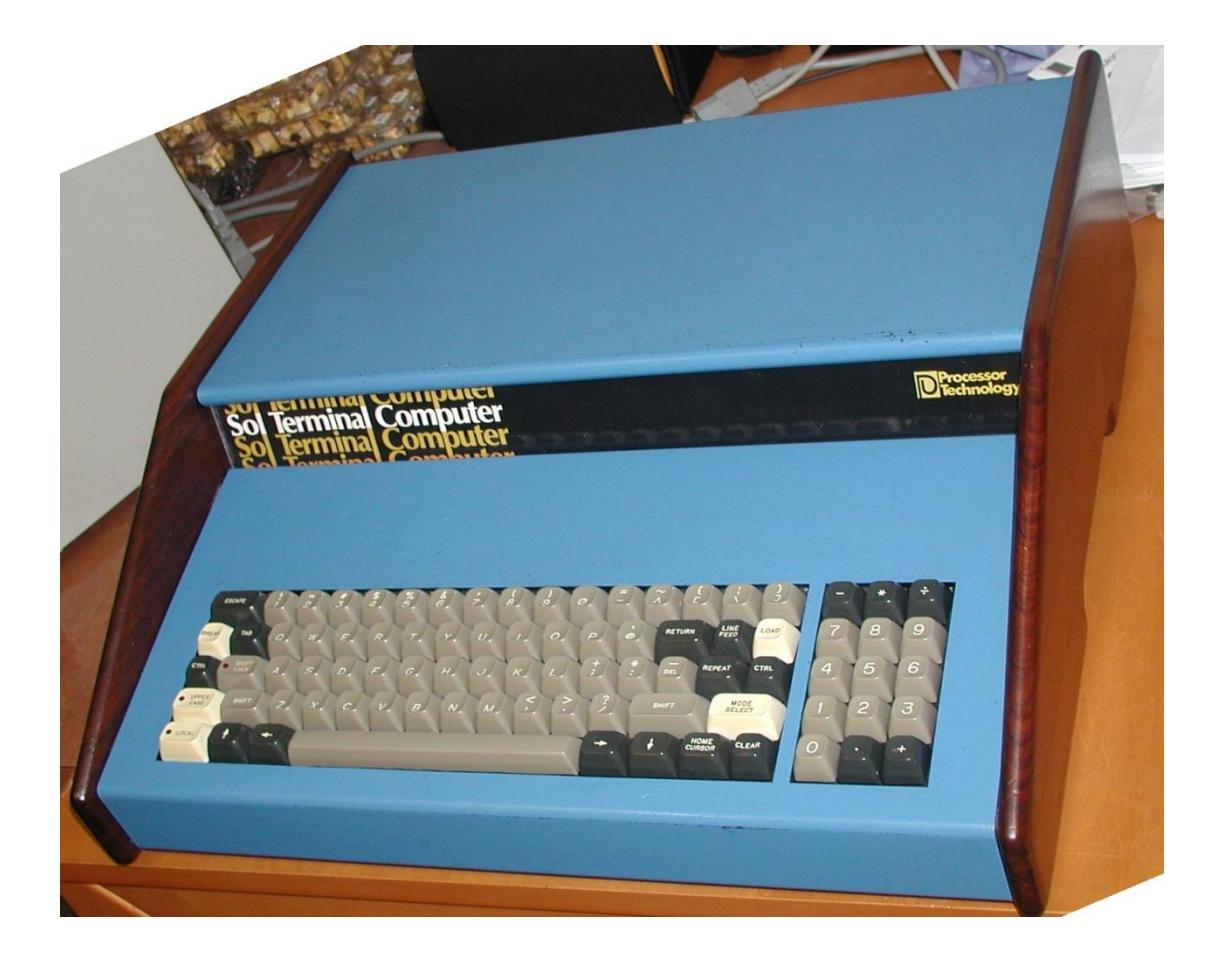
5) The power supply required replacement of a 6-32 Nylon screw that fixes the 7912 regulator to the heat-sink with a metal screw and insulating washer, new mica washer and new thermal compound. The original 7912 was heat damaged, because with heat the nylon screw stretches and there is loss of a solid contact between the 7912 and the heat-sink. This nylon screw was a very bad idea.

For cosmetic restoration, the timber side panels were gently rubbed down with 600 grade paper and re-spayed with satin wood varnish to restore the original appearance. They keys and paintwork was also cleaned to give the computer a new looking exterior finish.
