Index**A**

Announcement - IBM Fiftieth Anniversary Model Typewriter 12
Announcement of the IBM Model 95 Typewriter With Extended Memory 22
APM Correction 8
APM Revisions 12

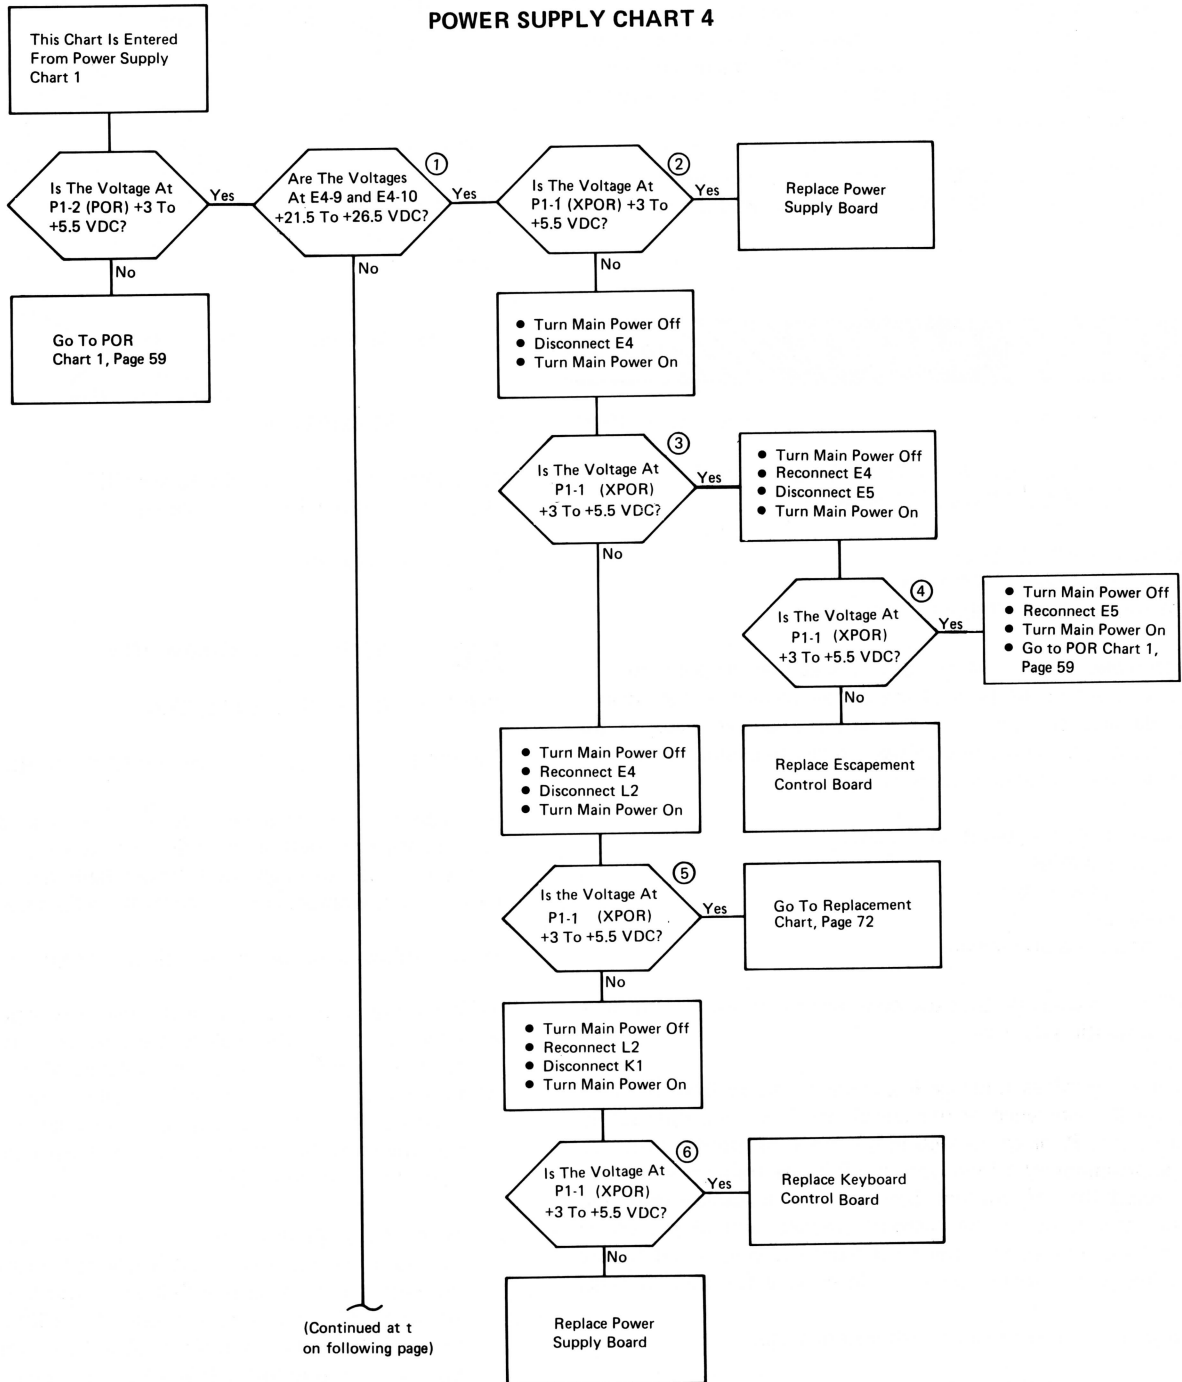
SUBJECT: DIAGNOSTIC MANUAL REVISION

The following flowchart should be used in place of the existing one in the Diagnostic Manual (F/N SR28-0075-1).

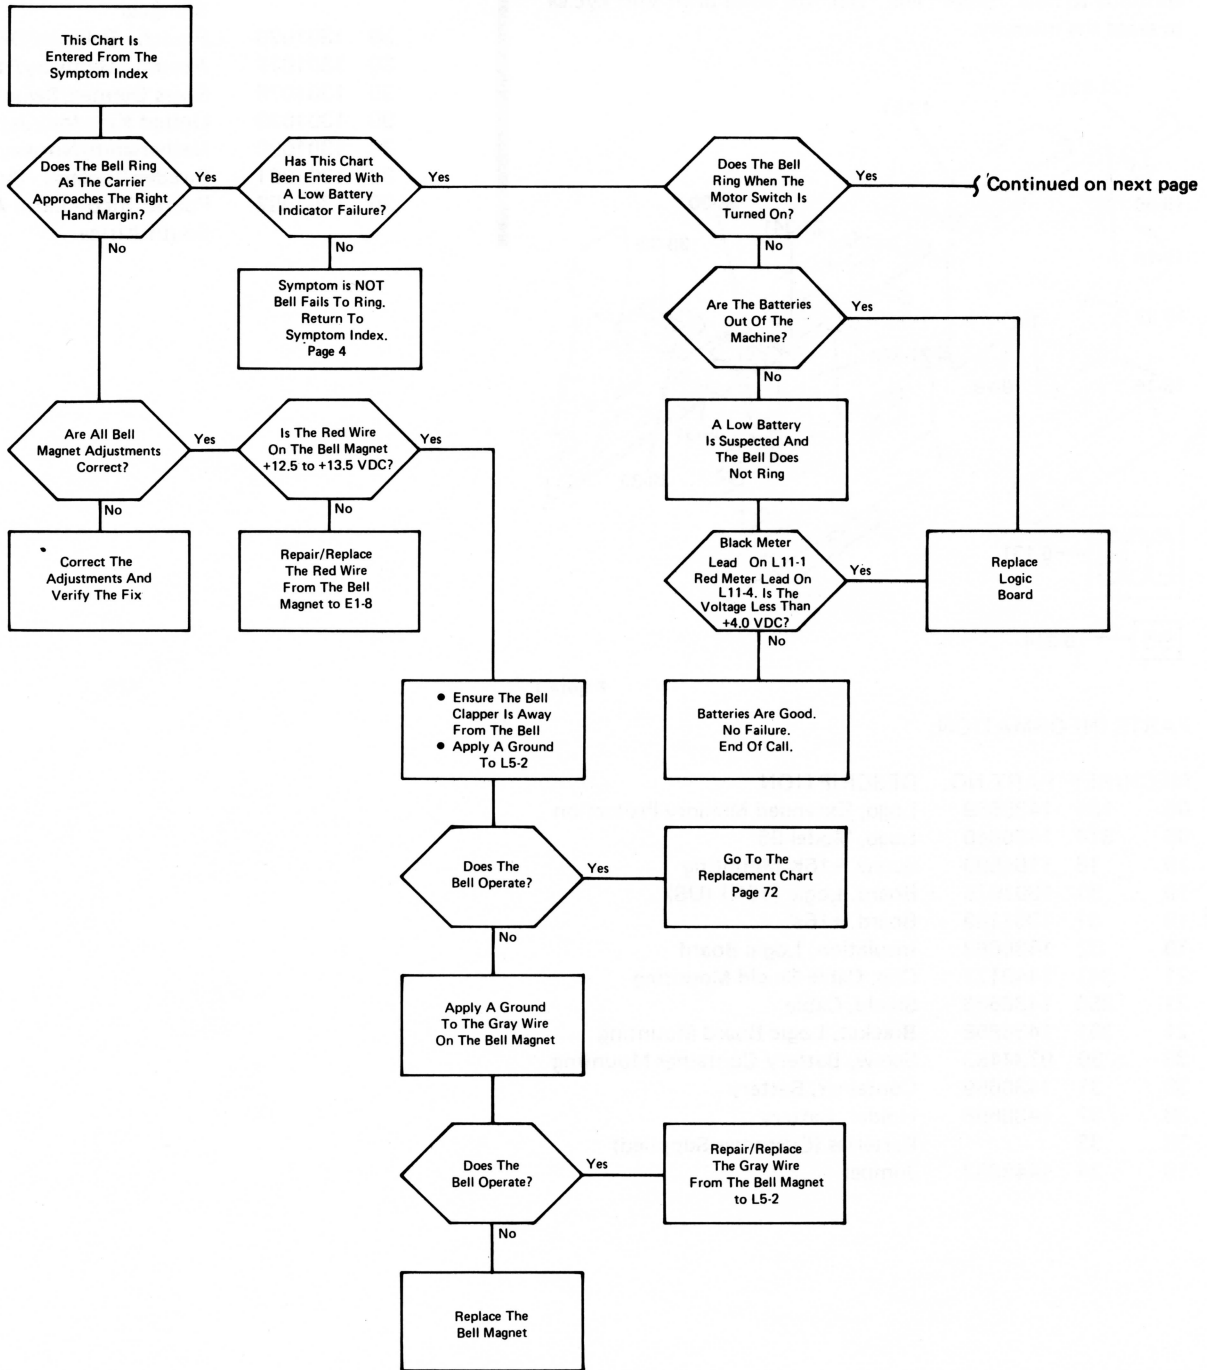
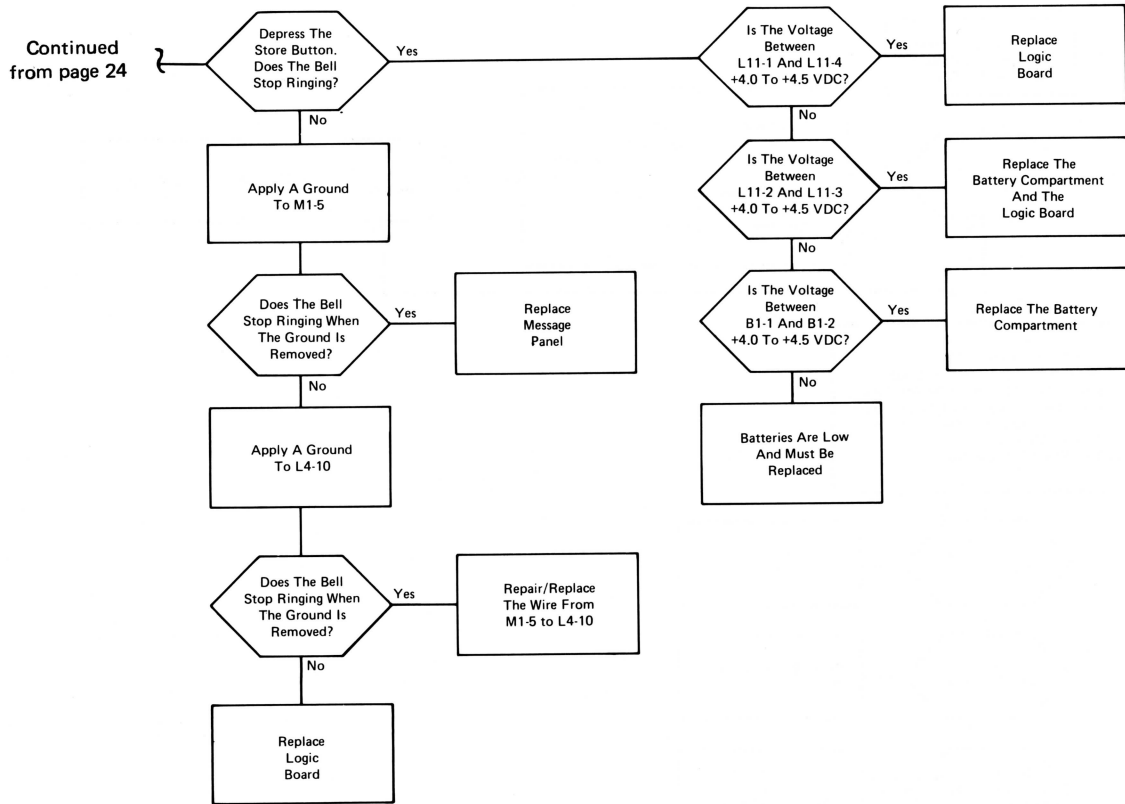
Figure 2

Three diagnostic charts have been changed to reflect a machine with Extended Memory Protection installed. These are the Bell Chart (Figure 2), the Replacement Chart 1 (Figure 3), and the Replacement Chart 2 (Figure 4).

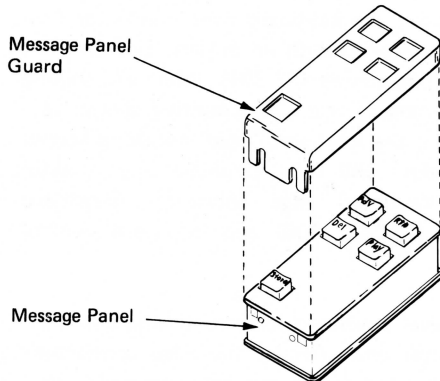
Figure 1

A message control panel guard (20-75) is now available for installation on Models 65, 75, 85 and 95. The new guard, when installed, will prevent accidental depression of the message panel buttons. The guard can also be used to eliminate unwanted message panel operations when diagnosing system busy problems.

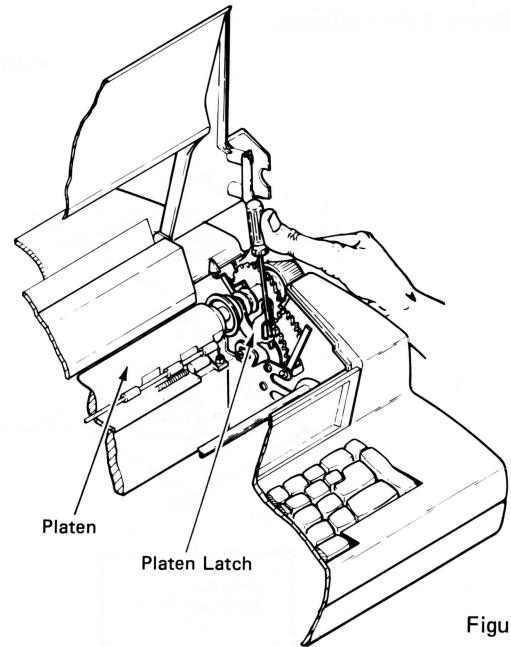
Figure 1

Care should be exercised to avoid trapping a finger between the RH platen latch and the top cover when removing the platen. Either of these suggested procedures may be used to remove the platen:

- A)
 1. Pull the platen detent release lever forward.
 2. Release both platen latches.
 3. Remove the platen.
- B)
 1. Insert the blade of a small screwdriver as shown in Fig. 1. (Note: Blade is positioned behind the RH platen latch stop lug.)
 2. Move the screwdriver handle to the rear, releasing the RH platen latch.
 3. Release the LH platen latch.
 4. Remove the platen.

NOTE: File smooth any rough edges found on the top cover in the area of the RH platen latch.

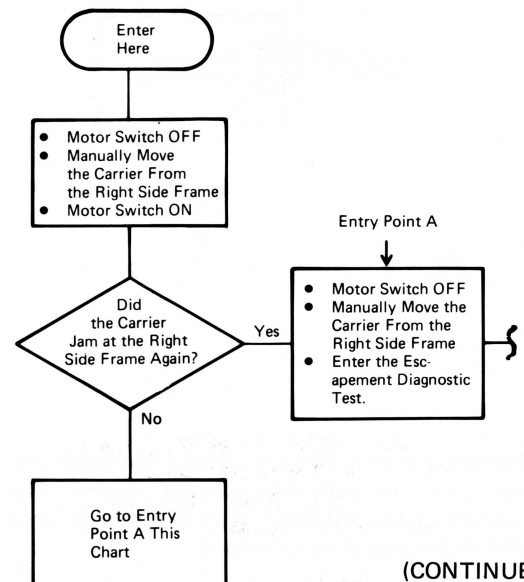
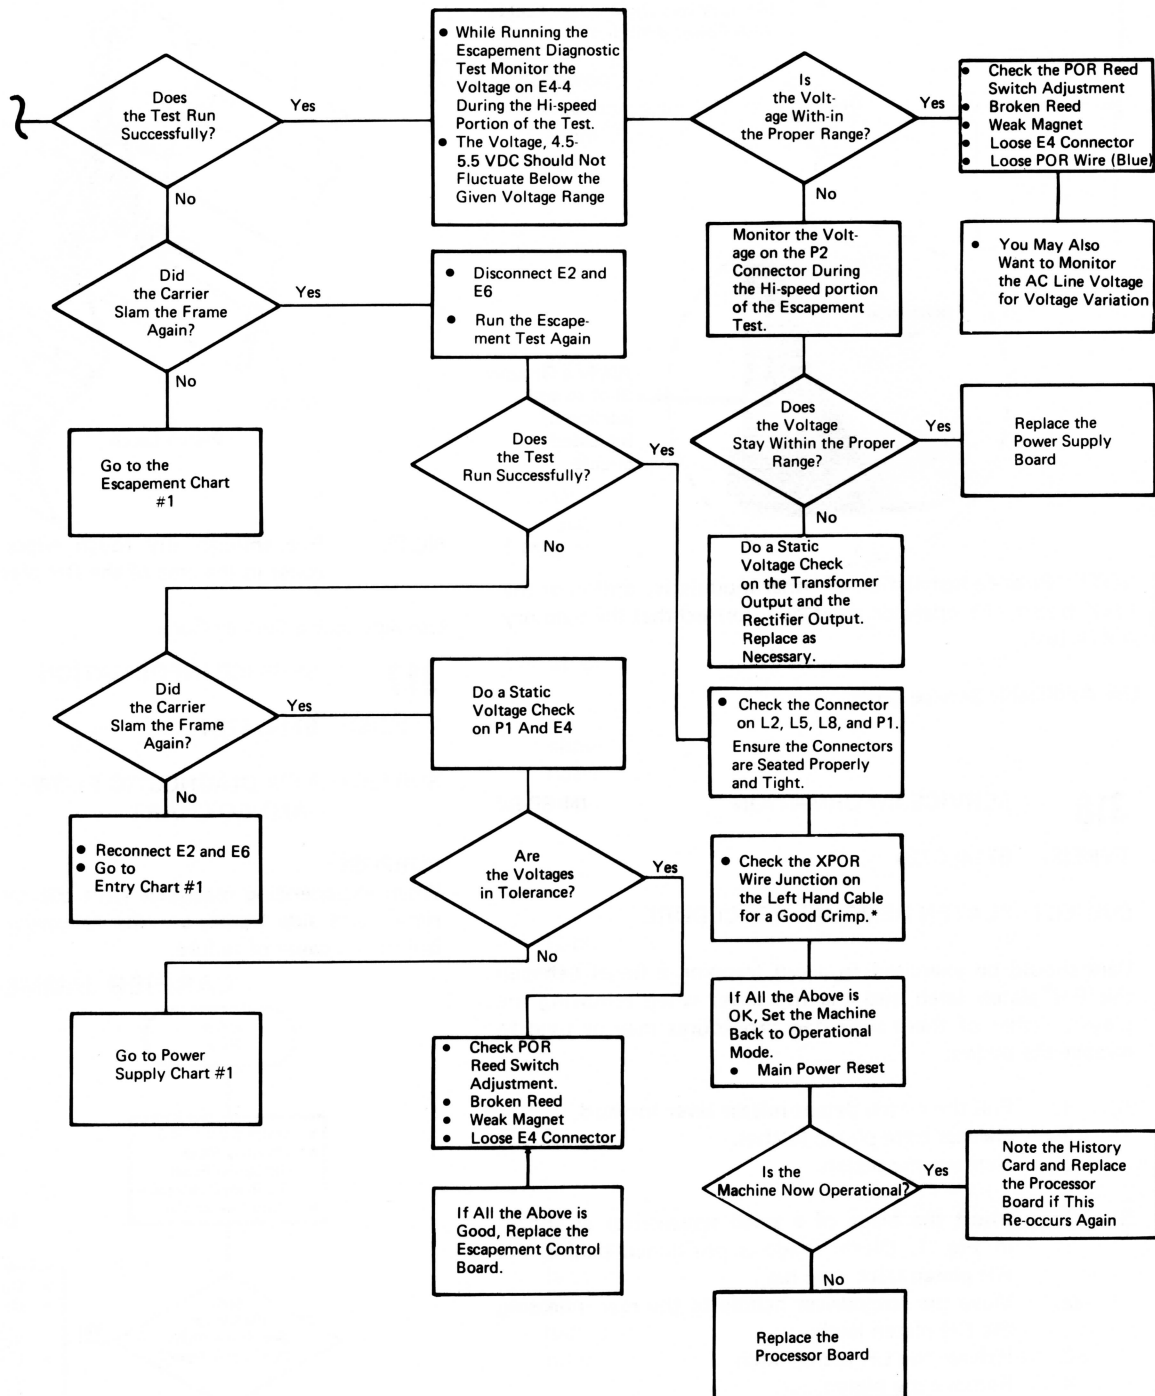
CARRIER JAMMED CHART

When experiencing machines with the carrier jammed at the right hand side frame, use the following flow chart to help isolate the cause of failure.

*The XPOR wire junction is a crimp connector with two yellow wires and one white wire crimped together. The junction is located on the left hand cable between the processor board and the keyboard control board.
