HINSDALE CENTRAL OFFICE FIRE FINAL REPORT

EXECUTIVE SUMMARY

Joint Report of:

March 1989

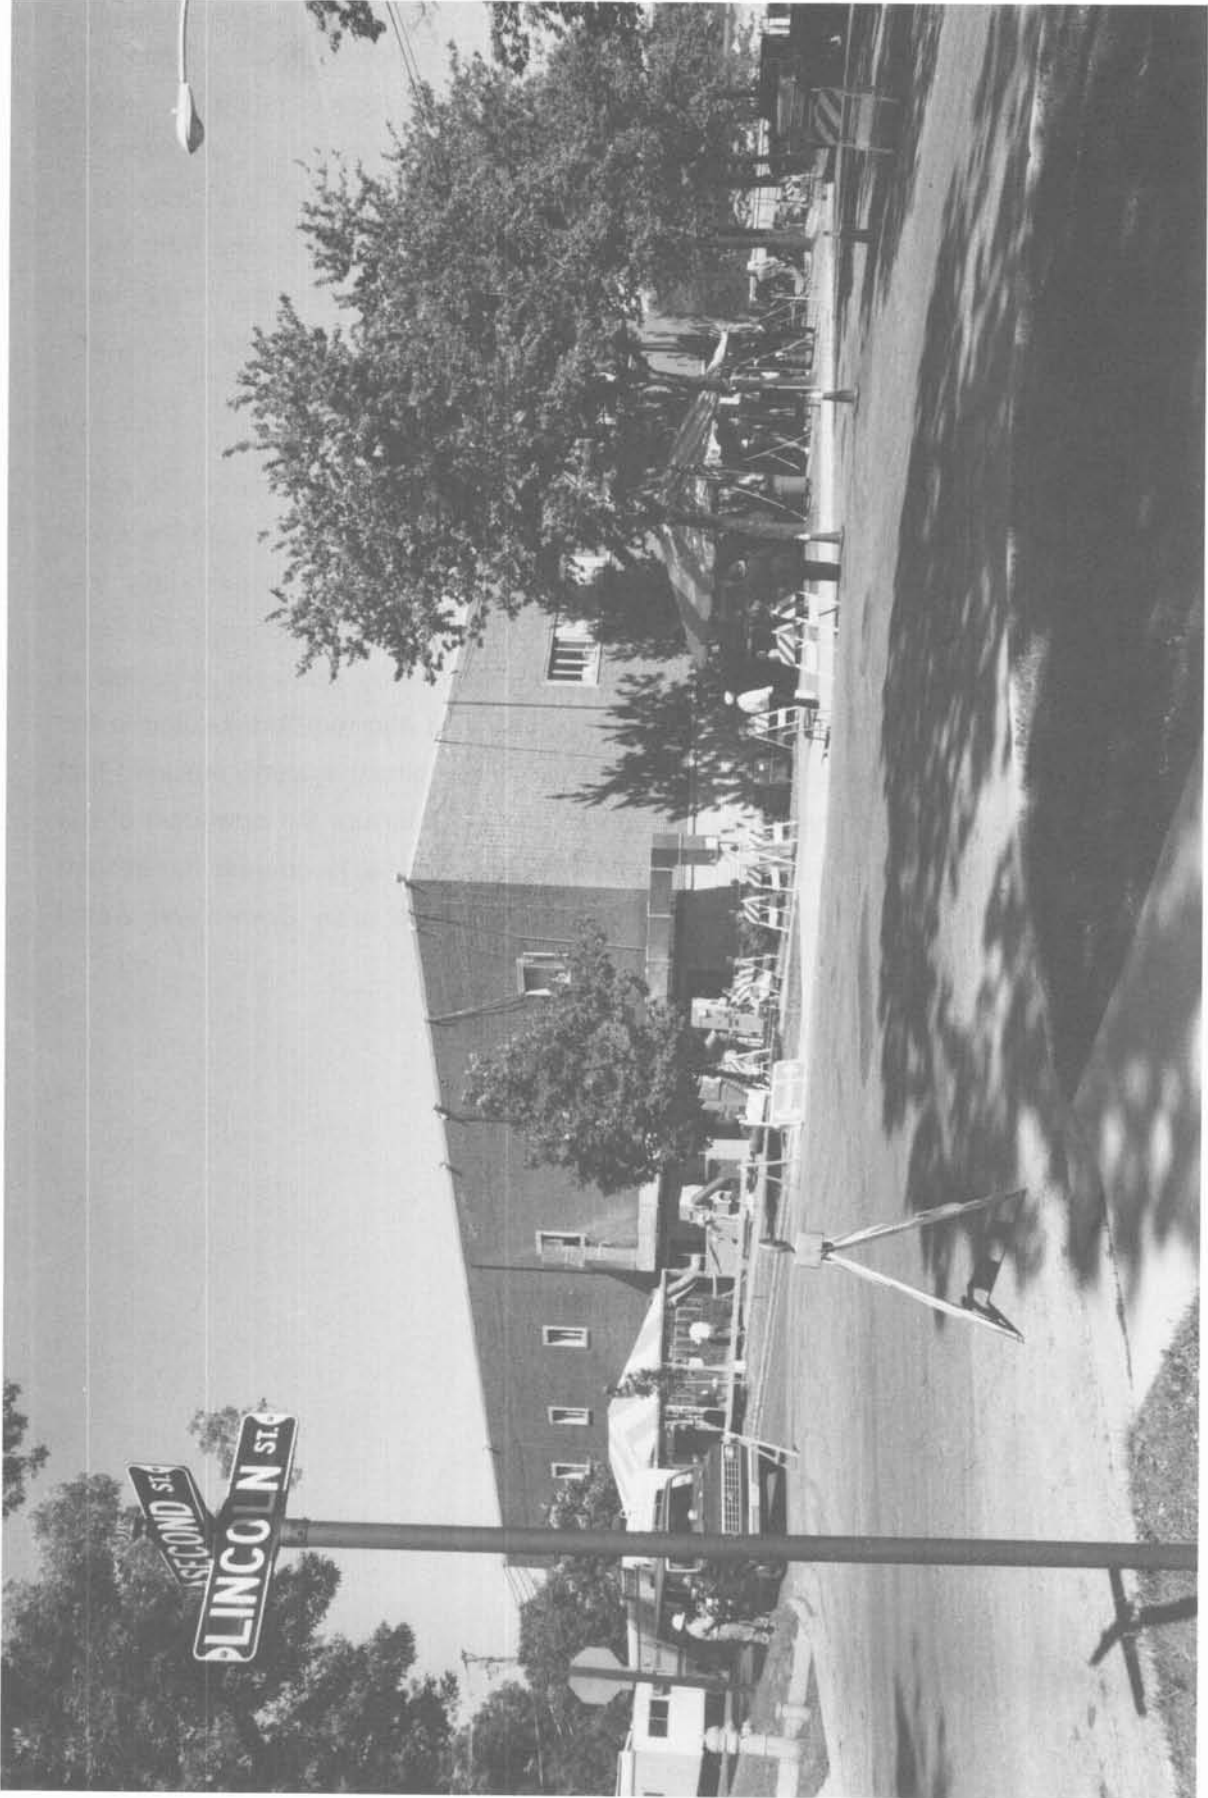
The Hinsdale Central Office (HCO) building is located at 120 South Lincoln Street in Hinsdale, Illinois, and occupies the northwest corner of Lincoln Street and Second Avenue. The HCO is shown in Photograph 1 as it appeared during the fire recovery.

Photograph 1.
The Hinsdale Central Office Building during recovery.
