HP 9133/9134 D/H/L Service Manual

Manual part number: 5957-6560

Edition 2
E0488

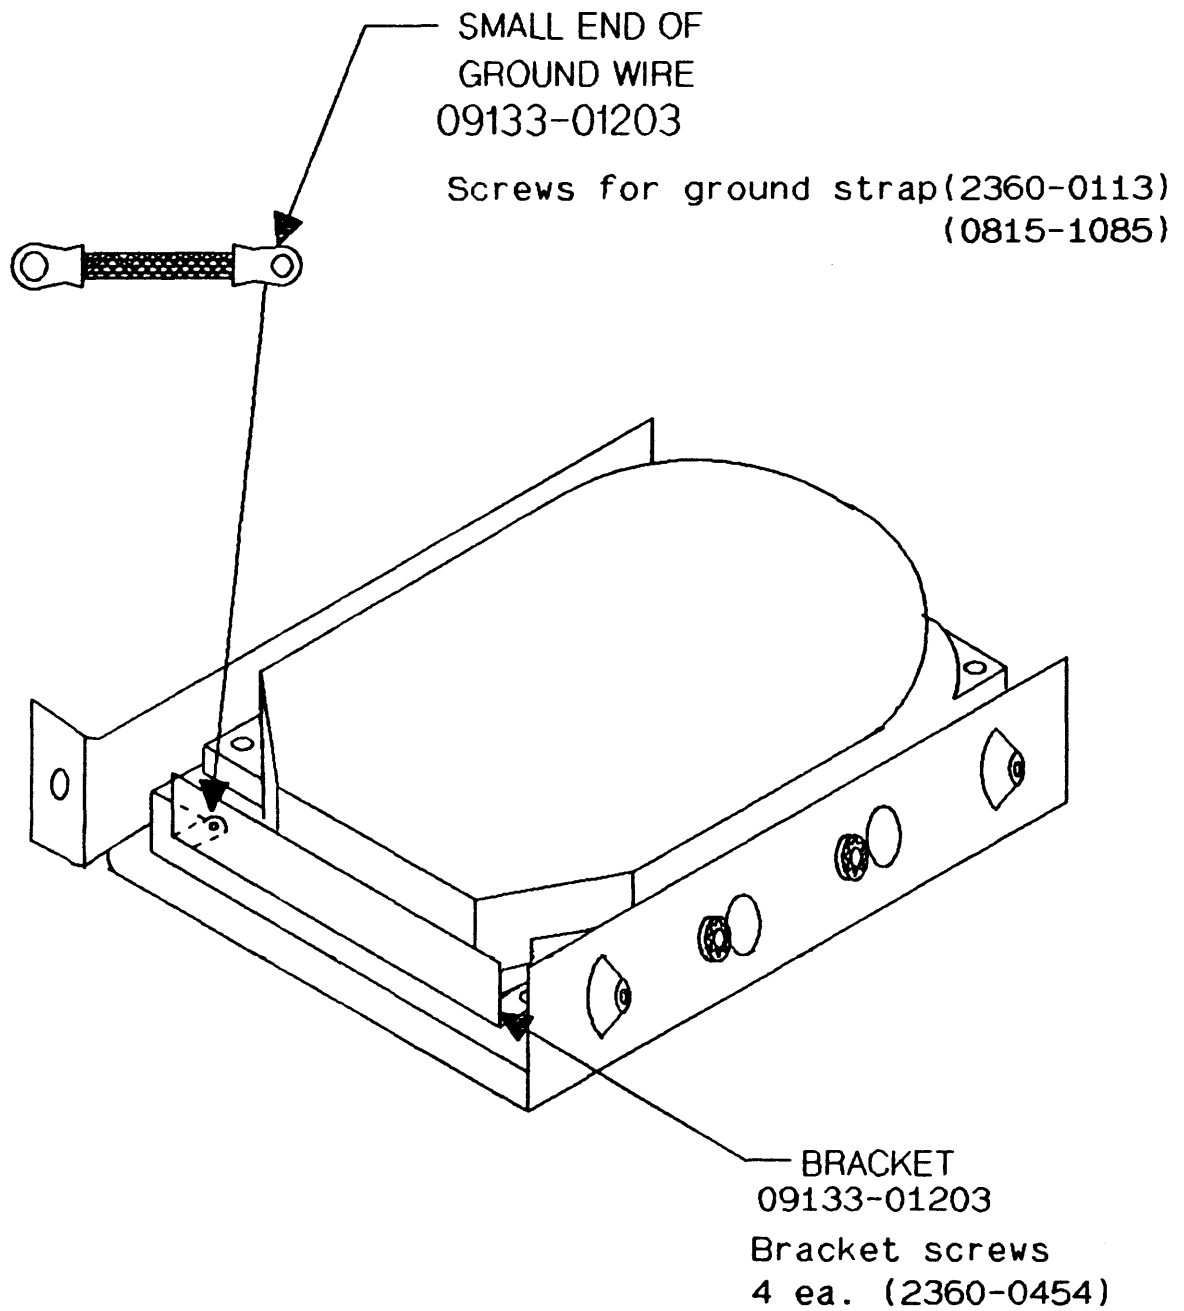
Figure 5-1. 9133/34H and L Winchester mounting bracket.

The HP 9133H and L have a different mounting bracket for the Winchester drive assembly. Following is a list of part numbers that are associated with the bracket and drive. Figure 5-1 shows the bracket, drive and ground strap.

Bracket	09133-01203
Bracket screws	2360-0454
Ground strap	09133-61620 (H only)
Ground strap screws	
to bracket	0515-1085
to chassis	2360-0113

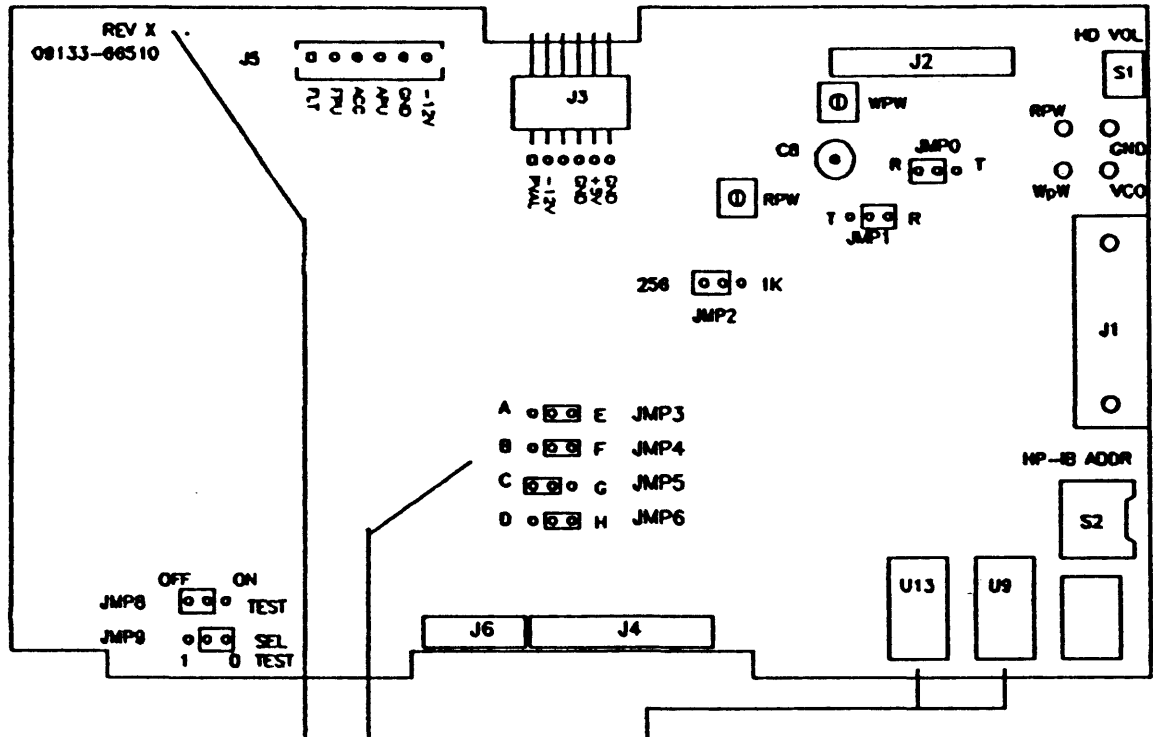
Product	S/N Prefix	Rev	JMP3-JMP6	Required Firmware
9133D	2419A/2511A	B	EFCH	Any 09133-8910X/-8920X
9133D	2419A/2511A	C	EFGD	09133-89105/-89205 and above
9133D	2513A and above	B	ABCH	09133-89105/-89205 and above
9133D	2513A and above	C	ABCD	09133-89105/-89205 and above
9134D	2425A	B	EFGH	Any 09133-8910X/-8920X
9134D	2425A	C	EFGD	09133-89105/-89205 and above
9134D	2514A and above	B	ABGH	09133-89105/-89205 and above
9134D	2514A and above	C	ABGD	09133-89105/-89205 and above
9133H	ALL	B	AFCH	09133-89105/-89205 and above
9133H	ALL	C	AFGD	09133-89105/-89205 and above
9134H	ALL	B	AFGH	09133-89105/-89205 and above
9134H	ALL	C	AFGD	09133-89105/-89205 and above

NOTE: JMP2 is shown in the position for standard product.
 Option001 will have JMP2 in 1K position.

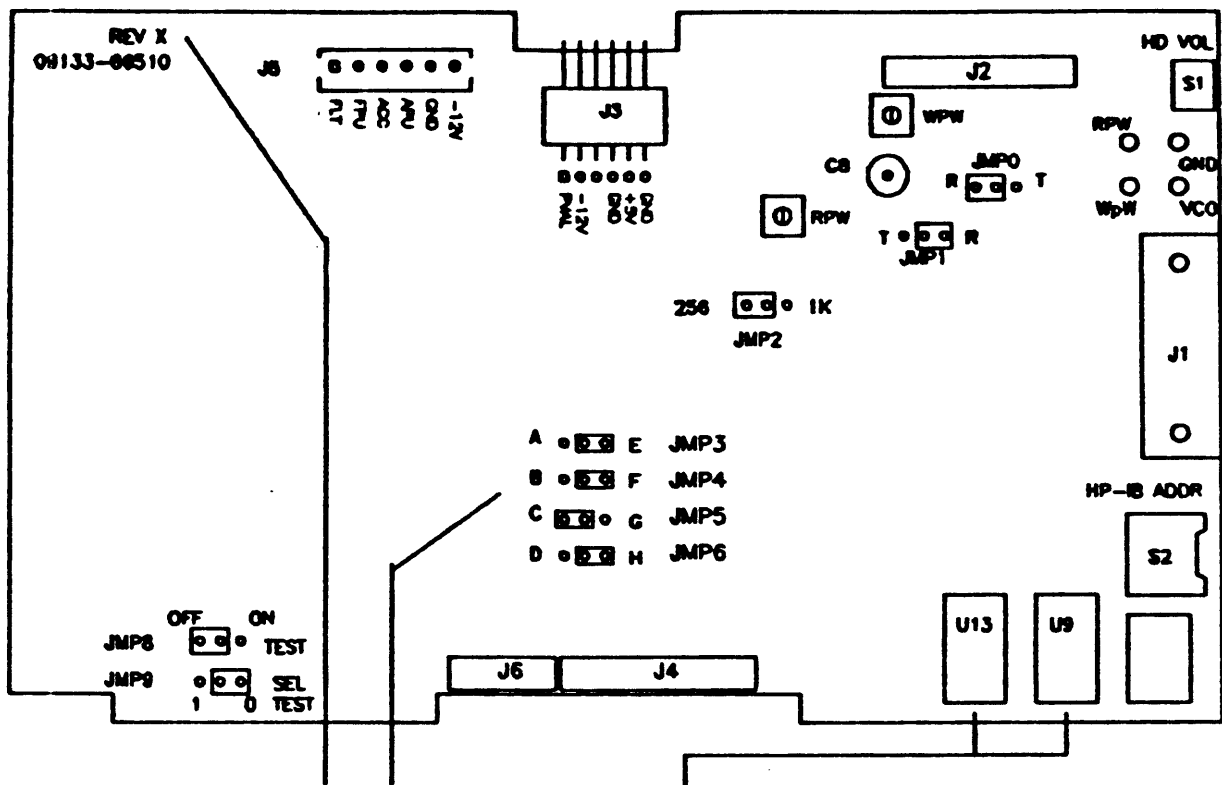
Product	S/N Prefix	Rev	JMP3-JMP6	Required Firmware
9133D	2419A/2511A	B	EFCH	Any 09133-8910X/-8920X
9133D	2419A/2511A	C	EFCD	09133-89105/-89205 and above
9133D	2513A and above	B	ABCH	09133-89105/-89205 and above
9133D	2513A and above	C	ABCD	09133-89105/-89205 and above
9134D	2425A	B	EFGH	Any 09133-8910X/-8920X
9134D	2425A	C	EFGD	09133-89105/-89205 and above
9134D	2514A and above	B	ABGH	09133-89105/-89205 and above
9134D	2514A and above	C	ABGD	09133-89105/-89205 and above
9133H	ALL	B	AFCH	09133-89105/-89205 and above
9133H	ALL	C	AFCD	09133-89105/-89205 and above
9134H	ALL	B	AFGH	09133-89105/-89205 and above
9134H	ALL	C	AFGD	09133-89105/-89205 and above

NOTE: JMP2 is shown in the position for standard product.
Option001 will have JMP2 in 1K position.

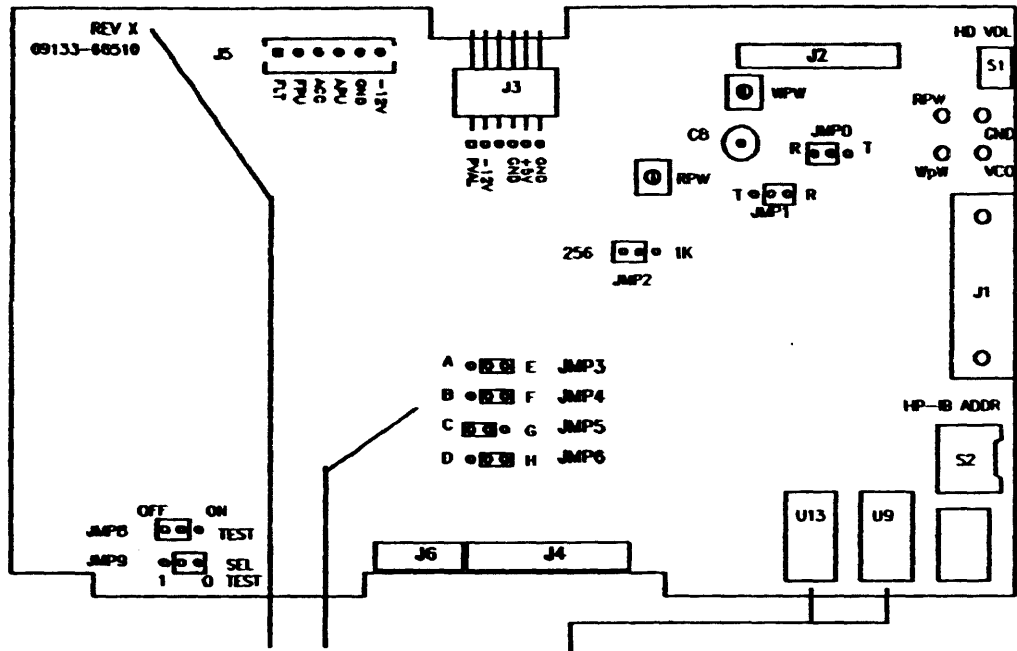
Product	S/N Prefix	Rev*	JMP3-JMP6	Required Firmware
9133D	2419A/2511A	B	EFCH	Any 09133-8910X/-8920X
9133D	2419A/2511A	C	EFCD	09133-89105/-89205 and above
9133D	2513A and above	B	ABCH	09133-89105/-89205 and above
9133D	2513A and above	C	ABCD	09133-89105/-89205 and above
9134D	2425A	B	EFGH	Any 09133-8910X/-8920X
9134D	2425A	C	EFGD	09133-89105/-89205 and above
9134D	2514A and above	B	ABGH	09133-89105/-89205 and above
9134D	2514A and above	C	ABGD	09133-89105/-89205 and above
9133H	ALL	B	AFCH	09133-89105/-89205 and above
9133H	ALL	C	AFCD	09133-89105/-89205 and above
9134H	ALL	B	AFGH	09133-89105/-89205 and above
9134H	ALL	C	AFGD	09133-89105/-89205 and above
9133L	ALL	B	EBCH	09133-89108/-89208 and above
9133L	ALL	C	EBCD	09133-89108/-89208 and above
9134L	ALL	B	EBGH	09133-89108/-89208 and above
9134L	ALL	C	EBGD	09133-89108/-89208 and above

NOTE: JMP2 is shown in the position for a standard product.
Option 001 will have JMP2 in the 1K position.
