## Altair Floppy with Pertec FD-410 (DC Belt Drive Hub Motor)

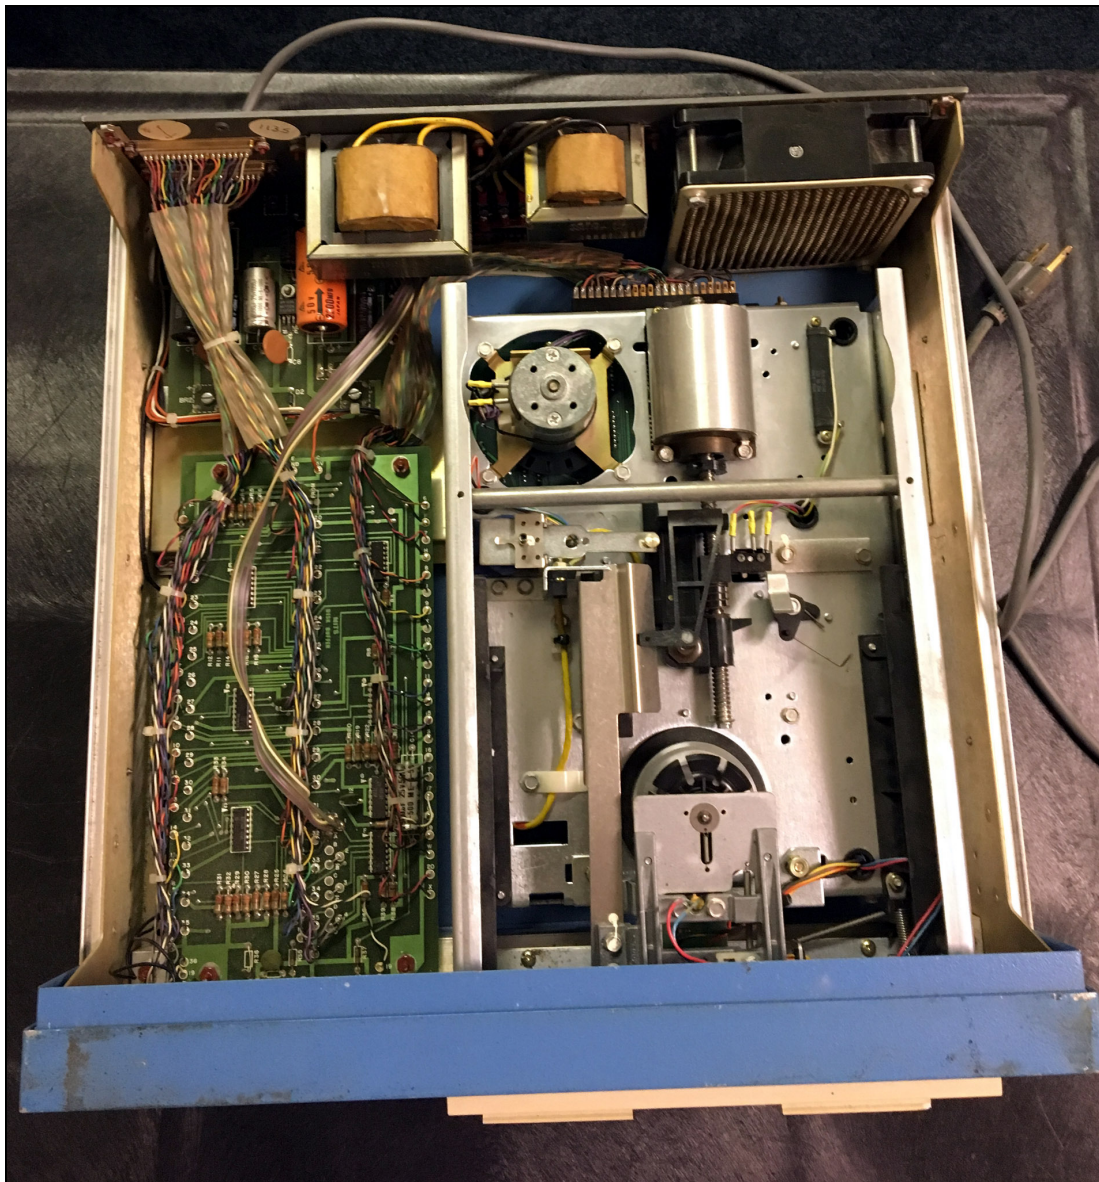
Since the Altair product line was cancelled prior to the introduction of the FD-410, this drive would not have been original equipment in an Altair drive cabinet. However, the drive could be used as a drop in replacement for the original FD-400 drive. Below is an Altair drive I received in which an FD-410 drive was installed. The DC hub motor can be seen in the back left corner of the drive in the large hole that is present for the AC motor used in the FD-5xx series of drives.

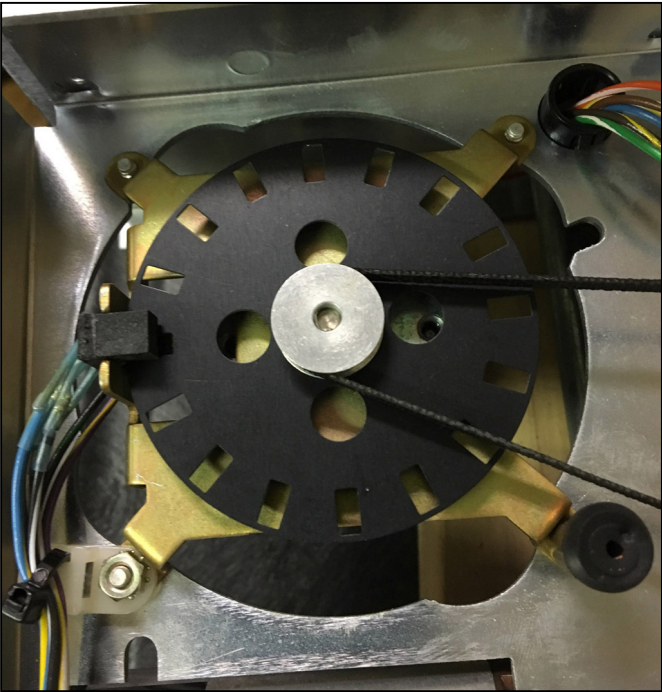
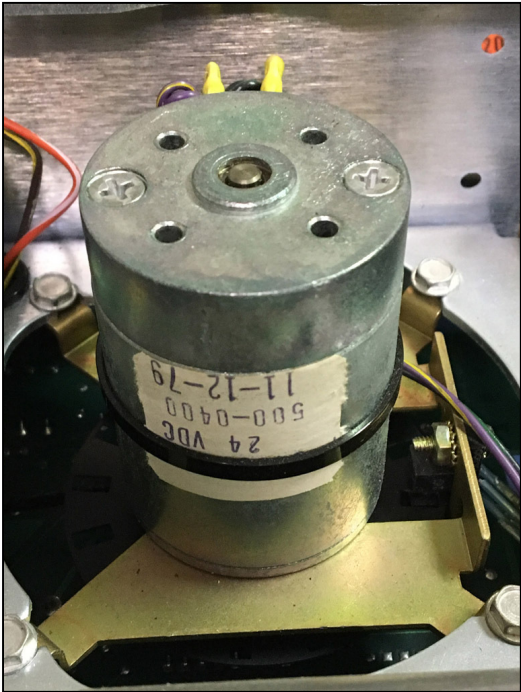
Close-ups of the motor from the bottom and top of the drive chassis are show below. The slotted disk and optical encoder can be seen in the left picture.

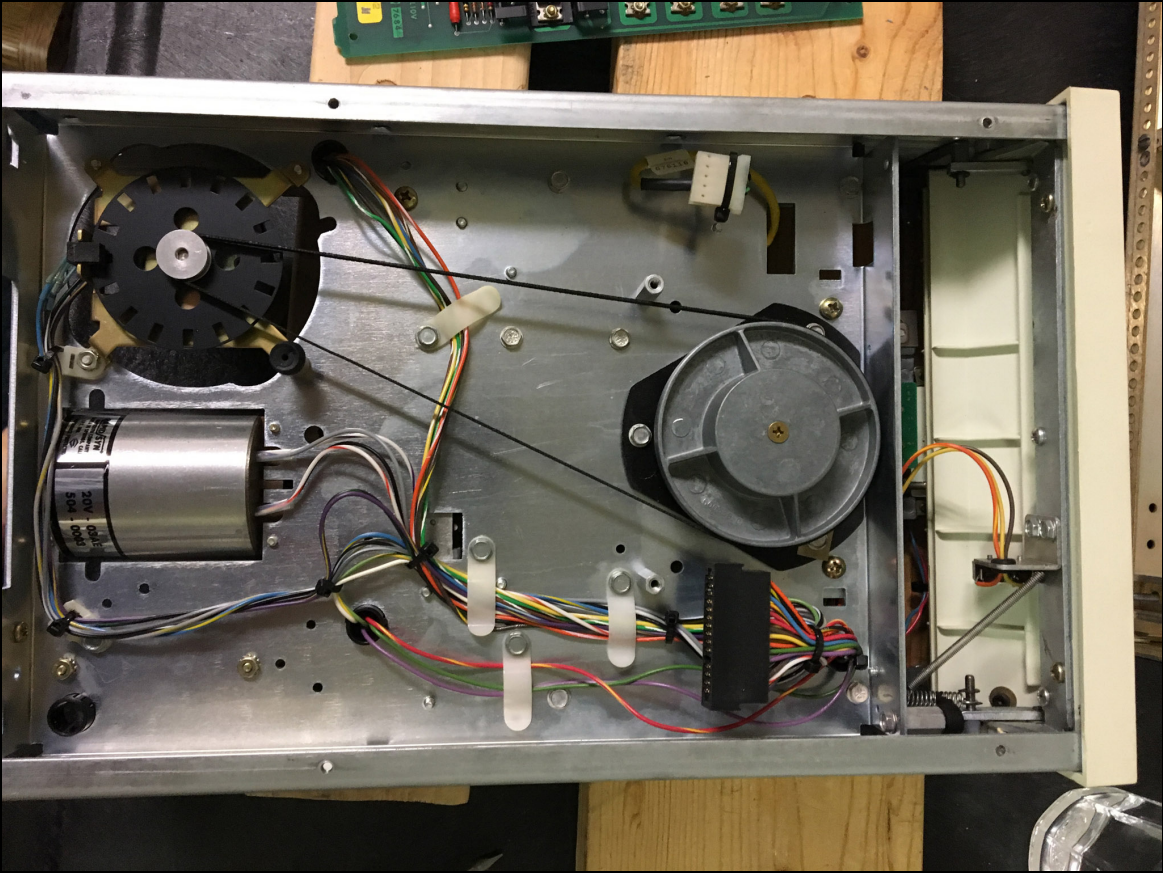
The bottom of the drive with the logic PCB removed is shown below. The hub flywheel and cone is the same as used with the FD-5xx series of AC motor drives.

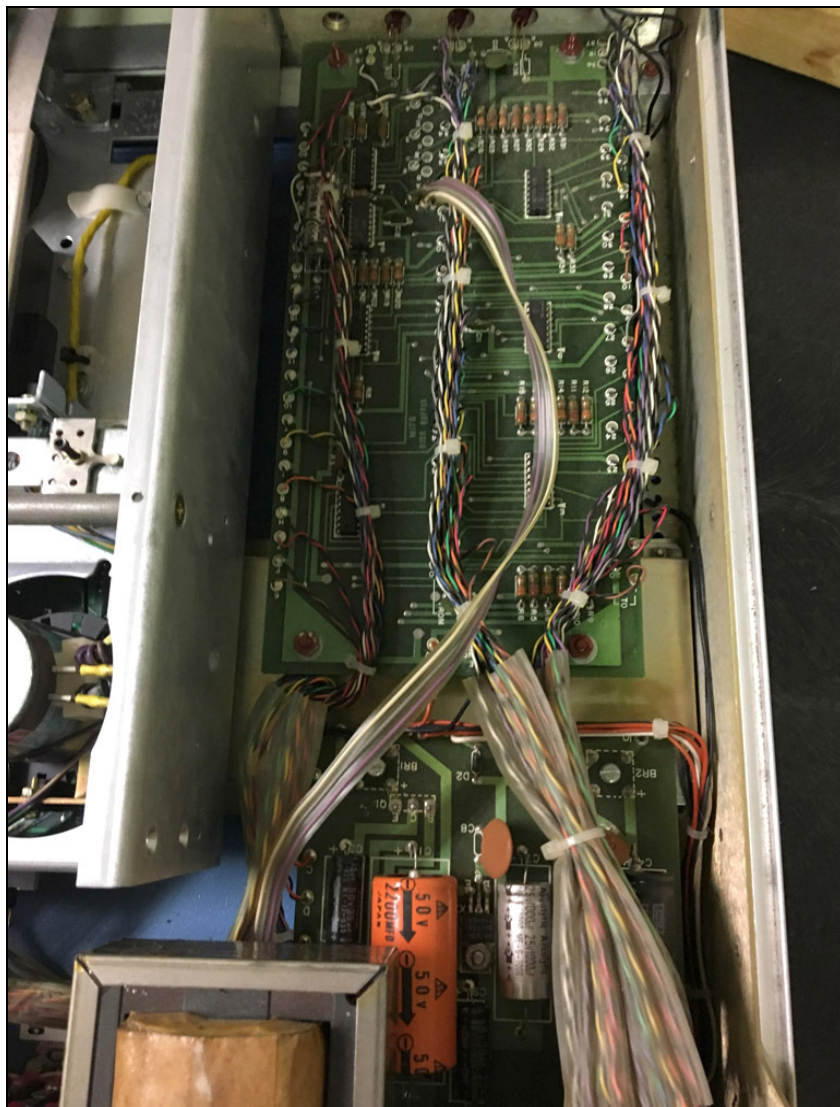
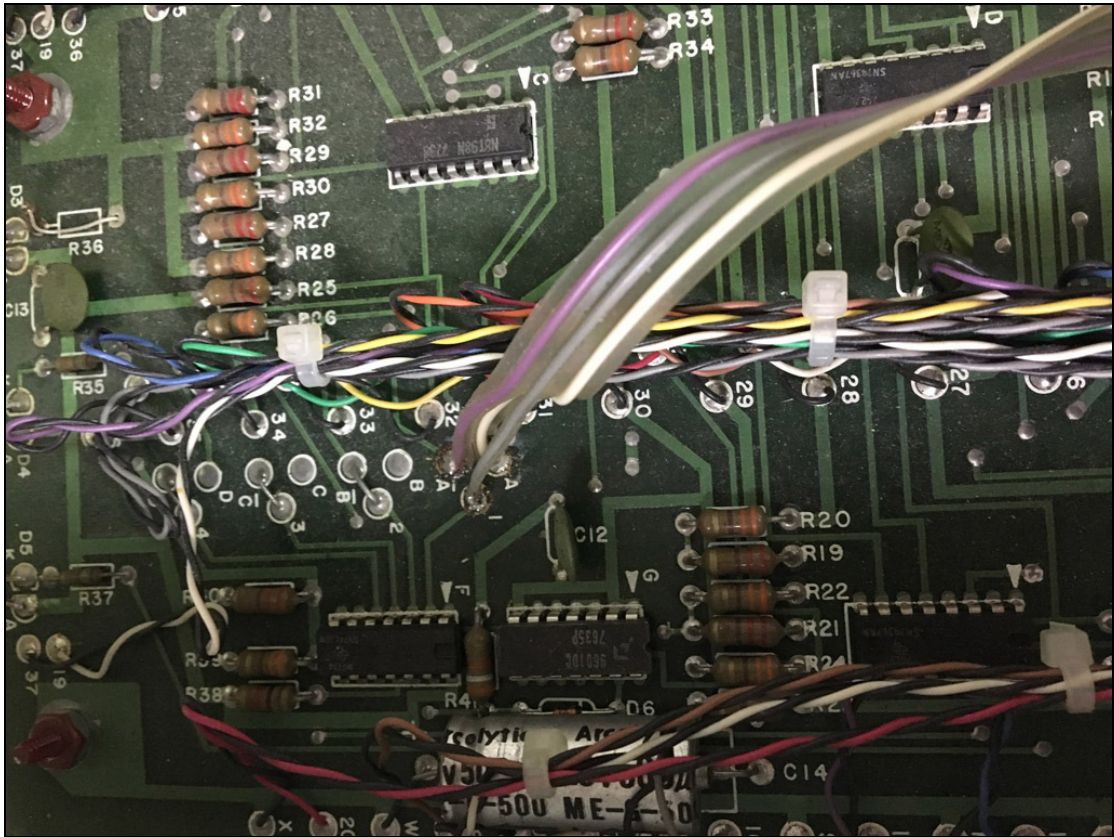
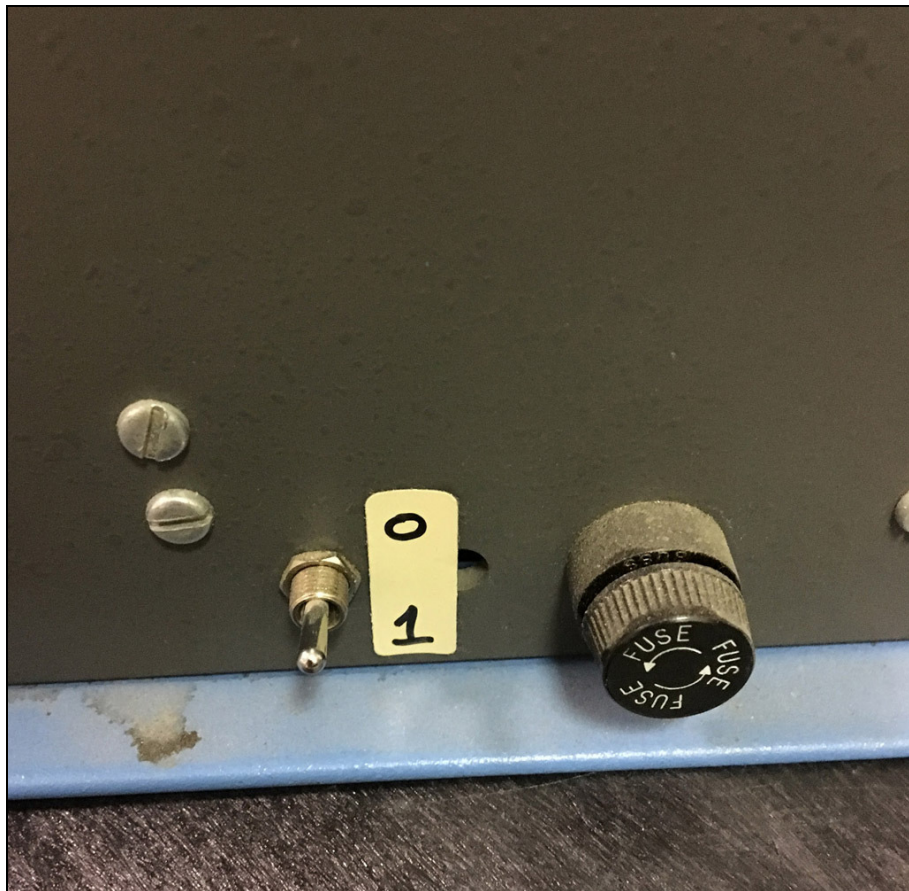
The thin ribbon cable seen below runs from the A0 drive address line (near the front of the PCB) to a switch mounted in the rear panel. This allows selection of drive address zero or one without having to open the cabinet and de-solder/solder a jumper.
