Errata: Installation Manuals for Sun Desktop Systems

This errata introduces two minor changes to the Sun desktop workstation chassis:

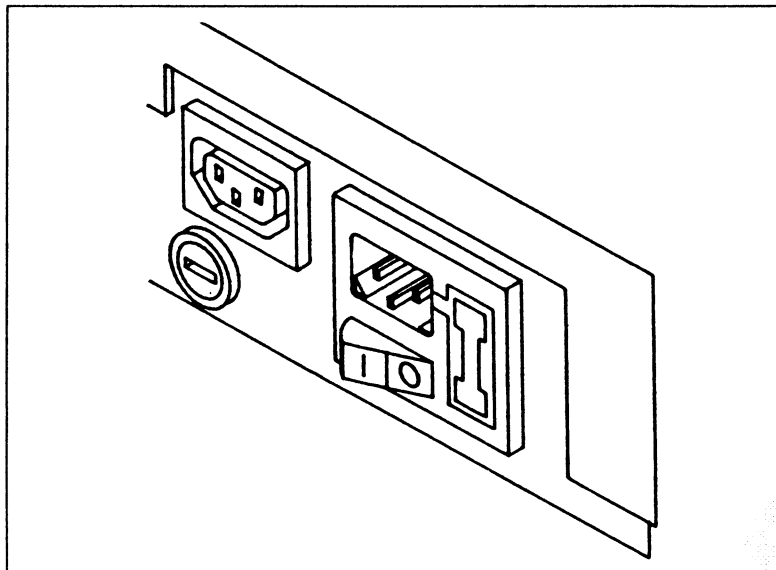
- The first change involves the way the monitor is attached to the chassis. Previously, the monitor rested in a dish-shaped cavity in the top of the chassis, where it was locked in place. The new desktop chassis is flat on top, with no cavity for the monitor. The base of the monitor is a flat pad, which simply rests on top of the chassis. Note that, because of this change, the monitor is now shipped separately from the chassis.
- The second change involves the positioning of the AC power receptacle for the monitor, and the voltage select, both located at the rear of the chassis. The positions of these two components, relative to each other, have been reversed. The AC power receptacle is now located above the voltage select, rather than below it (see the illustration below).
